### Fits:

#### Toyota U140 E&F 4 speeds:

#### Toyota U240 & U241 4 speeds:

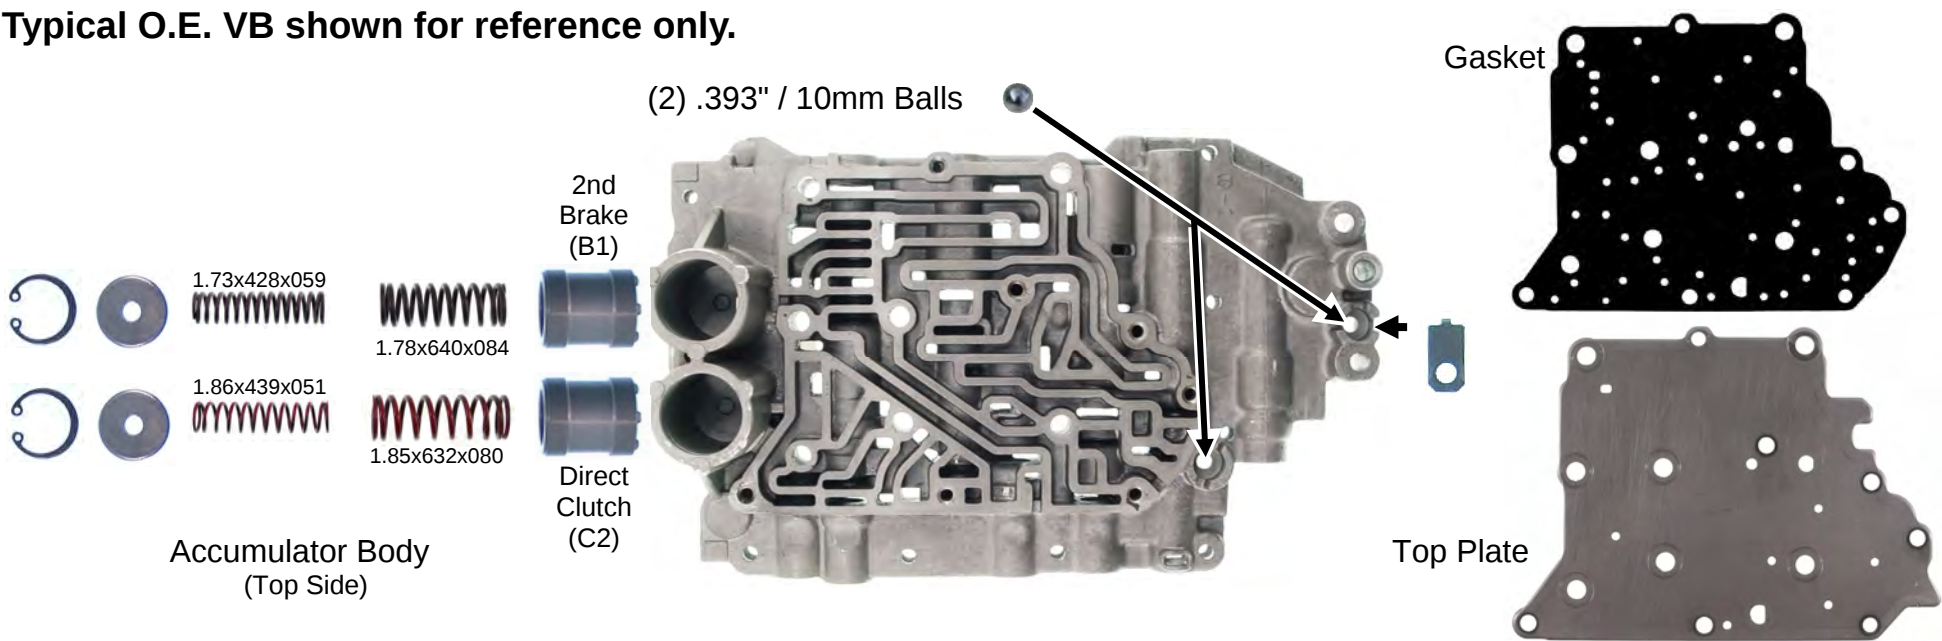
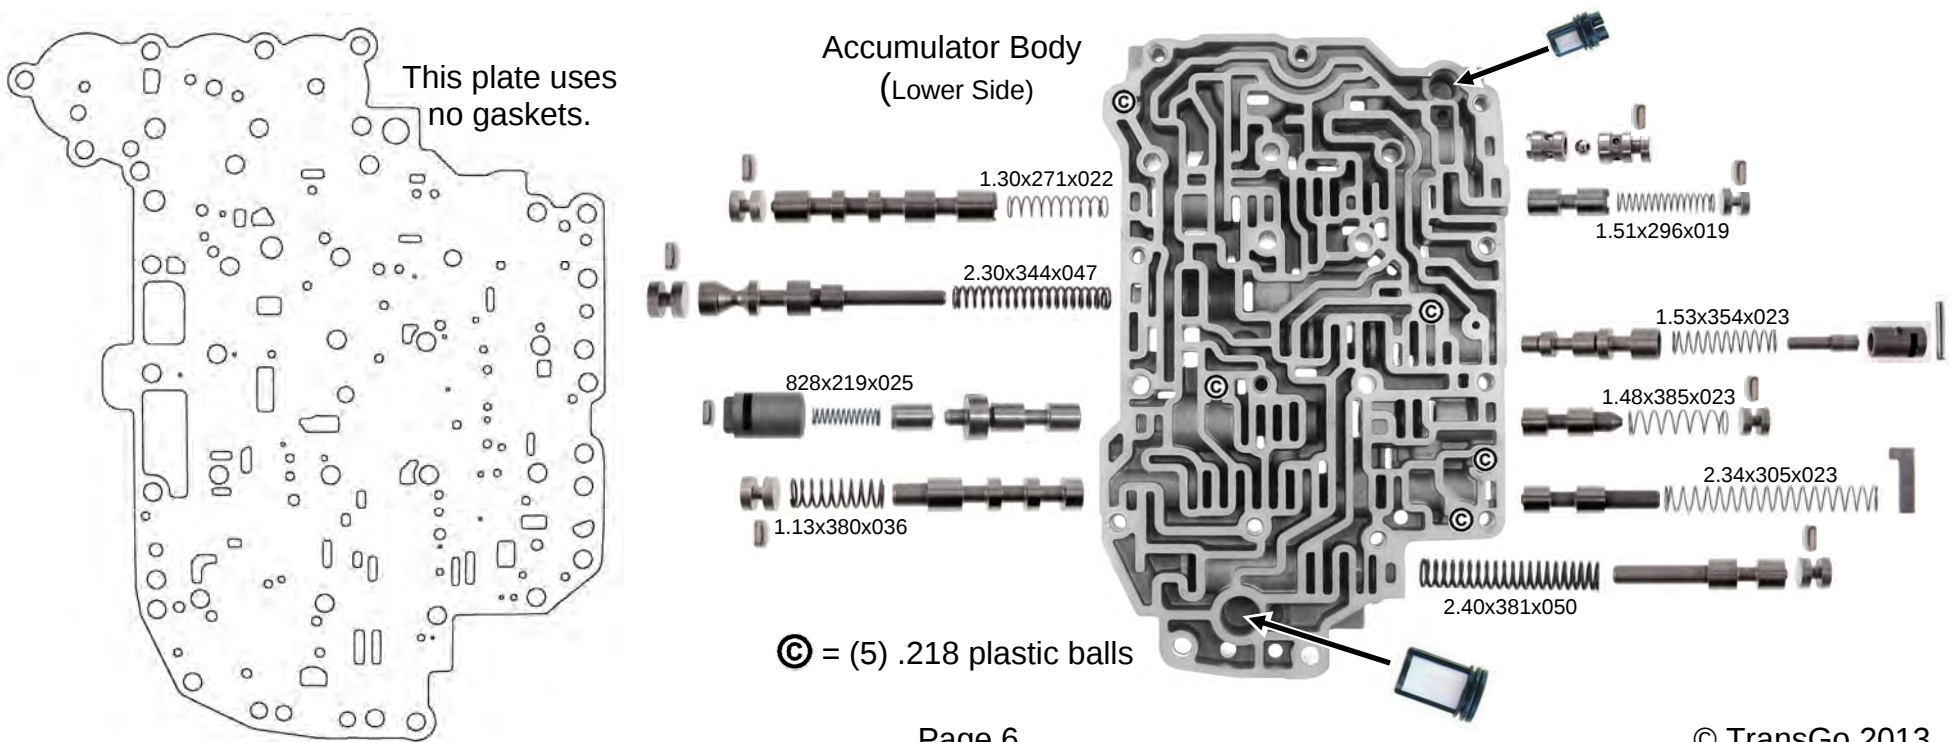
Typical O.E. VB shown for reference only.
