MX40 Pro LED Display Controller

V1.4.0

Release Notes

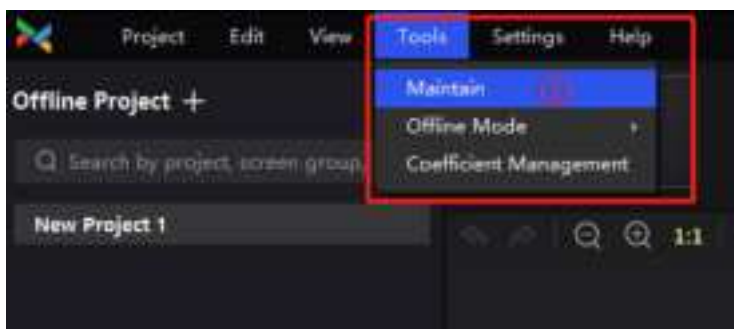
Step 1 From the menu bar, choose **Tools > Maintain**.

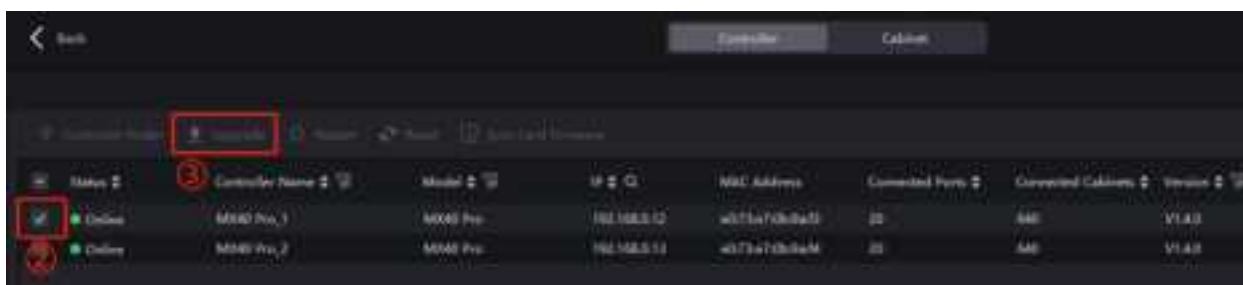
Step 2 On the **Controller** page, select the target controllers.

Step 3 Click **Upgrade**, select the V1.4.0 firmware program file (.img) or .zip file and click **OK**.
