# TECHNICAL SERVICE BULLETIN

| AN23-006A | ITB23-010A | April 4, 2023 |

## SOFTWARE UPDATE FOR INFOTAINMENT ISSUES

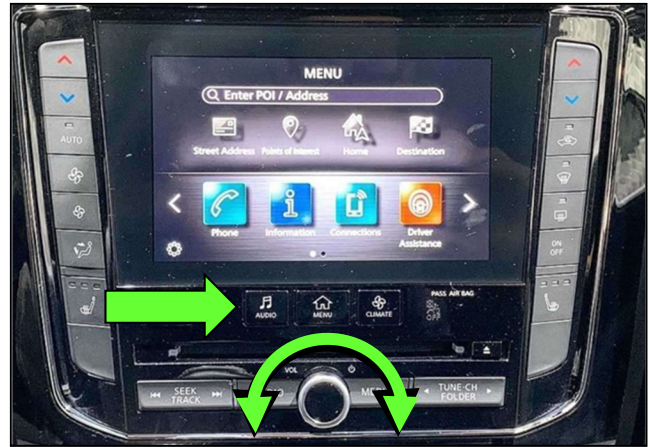
Figure 2

1. Press and hold the **AUDIO** button while, at the same time, rotating the volume knob left-right-left.

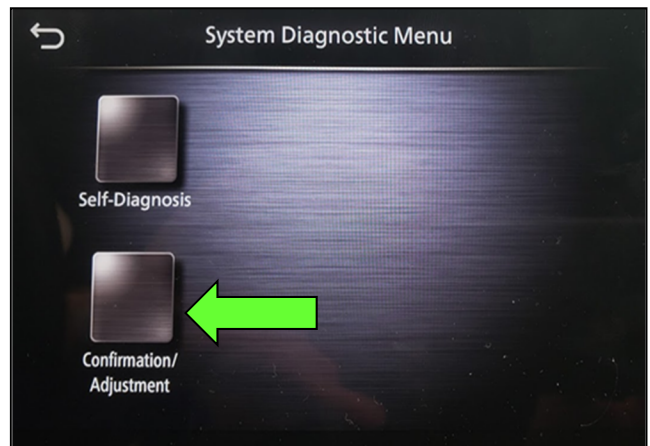
Figure 3

2. Select **Confirmation/Adjustment**.

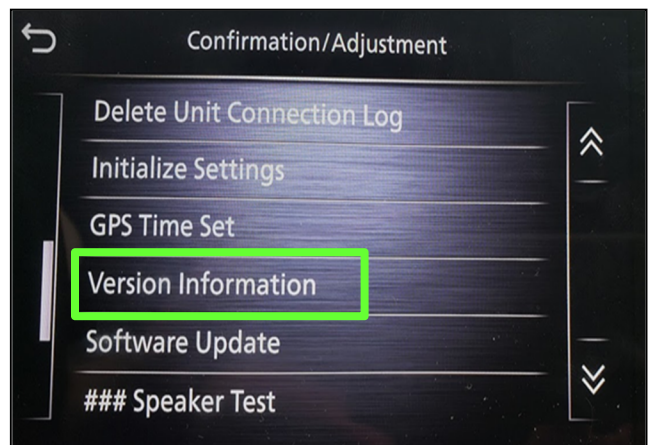
Figure 4

3. Select **Version Information**.

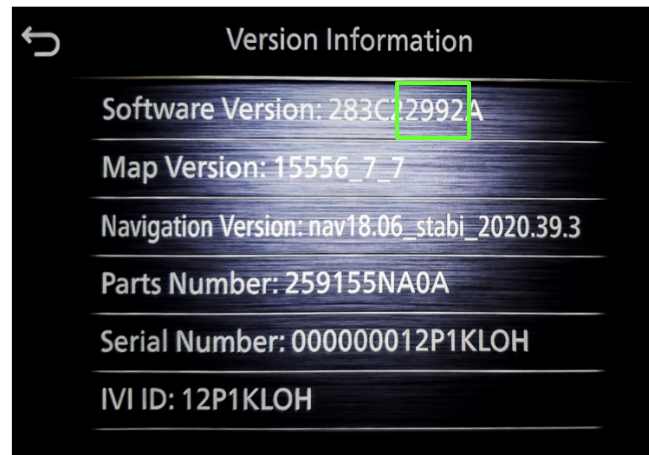
Figure 5

- If the **Software Version** (characters 6-9, as shown in Figure 5) is not the latest software version listed in the vehicle table, select the back icon and continue to step 5.
- If the **Software Version** is the latest software version listed in the vehicle table, an update is not available. Select the back icon and skip to **CLAIMS INFORMATION** on the last page.

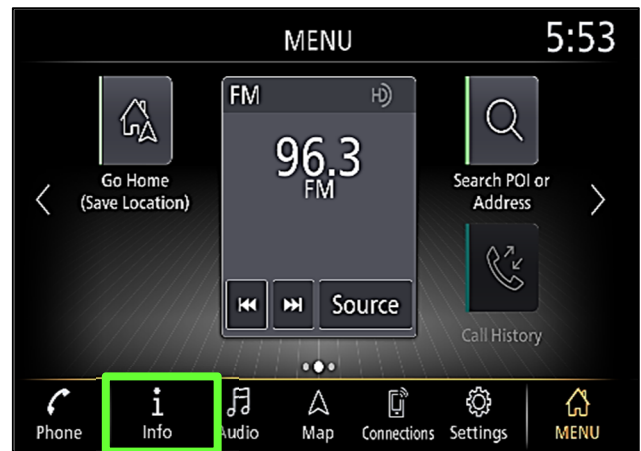
Figure 6

- Starting from the HOME screen (Figure 6), select **Info**.

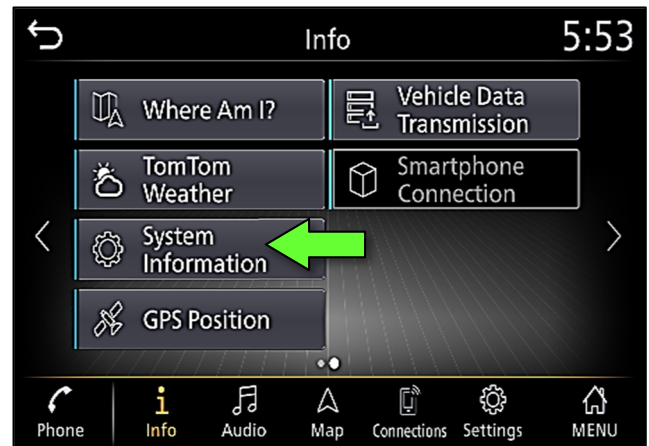
Figure 7

- Select **System Information**.

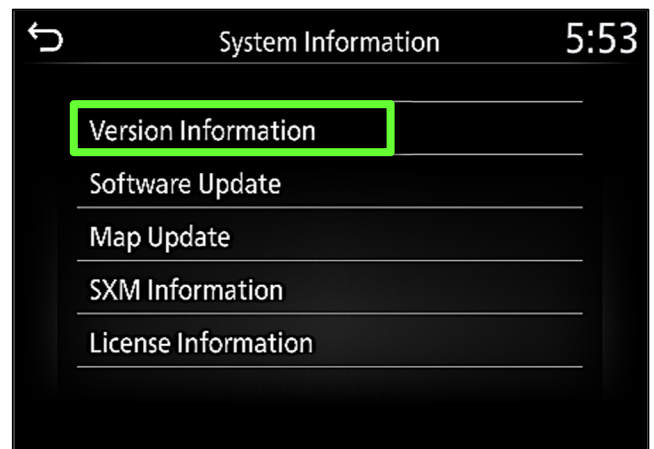
Figure 8

- Select **Version Information**.

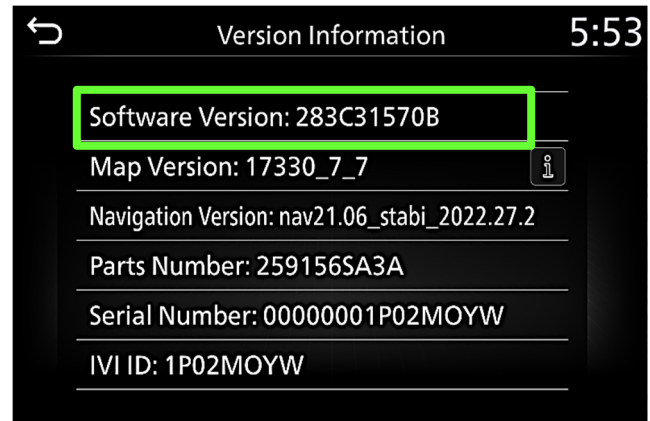
Figure 9

- If the **Software Version** is not the latest software version listed in the vehicle table, select the back icon and continue to step 10.
- If the **Software Version** is the latest software version listed in the vehicle table, an update is not available. Select the back icon and skip to **CLAIMS INFORMATION** on the last page.

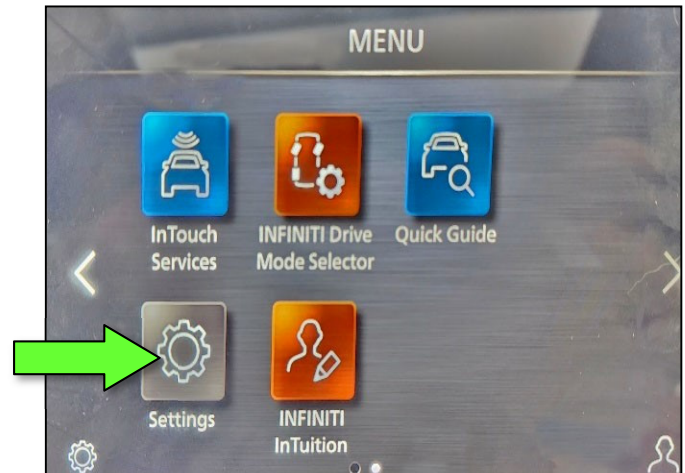
Figure 10

- a. From the **MENU** screen, select **Settings**.

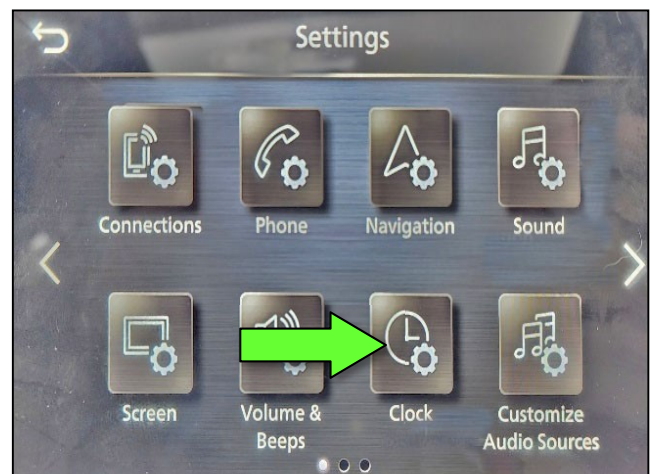
Figure 11

- b. Select **Clock**.

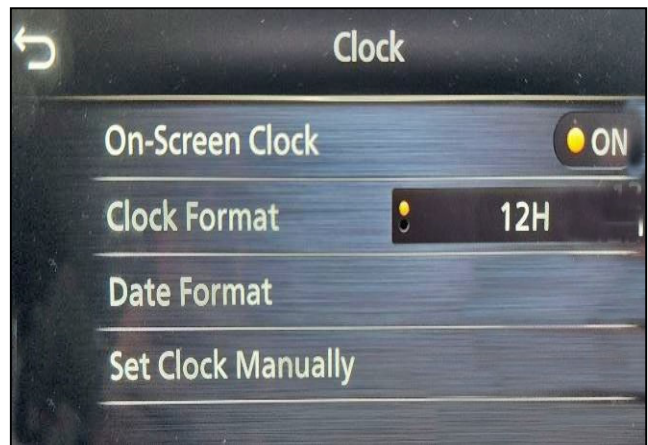
Figure 12

- c. Record all the clock settings.
  - o For vehicles without navigation:
    - **On-Screen Clock**
      - ON/OFF
    - **Clock Format**
      - 12H/24H
    - **Date Format**
      - Select **Date Format** to view and record settings.
    - **Set Clock Manually**
      - Select **Set Clock Manually** to view and record settings.

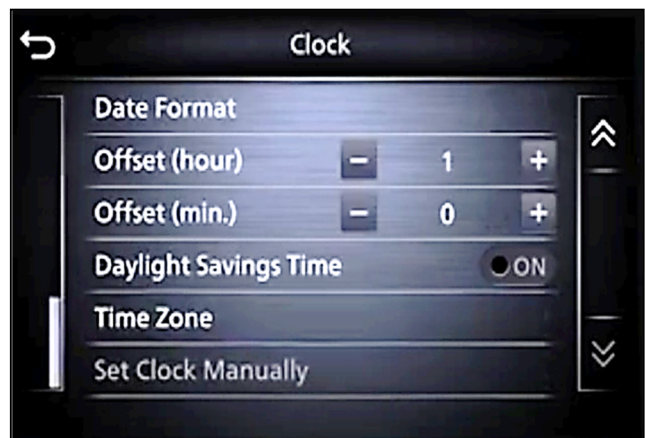
Figure 13

- o For vehicles with navigation:
  - **On-Screen Clock** (not shown)
    - ON/OFF
  - **Clock Mode** (not shown)
    - Auto/Manual/Time Zone
  - **Clock Format** (not shown)
    - 12H/24H
  - **Date Format**
    - Select **Date Format** to view and record settings.
  - **Offset (hour)**
  - **Offset (min.)**
  - **Daylight Savings Time**
    - ON/OFF
  - **Time Zone**
    - Select **Time Zone** to view and record settings.
  - **Set Clock Manually**
    - Select **Set Clock Manually** to view and record settings.

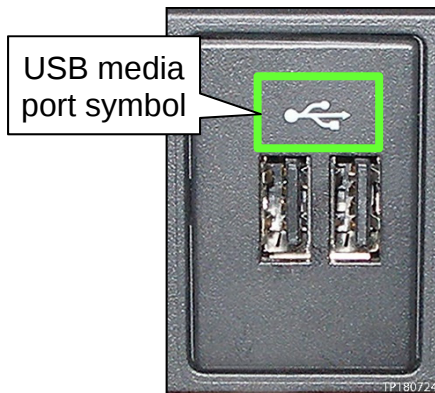
Figure 14

14. Insert the USB drive with the infotainment update-software into the vehicle's USB media port (Figure 14).

Do not insert the USB drive into a charging port. If used, the update-software and/or USB drive may become damaged. Only insert the USB drive in a USB media port.

**HINT:** Charging ports are marked in the vehicle with a “lightning bolt” symbol.

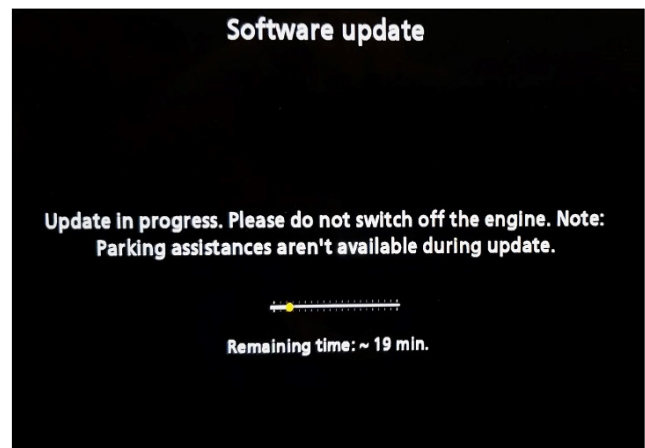
Figure 16

15. Wait for the update to complete.
  - Follow the on-screen instructions while waiting.

**HINT:** The update lasts 15-25 minutes.

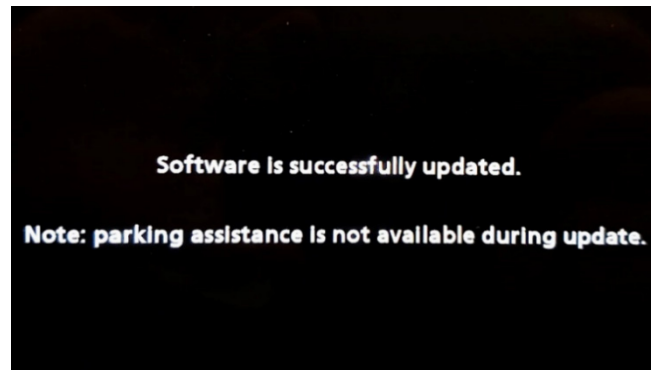
Figure 17

16. Once the update is complete (Figure 17), remove the USB drive; the system will reboot (restart).

**HINT:** The system will not reboot until the USB drive is removed.

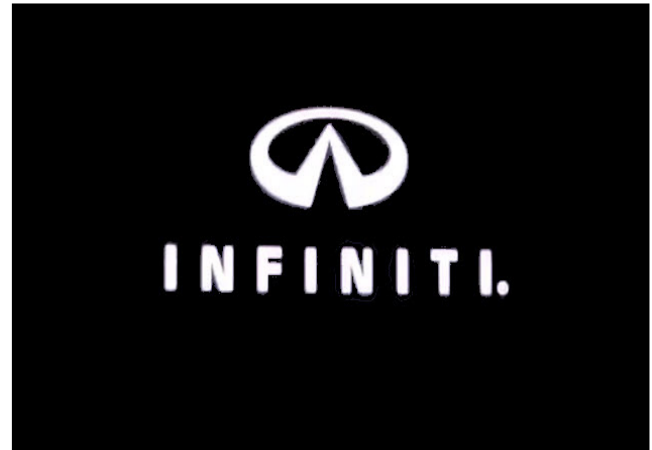
Figure 18

17. Allow the reboot to complete (approximately 30 seconds).
  - The Infiniti logo will be displayed during the reboot.

21. Turn the ignition ON (engine OFF) and wait for the Infiniti logo to appear (Figure 18).
  - If the Infiniti logo does not appear (this might take up to 30 seconds), start over from step 18.

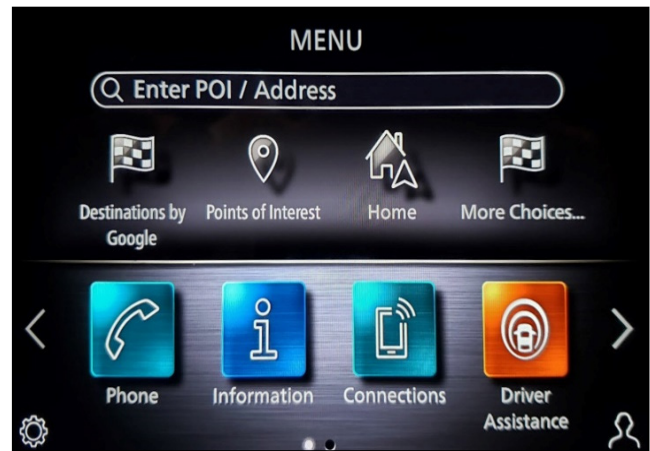
- The MENU (Home) screen in Figure 19 will be displayed.

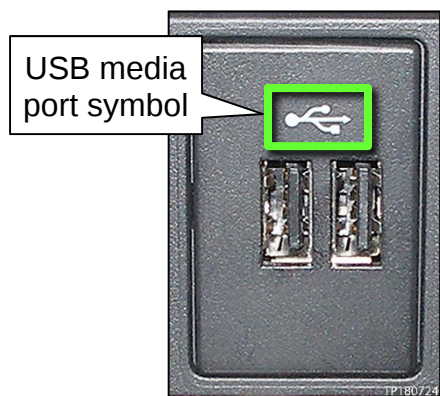
Figure 20

30. Insert the USB drive with the infotainment update-software into the vehicle's USB media port (Figure 20).

Do not insert the USB drive into a charging port. If used, the update-software and/or USB drive may become damaged. Only insert the USB drive in a USB media port.

**HINT:** Charging ports are marked in the vehicle with a “lightning bolt” symbol.

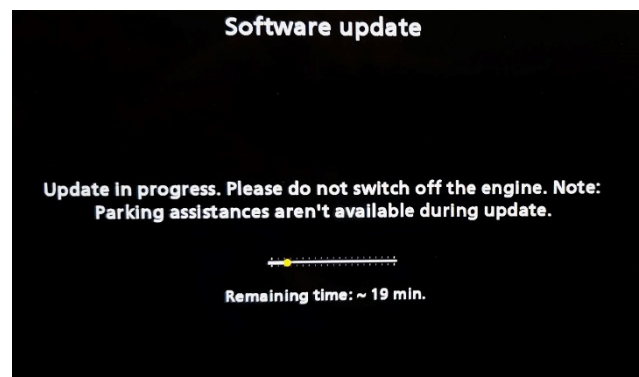
Figure 22

31. Wait for the update to complete.

**HINT:** The update lasts 20-30 minutes.

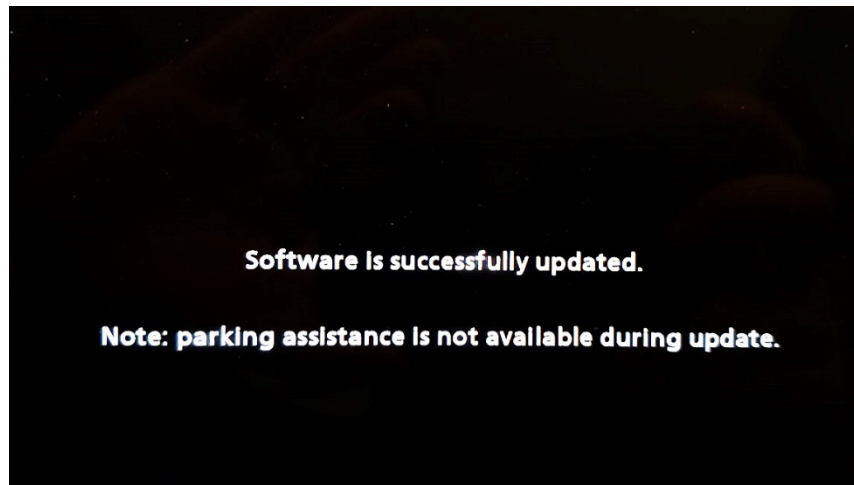
Figure 23

32. Once the update is complete (Figure 23), remove the USB drive; the system will reboot (restart).

**HINT:** The system will not reboot until the USB drive is removed.

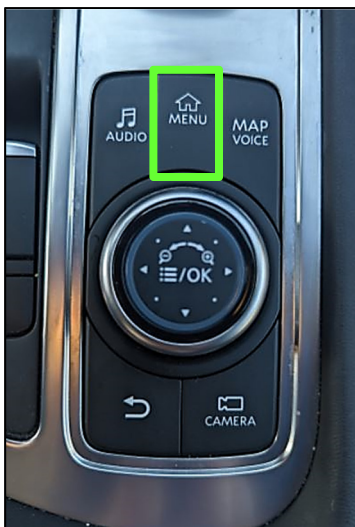
Figure 24

33. Press and hold the **MENU** button on the IT Commander (Figure 24) and turn the AV Control Unit volume knob (Figure 25) left-right-left at the same time.

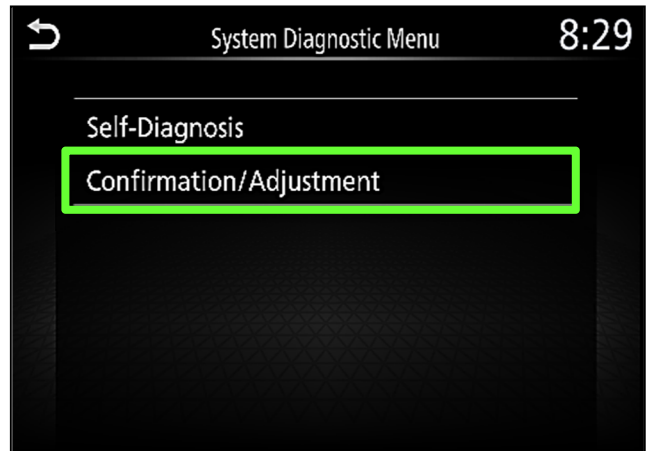
Figure 26

34. Select **Confirmation/Adjustment**.

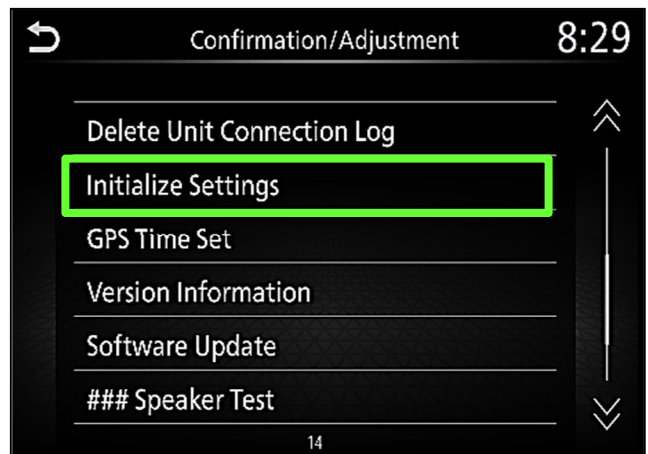
Figure 27

35. Select **Initialize Settings**.

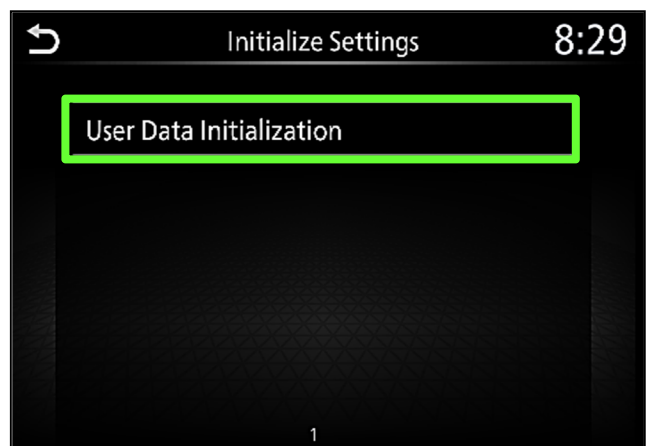
Figure 28

36. Select **User Data Initialization**.

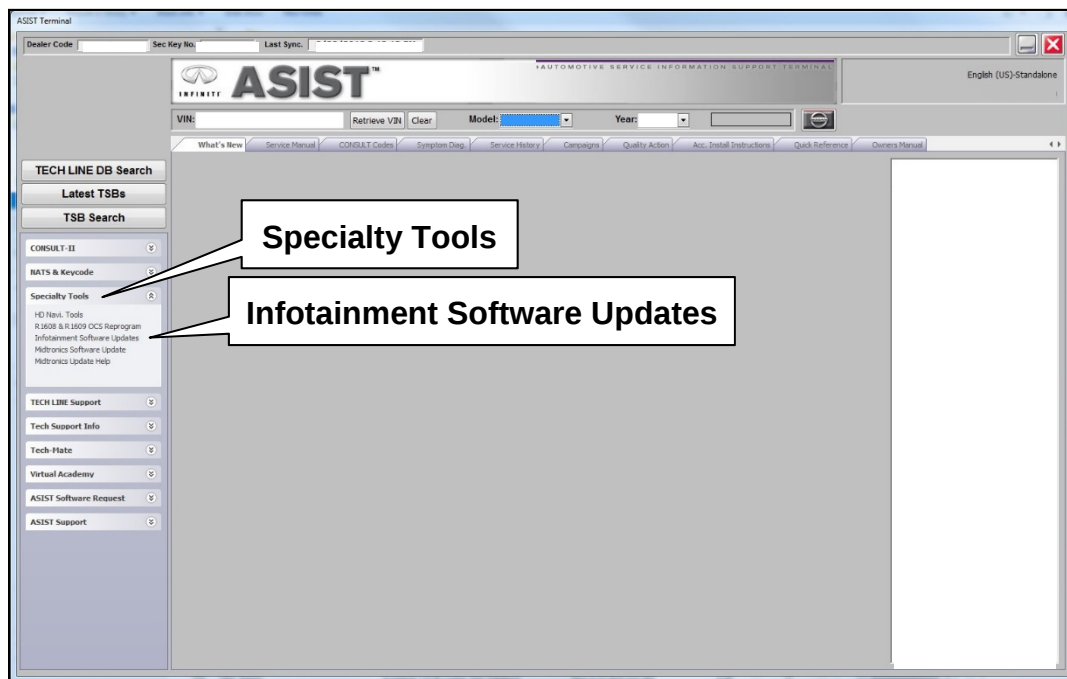
Figure 31

42. Select **Specialty Tools**, and then select **Infotainment Software Updates**.

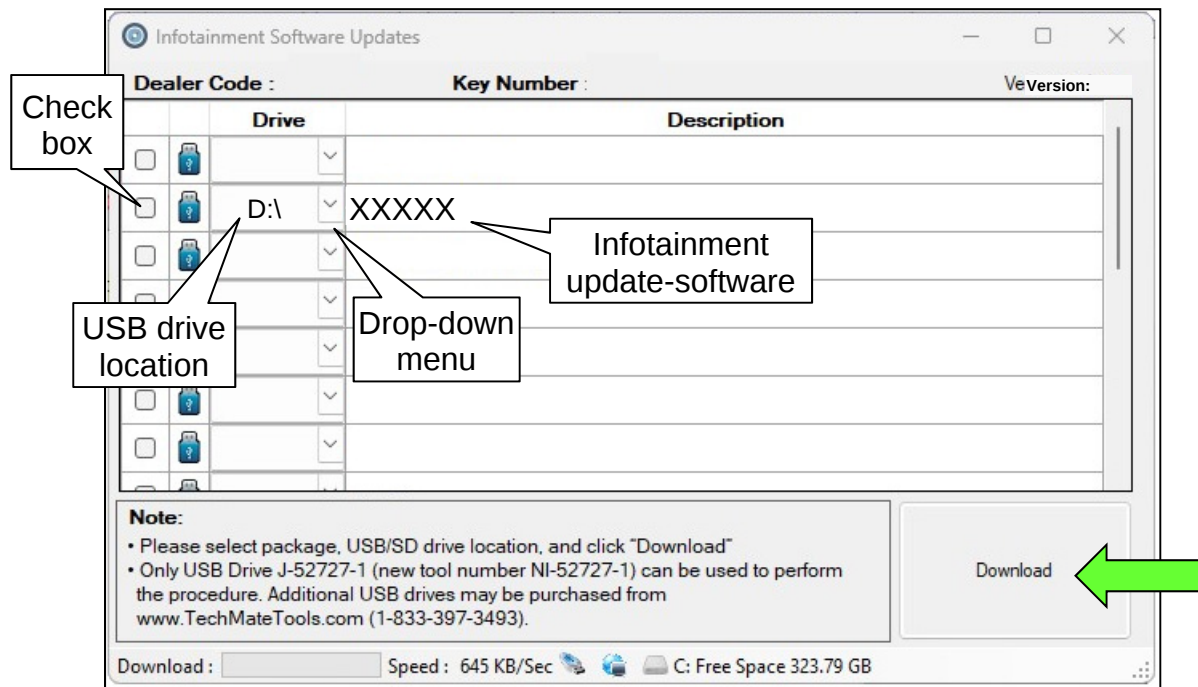
Figure 32

43. Select the check box next to the infotainment update-software (Figure 32).
  - Refer to the appropriate vehicle table to determine the correct infotainment update-software for your vehicle.
44. Use the drop-down menu and select the location of the USB drive that was inserted in step 40 on page 28.

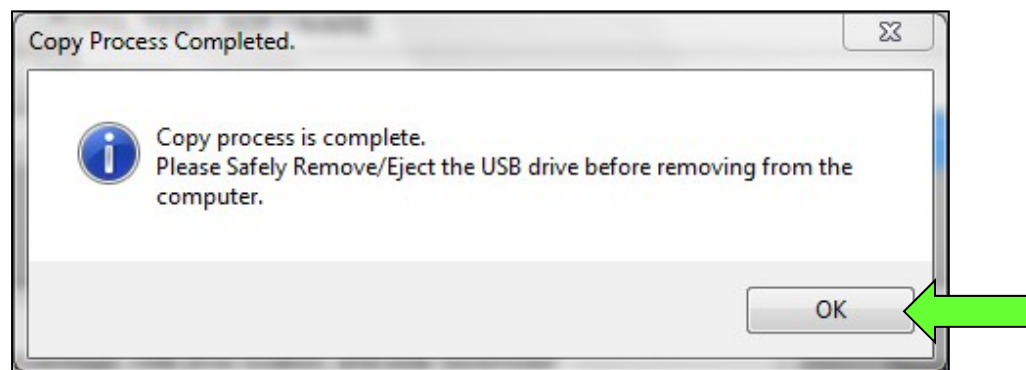
45. Select **Download**, and then wait for the download to complete.  
**HINT:** The update-software is estimated to take 10-15 minutes to download to the USB drive.
46. Select **OK** when the message in Figure 33 is displayed.

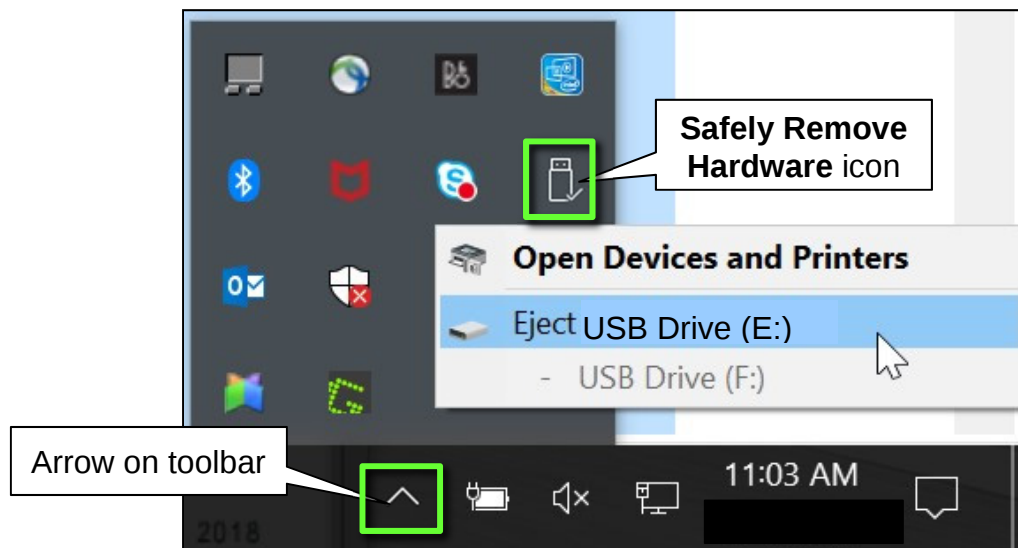
Figure 34

- a. From the PC toolbar, select the **Safely Remove Hardware** icon.
  - o The icon is on the toolbar, or can be found after selecting the arrow.
- b. Select the USB drive to be removed, and then remove the USB drive from the CONSULT PC.
