SILICON LABS SiWG917 TA Flash Memory Map User Guide

SILICON LABS SiWG917 TA Flash Memory Map

Introduction

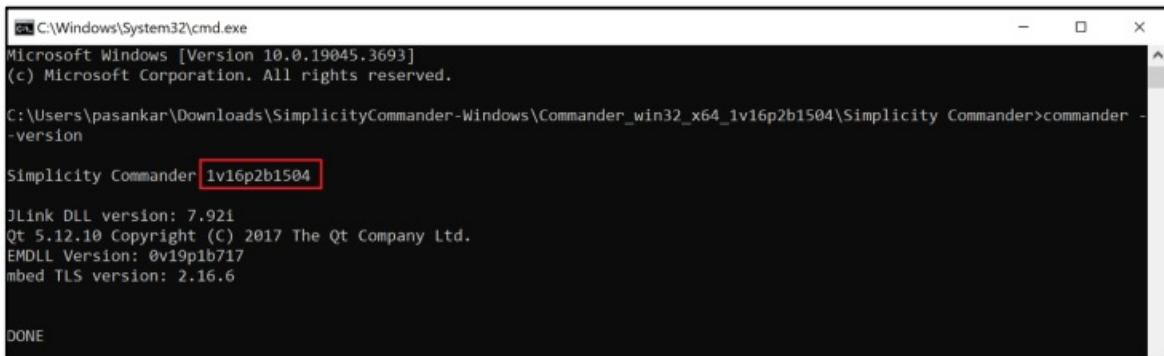
- [Simplicity Commander CLI](#) (1v16p1 and above versions)
- **Note:** To check commander version open the cli mode (To open the commander cli mode follow Section 3.1 from step 1 to step 3) and give the following.
- **command:** commander –version

C:\Users\pasankar\Downloads\SimplicityCommander-Windows\Commander_win32_x64_1v16p2b1504\Simplicity Commander>commander -
-version

Simplicity Commander 1v16p2b1504

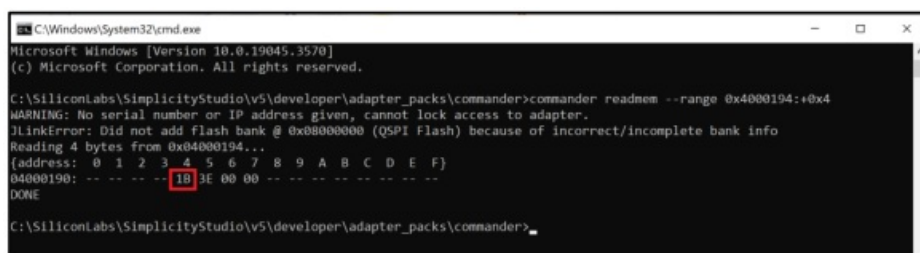
4. Enter the following command in the command prompt CLI to read the MBR from the memory location address "0x4000194". Command: `commander readmem --range 0x4000194:+0x4`
5. The user would get output similar to below after executing the above command.

6. If the output contains "1B"(as marked in a red box in the image above) then the device has 1.6 MB MBR flashed in it Go to the section "Programming the MBR"
 - If the output contains "1F" (same place where the red box is in the image above) then the device has 1.8 MB MBR flashed in it.
 - Users can use the GA release to proceed or Go to the section "Configuring the M4 Application" if using a release earlier than the GA release to find out linker changes.
 - **Note:** If the output (after executing the command: `commander readmem --range 0x4000194:+0x4`) is like the below figure: Having all "CC"s(marked inside red box), then the board is corrupted. Please go to Section 6 to reflash 1.8v MBR in it.
