# Tektronix AFG31XXX Arbitrary Function Generator Instruction Manual

AFG31000 Version 1.6.2  
Tektronix, Inc.  
14150 SW Karl Braun Drive  
P.O. Box 500  
Beaverton, OR 97077  
USA

Software Release Notes & Installation Instructions

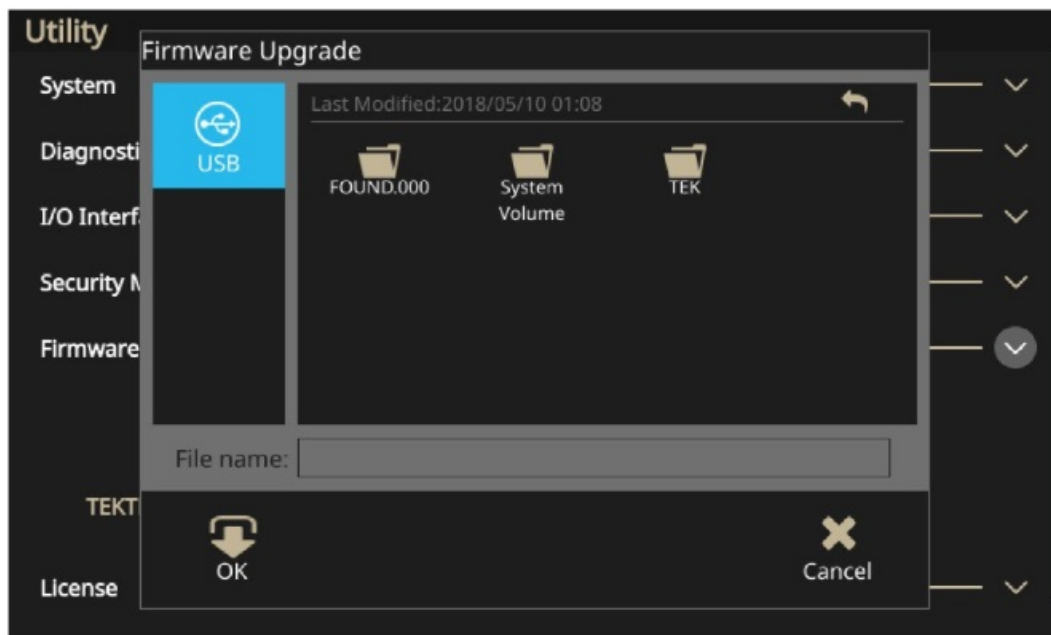
1. Visit [tek.com](https://www.tek.com) and search for the Series 31000 firmware.
2. Download the compressed .zip file to your computer.
3. Unzip the downloaded file and copy the .ftb file to the USB flash drive root directory.
4. Insert the USB in the AFG31000 Series instrument front panel.
5. Press the Utility button.
6. Select Firmware > Update.
7. Select the USB icon.

8. Select the file that you are using to update your instrument.
9. Select OK. You will see a message asking to confirm this update.
10. Verify that the instrument powered off and powered on to install the update.
11. Remove the USB drive.
