**AV-20-E Display
TailBeaconX
Interface**

uAvionix AV-20-E Display TailBeaconX Interface Instruction Manual

This Service Bulletin provides instructions for loading uAvionix AV-20-E UAV-1003626-001 with updated software release 1.7.1.

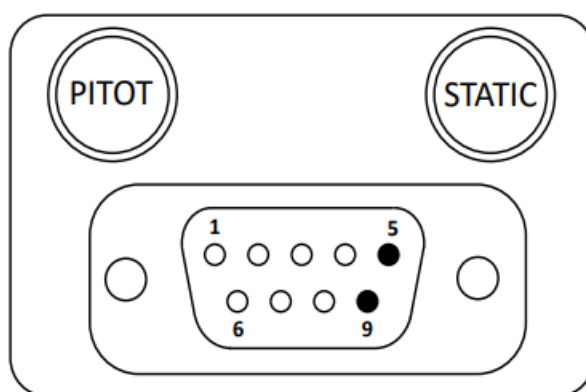
Figure 4 – Unit Connections – DB-9, Male Connector – Rear View

All connections are provided on the single 9-Pin D-sub connector and the two pneumatic fittings

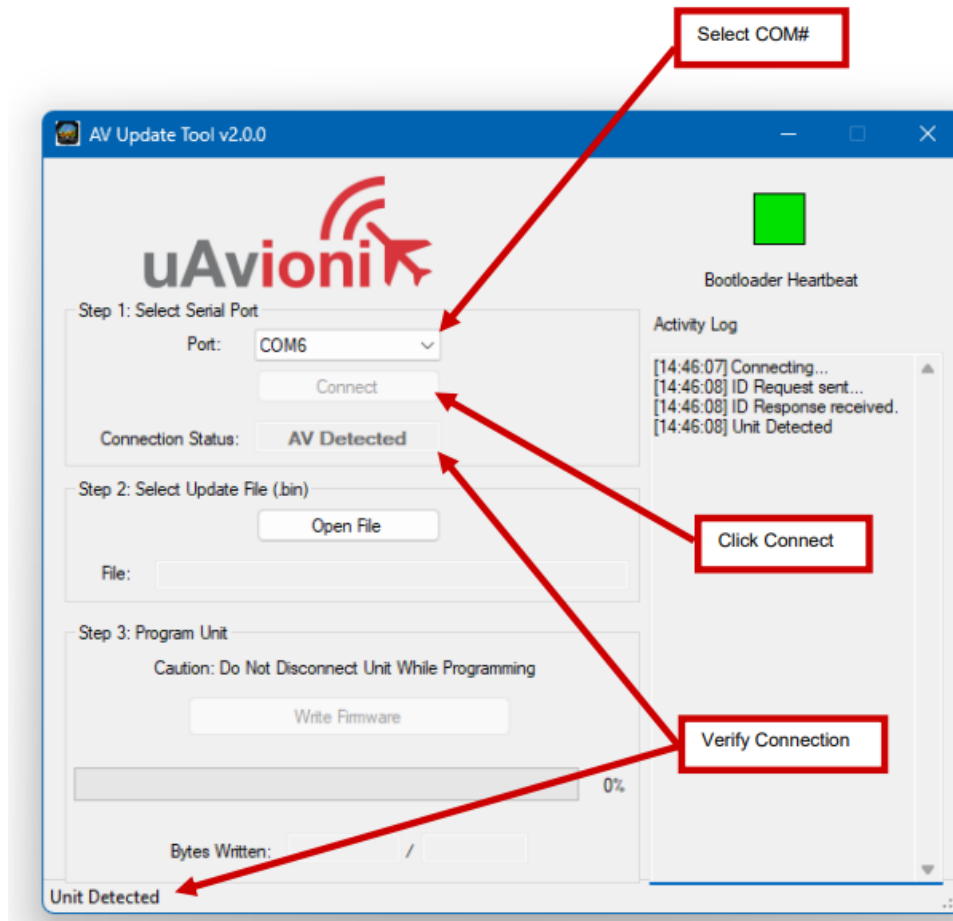
7. Proper connection has been made when the message “Unit Detected” has appeared on the bottom left corner of the AV Updater Tool. The screen on the AV-20-E will go black for the remainder of this procedure. If “Unit Detected” does not appear, re-check your wired connections or contact uAvionix Support for additional guidance.
8. Once proper connection has been made, select the software file to upload to the AV-20-E by clicking “Open File” and selecting the previously downloaded software file as identified in Table 4. Note that you need to select “AV-20 Update Files” in the lower right corner

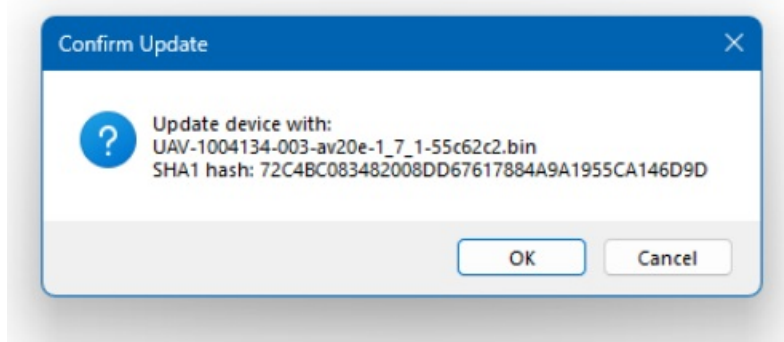
When confirmed, press OK and the main dialog will re-appear.

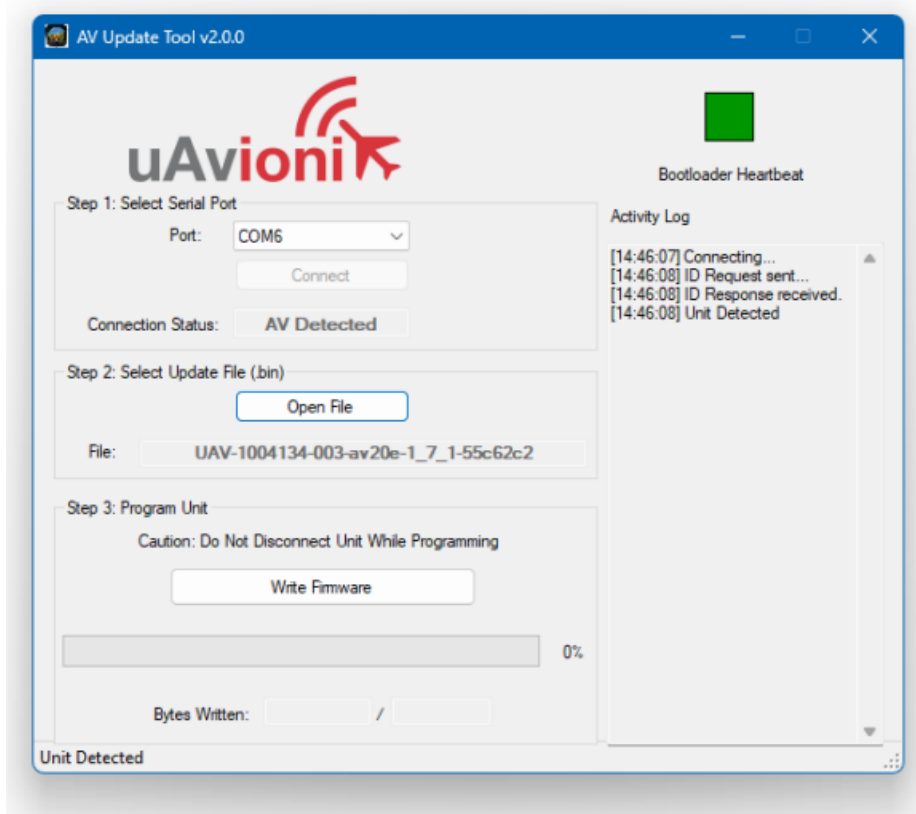
Press "Write Firmware" to begin the upload.

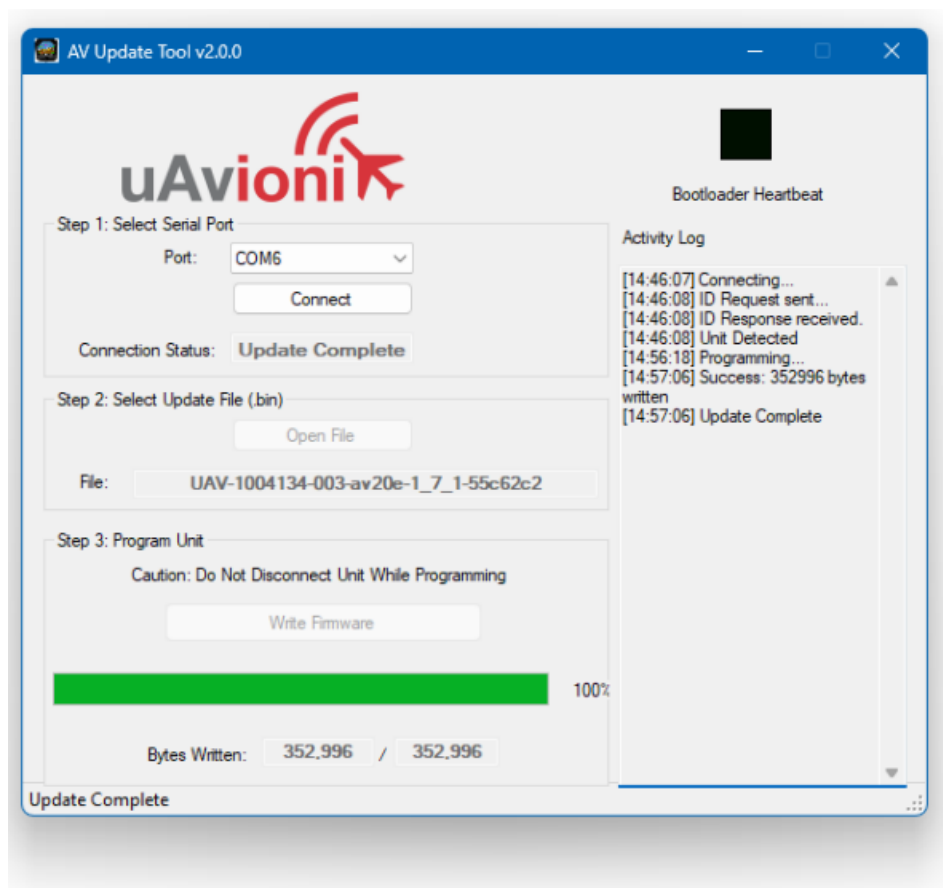
Figure 8-5 AV Update Tool

- When the AV Update Tool displays “100%” and the lower status reads “Update Complete” the process is complete.
- The unit will automatically restart. Upon restart of the unit, verify the startup screen indicates the updated software version.
