# Stant Radiator Cap Model 10229 Instruction Manual

Your guide to proper installation, operation, and maintenance

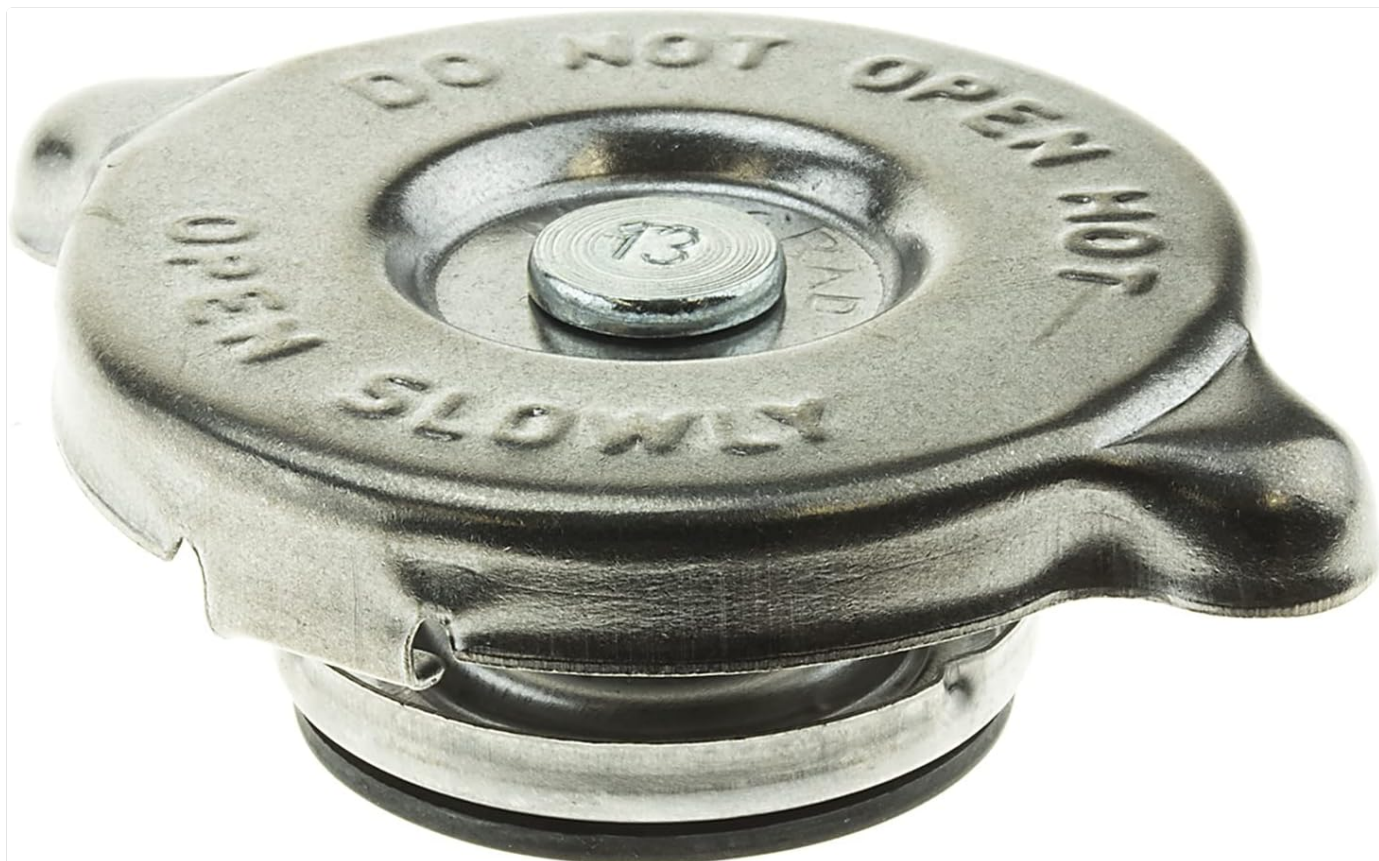
Image: Top view of the Stant Radiator Cap 10229, clearly displaying the 'DO NOT OPEN HOT' warning and the '13' pressure rating in the center. This view highlights the cap's robust metal construction and the four-ear design for secure fitting.

The Stant Radiator Cap Model 10229 is a crucial component of your vehicle's cooling system, designed to maintain the correct pressure within the radiator. This pressure raises the boiling point of the coolant, preventing overheating and ensuring efficient engine operation. This cap is specifically engineered for a 13 PSI system and fits a 3/4" deep "A" size filler neck. It features a durable metal construction with a 4-ear design, suitable for both open and closed cooling systems.

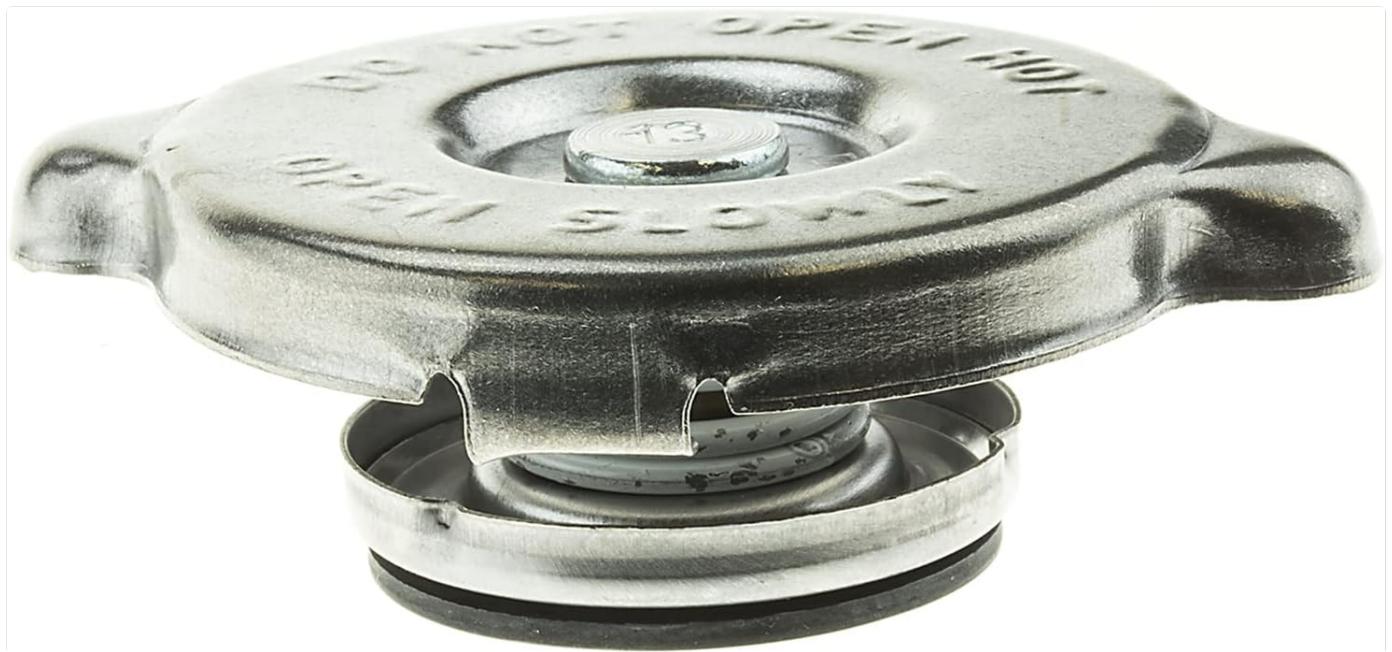
Image: Side view of the Stant Radiator Cap 10229, illustrating the internal spring mechanism and the lower rubber seal. This view is helpful for understanding how the cap creates a pressure seal within the radiator neck.

The Stant Radiator Cap Model 10229 is designed to maintain a specific pressure (13 PSI) within your vehicle's cooling system. As the engine heats up, the coolant expands, increasing pressure. The cap's spring-loaded valve allows pressure to build up to the specified limit. This increased pressure raises the boiling point of the coolant, preventing it from boiling over at normal operating temperatures. When the engine cools down, the coolant contracts, creating a vacuum. The cap's vacuum valve opens to allow coolant from the overflow reservoir back into the radiator, preventing the radiator hoses from collapsing. It is critical to ensure the cap is always securely fastened during vehicle operation to maintain proper system pressure and prevent coolant loss.

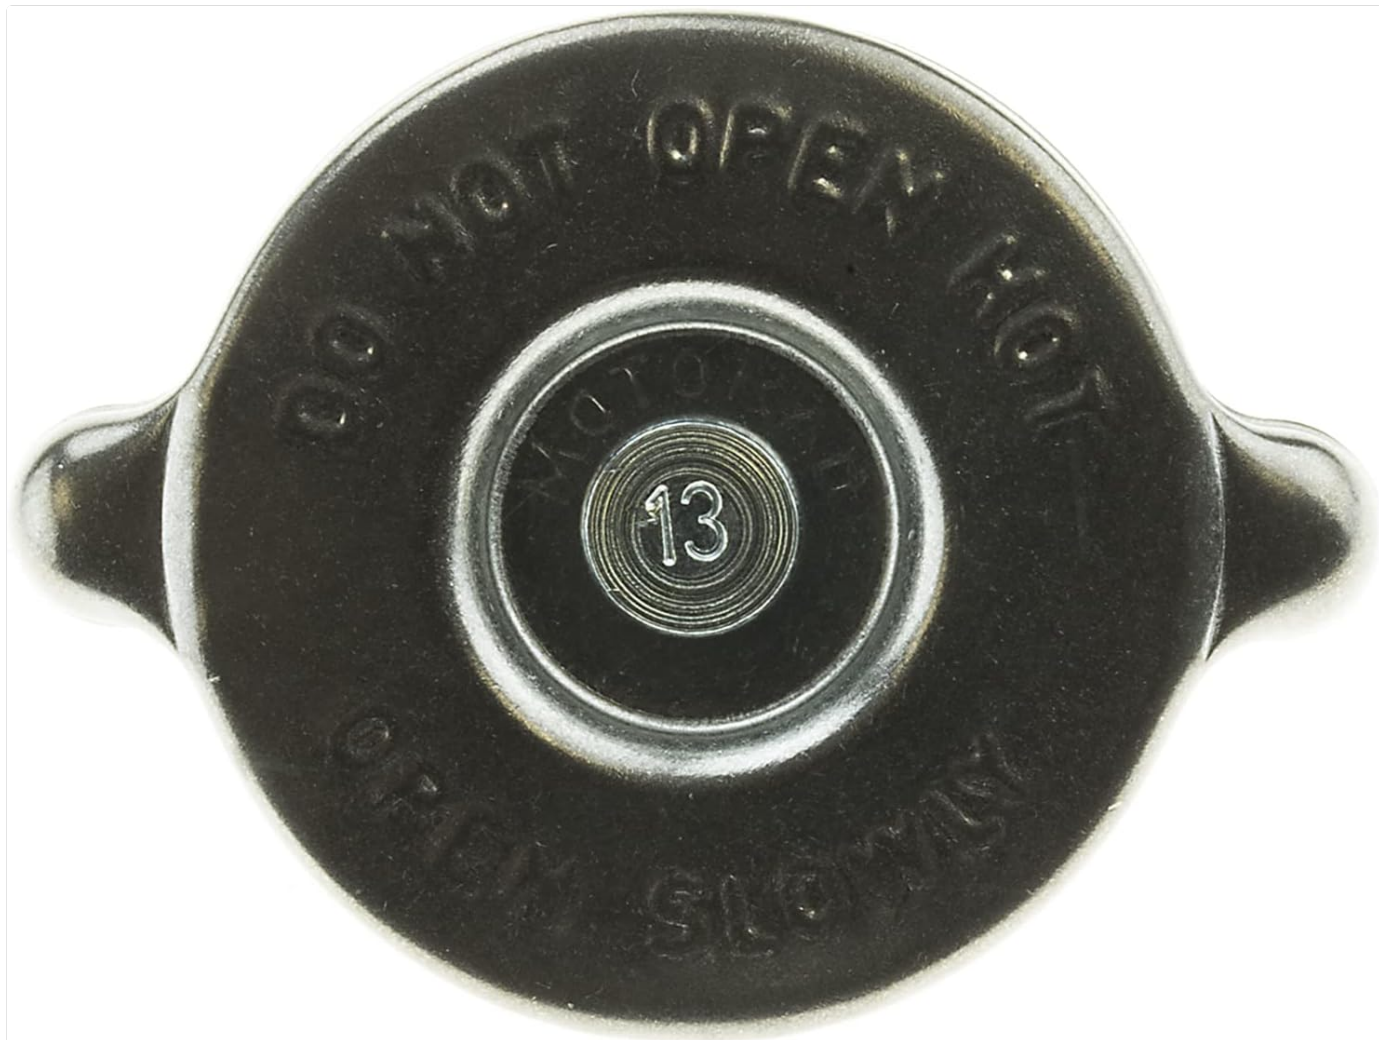
Image: A close-up top view of the Stant Radiator Cap 10229, emphasizing the '13' marking in the center, which indicates its pressure rating of 13 PSI. This detail is crucial for ensuring compatibility with your vehicle's cooling system requirements.

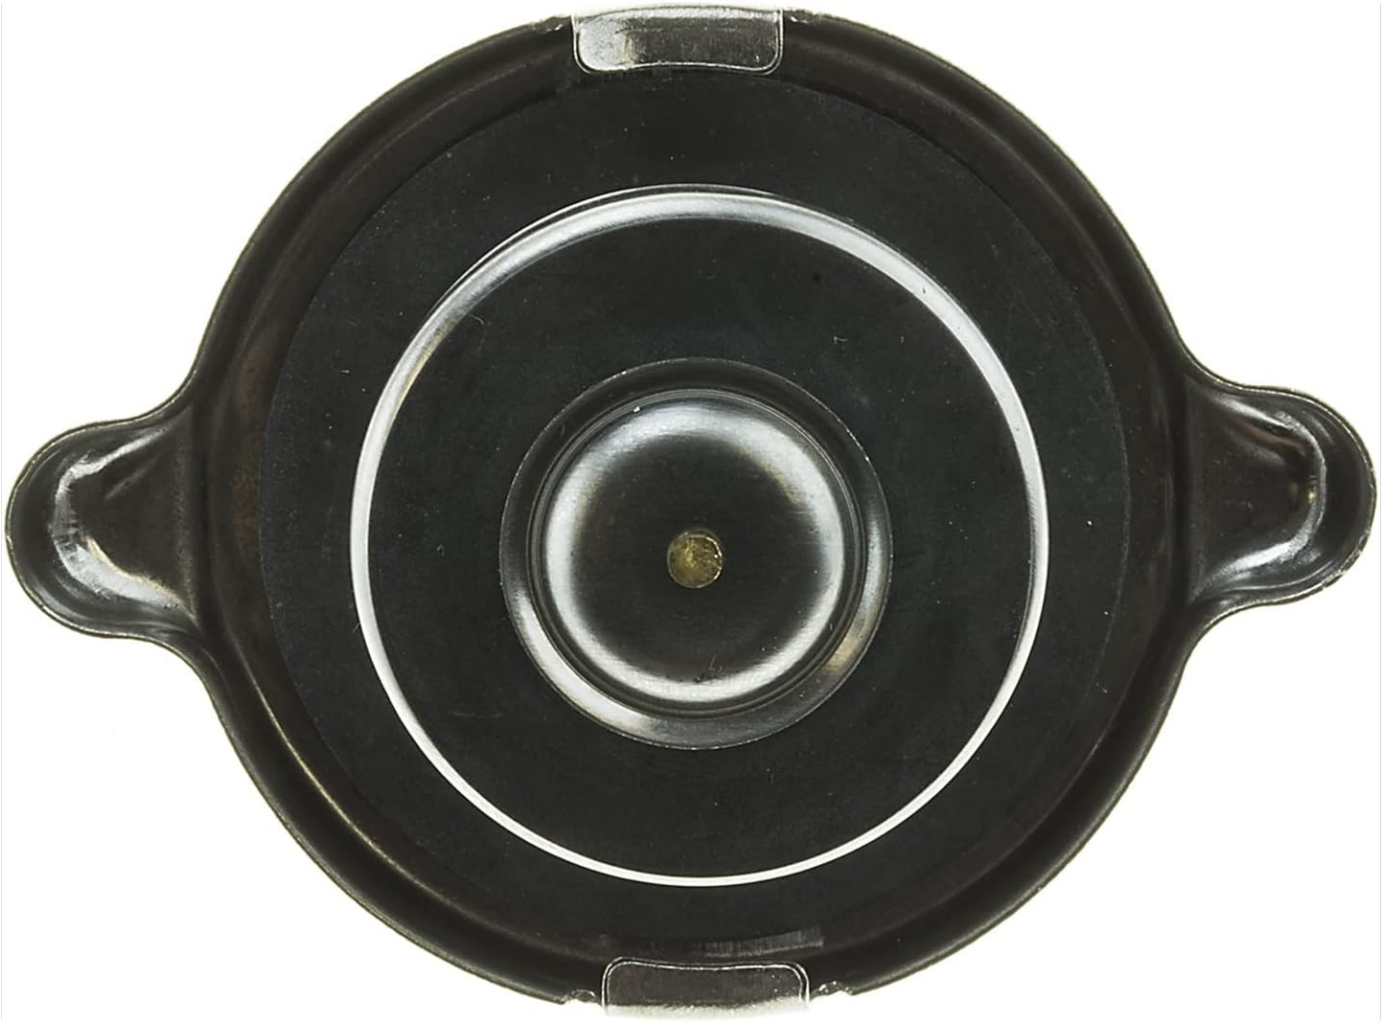
Image: Bottom view of the Stant Radiator Cap 10229, clearly showing the main rubber seal that creates the pressure seal against the radiator neck, and the smaller vacuum valve in the center. This view is critical for inspecting the integrity of the sealing components.

- **Visual Check:** Periodically inspect the cap for any signs of damage, such as cracks, dents, or corrosion.
- **Rubber Seal:** Check the condition of the rubber seals (both the main seal and the vacuum valve seal). They should be pliable and free of cracks, hardening, or swelling. A damaged seal can prevent the cap from holding pressure correctly.
- **Spring Mechanism:** Gently press the center valve to ensure the spring moves freely and returns to its original position without sticking.
- **Filler Neck:** Inspect the radiator filler neck for any corrosion or damage that might prevent a proper seal.
