# ACDelco PT779 GM Original Equipment 3-Way Female Multi-Purpose Pigtail Instruction Manual

Model: PT779 | Brand: ACDelco

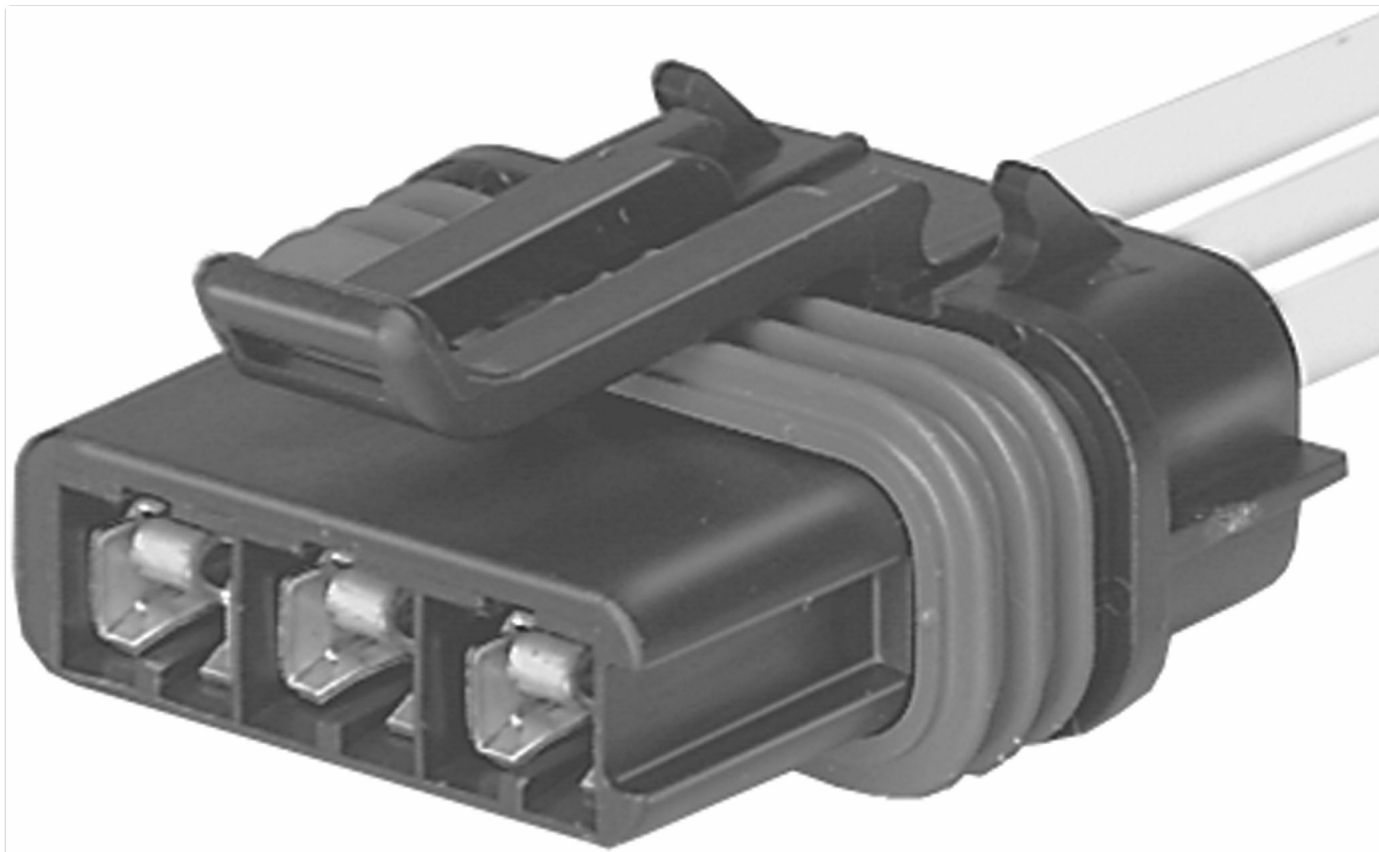
**Figure 1:** The ACDelco PT779 3-Way Female Multi-Purpose Pigtail. This image shows the black connector with three terminals and a red sealing gasket, designed for secure electrical connections.

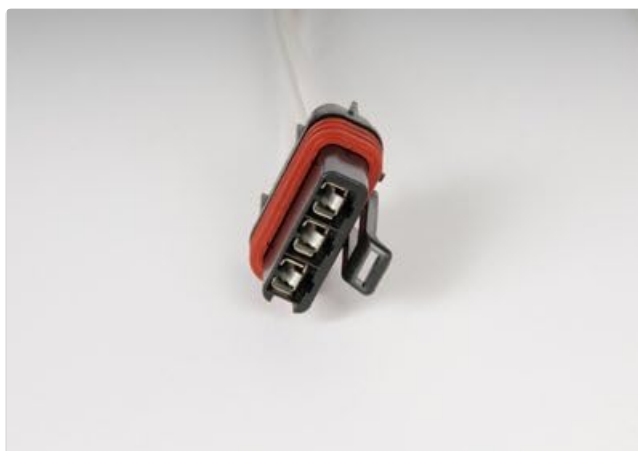
**Figure 2:** A closer view of the ACDelco PT779 pigtail, highlighting the connector's design and wire entry point.
