LASCO S-1028-3 Colony Tub and Shower Stem for American Standard 6503 Instruction Manual

PRODUCT OVERVIEW

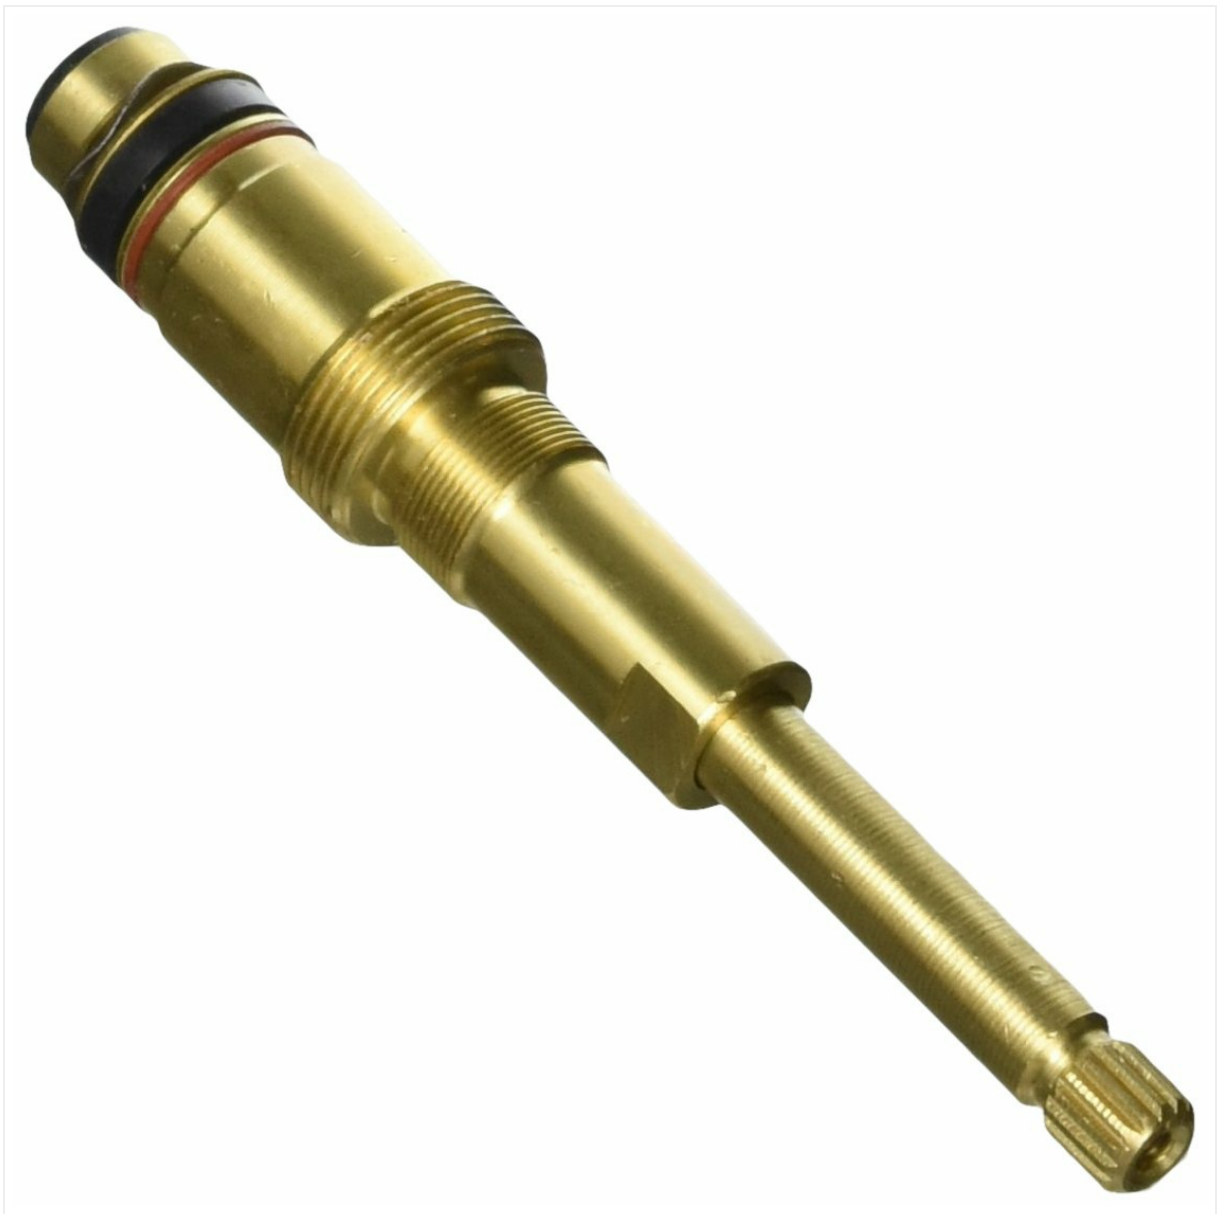
Image: The LASCO S-1028-3 Colony Tub and Shower Stem, a brass component with threaded sections and a splined top for handle attachment.

The LASCO S-1028-3 is a replacement tub and shower stem specifically designed for American Standard 6503 Colony series faucets. Constructed from durable brass material, this stem is suitable for both hot and cold water applications, ensuring reliable performance in your tub and shower system.
