Moen 94543 Chateau Three Valve Tub and Shower Stem Extension User Manual

Brand: Moen | **Model:** 94543

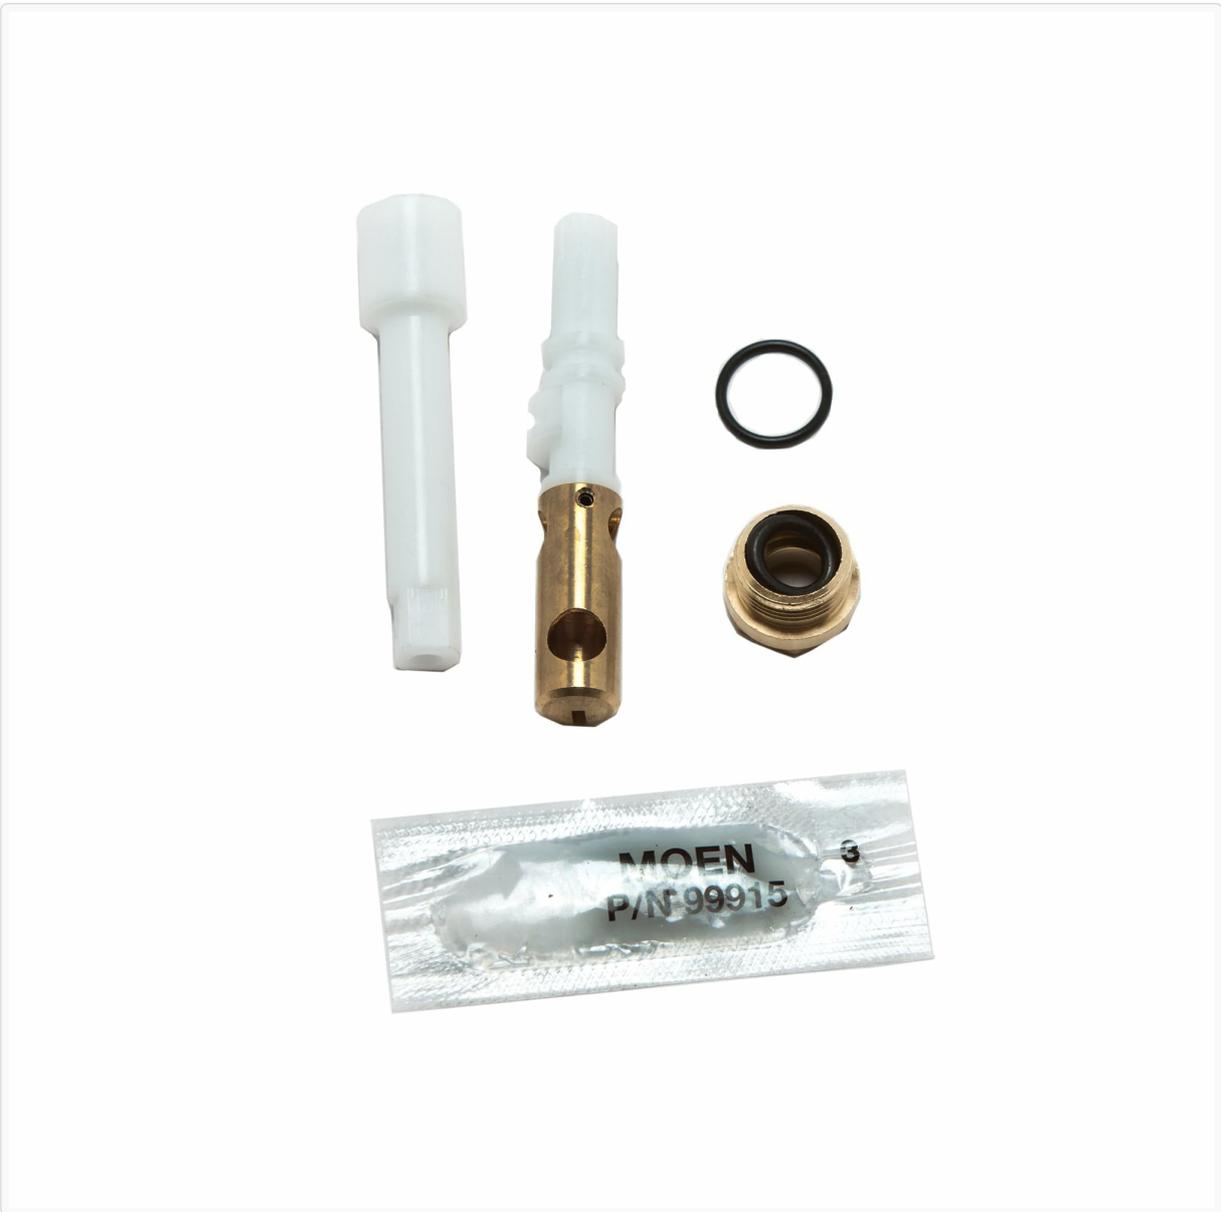
Image 1.1: The Moen 94543 Chateau Three Valve Tub and Shower Stem Extension. This image displays the complete stem extension component.

The Moen 94543 is a genuine replacement stem extension designed for Moen Chateau series three-handle tub and shower valves. This component is essential for repairing or maintaining the functionality of your existing Moen Chateau faucet system, ensuring proper operation of the hot, cold, and diverter functions.

Product Dimensions (L x W x H)	3.12 x 0.75 x 3.12 inches
Number of Handles Supported	3
Inlet Connection Size	1.06 Inches
Inlet Connection Type	Sweat
Outlet Connection Size	1.06 Inches
Outlet Connection Type	Sweat
Specification Met	UL
