## Moen 3853BN

# Moen Eva 3853BN Replacement Tub Diverter Spout Instruction Manual

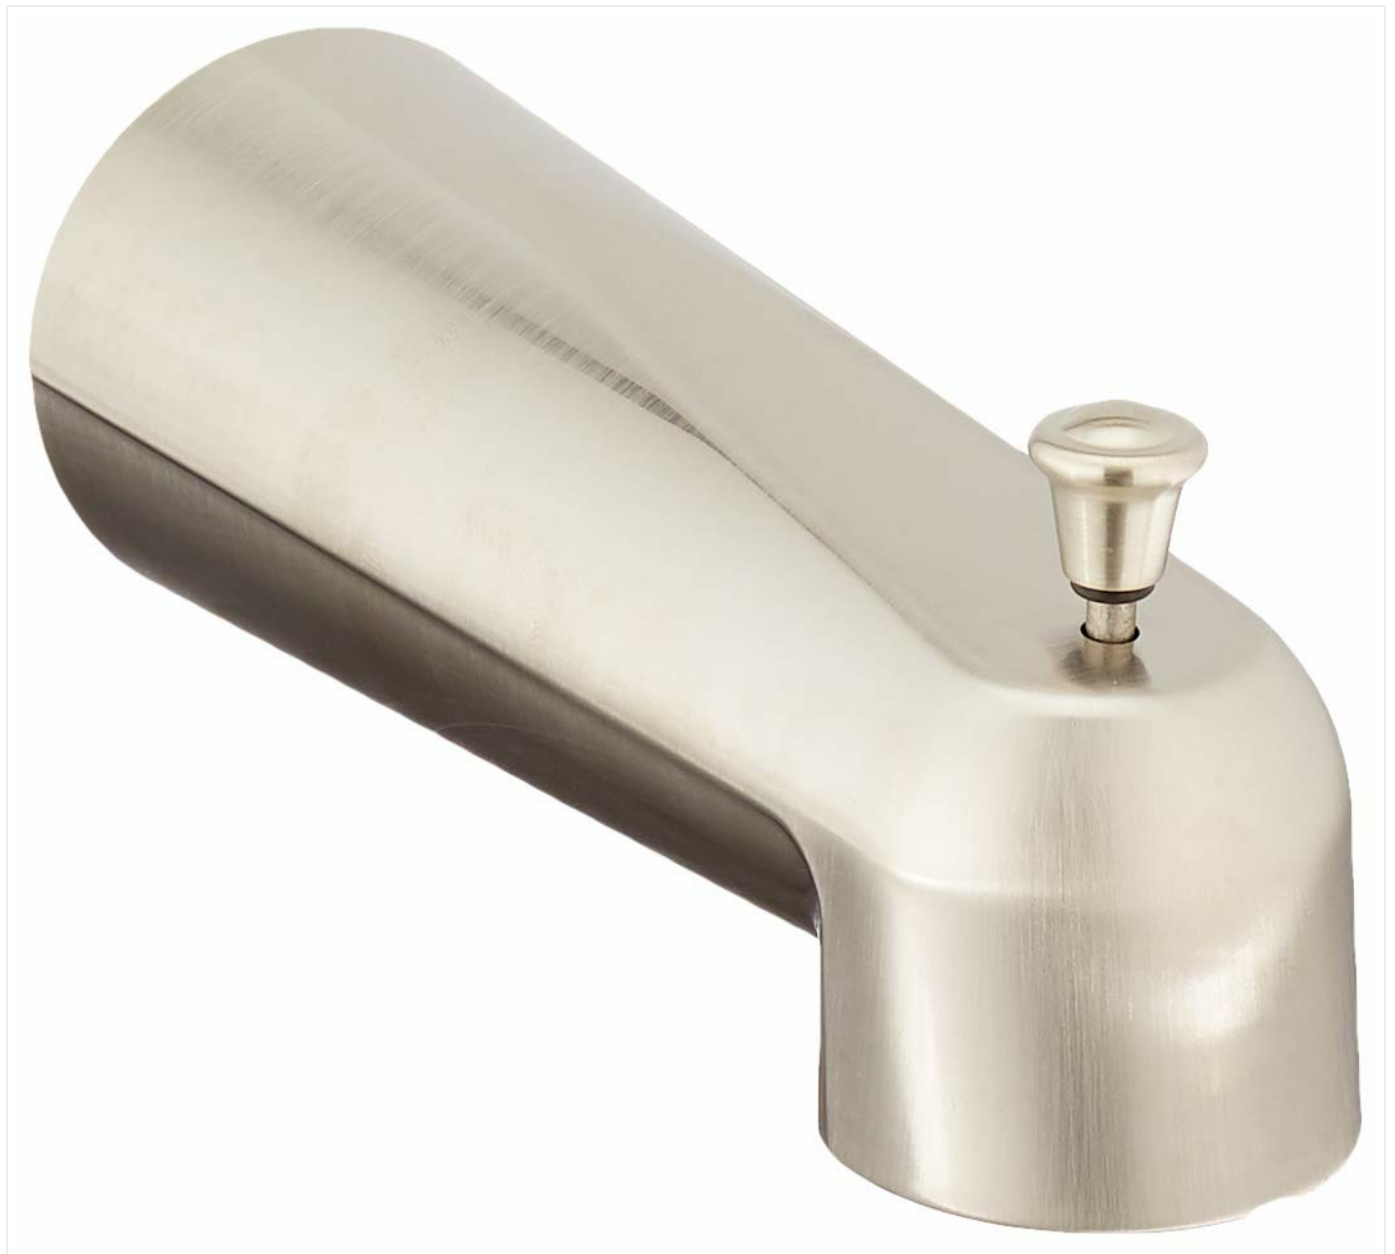
Image: Moen Eva 3853BN Replacement Tub Diverter Spout, showcasing its brushed nickel finish and design.

The Moen Eva 3853BN Replacement Tub Diverter Spout in Brushed Nickel is designed for use in bathroom shower faucets with a slip-fit connection. This spout is ideal for directing water flow to either the tub or the showerhead. Its brushed nickel finish provides a lightly brushed warm-gray metallic look, coordinating with various bathroom accessories in the Eva collection.

- **Coordinating Collection:** Designed to match other items in the Eva collection.
- **Warm and Inviting Finish:** Brushed Nickel for a modern aesthetic.
- **Diverting Function:** Includes a lift rod to easily switch water flow between the tub and showerhead.
- **Length:** An extra-long 7-inch spout for ample reach.
- **Connection Size:** Features 1/2-inch CC (Copper Connection) for slip-fit installation.
- **Replacement Part:** Suitable for repairing existing plumbing fixtures.
