Moen 116618BN Aerator Instruction Manual

Model: 116618BN | Brand: Moen

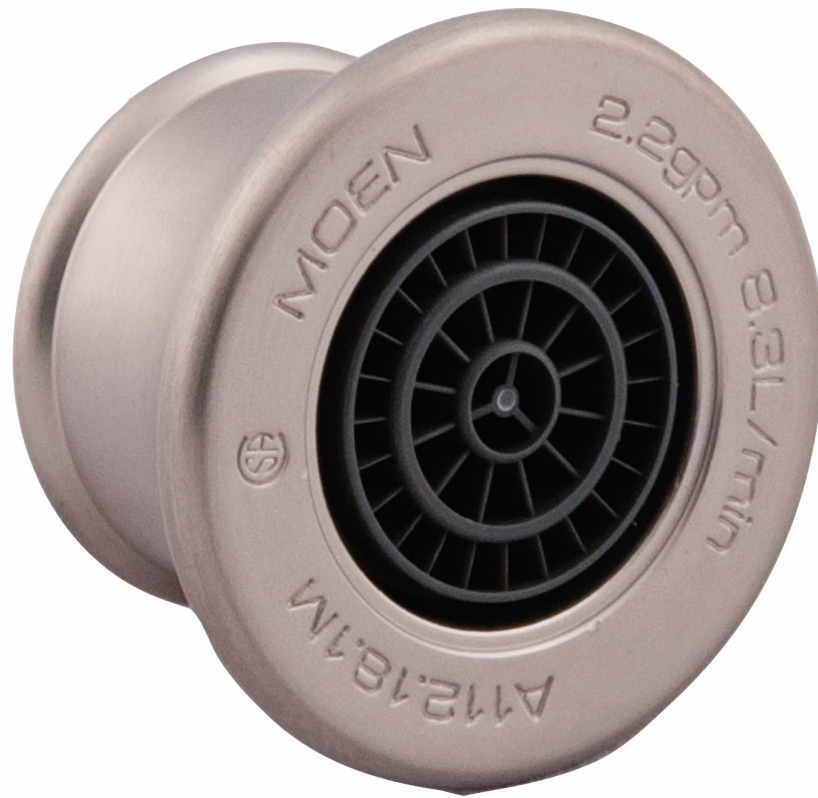
Image: The Moen 116618BN Aerator in Brushed Nickel finish, showing its design and 2.2 GPM flow rate marking.

Once installed, the Moen 116618BN Aerator functions automatically with your faucet. It mixes air with the water stream, creating a consistent, splash-free flow while maintaining efficient water usage at 2.2 gallons per minute (GPM).

Attribute	Detail
Brand	Moen
Model Number	116618BN
Material	Stainless Steel, Brass
Finish Type	Brushed Nickel
Flow Rate	2.2 Gallons Per Minute (GPM)

Attribute	Detail
Thread Size	M24x1
Item Weight	2.08 ounces
Product Dimensions	2.5 x 2 x 3 inches
Specification Met	CSA B125.1, ASME A112.18.1
