# Yellow Jacket 41133 Piston O-ring Seal User Manual

MODEL: 41133

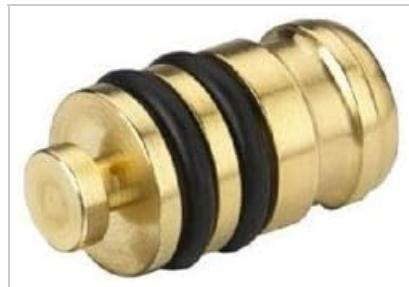
Image: The Yellow Jacket 41133 Piston O-ring Seal, a brass component with two black O-rings.

Once properly installed, the Yellow Jacket 41133 Piston O-ring Seal functions passively within the manifold's piston assembly. Its primary role is to create a tight seal, preventing refrigerant or vacuum leaks when the manifold valves are operated. A correctly installed O-ring ensures that the manifold maintains pressure or vacuum integrity, allowing for accurate system diagnostics and charging.

The O-ring facilitates smooth movement of the piston while maintaining a seal, which is critical for the precise control of refrigerant flow during HVAC/R service operations.
