> Moen 100040 Cartridge Replacement Kit User Manual

Moen 100040 Cartridge Replacement Kit

User Manual

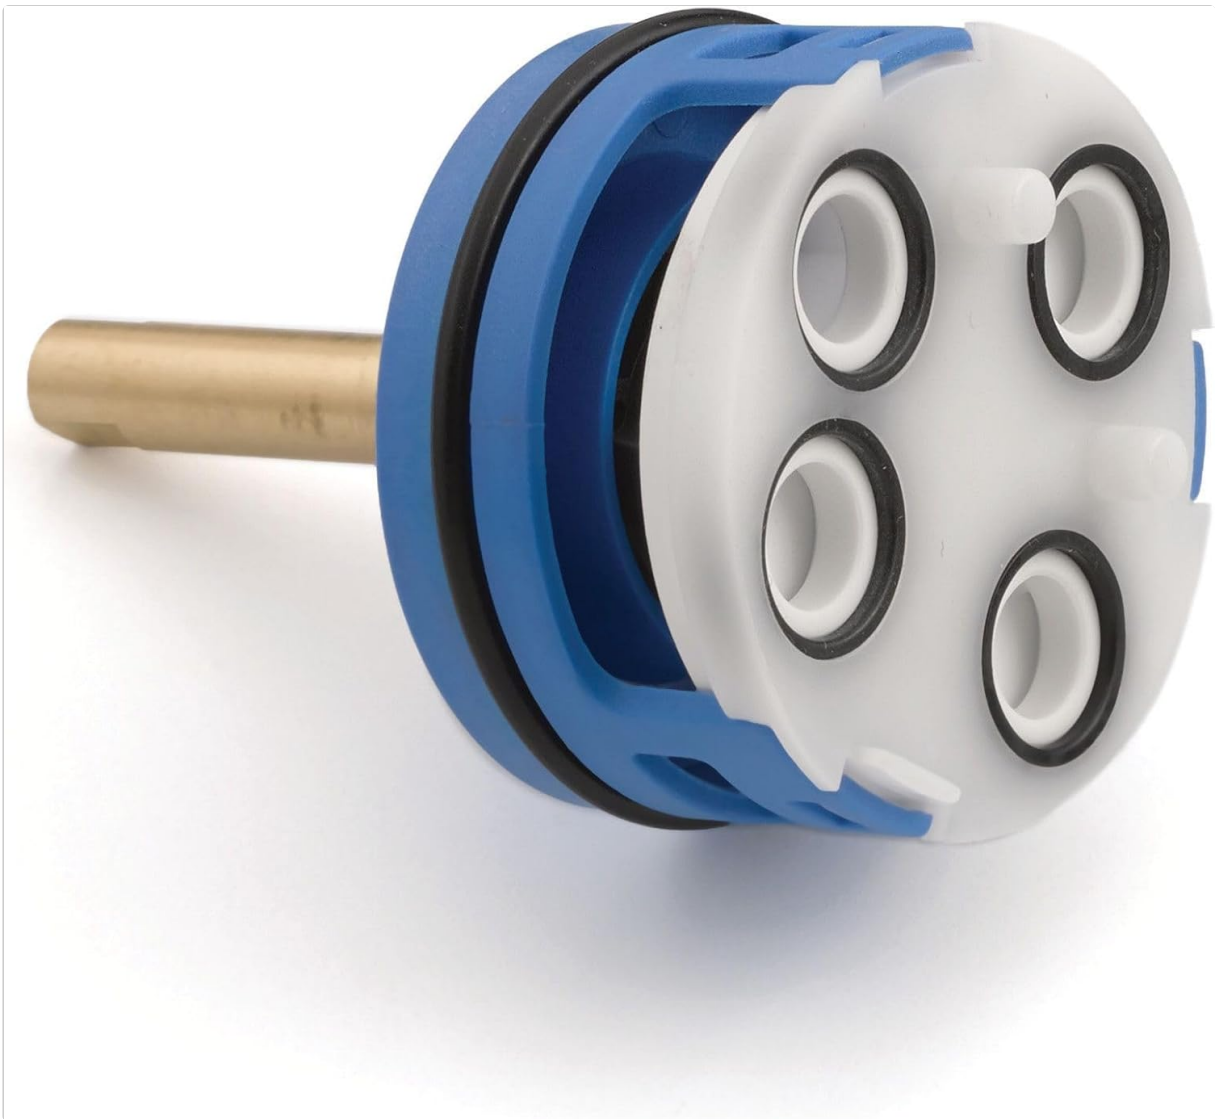
Figure 1: Moen 100040 Cartridge Replacement Kit. This image shows the blue and white cartridge with black O-rings and a brass stem, ready for installation.
