Genuine LR025048

Genuine LR 025048 Engine Oil Drain Plug Instruction Manual

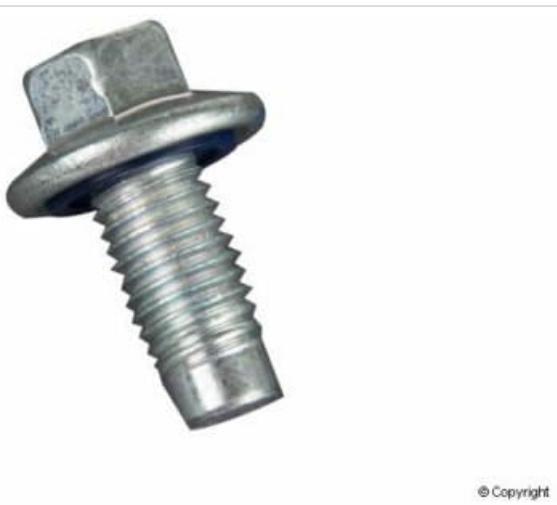
A close-up view of the Genuine LR 025048 Engine Oil Drain Plug, showing its hexagonal head, integrated washer, and threaded shaft.
