# APDTY 034141 Tail Lamp Light Bulb Socket Holder Circuit Board User Manual

Model: 034141 | Brand: APDTY

### PRODUCT OVERVIEW

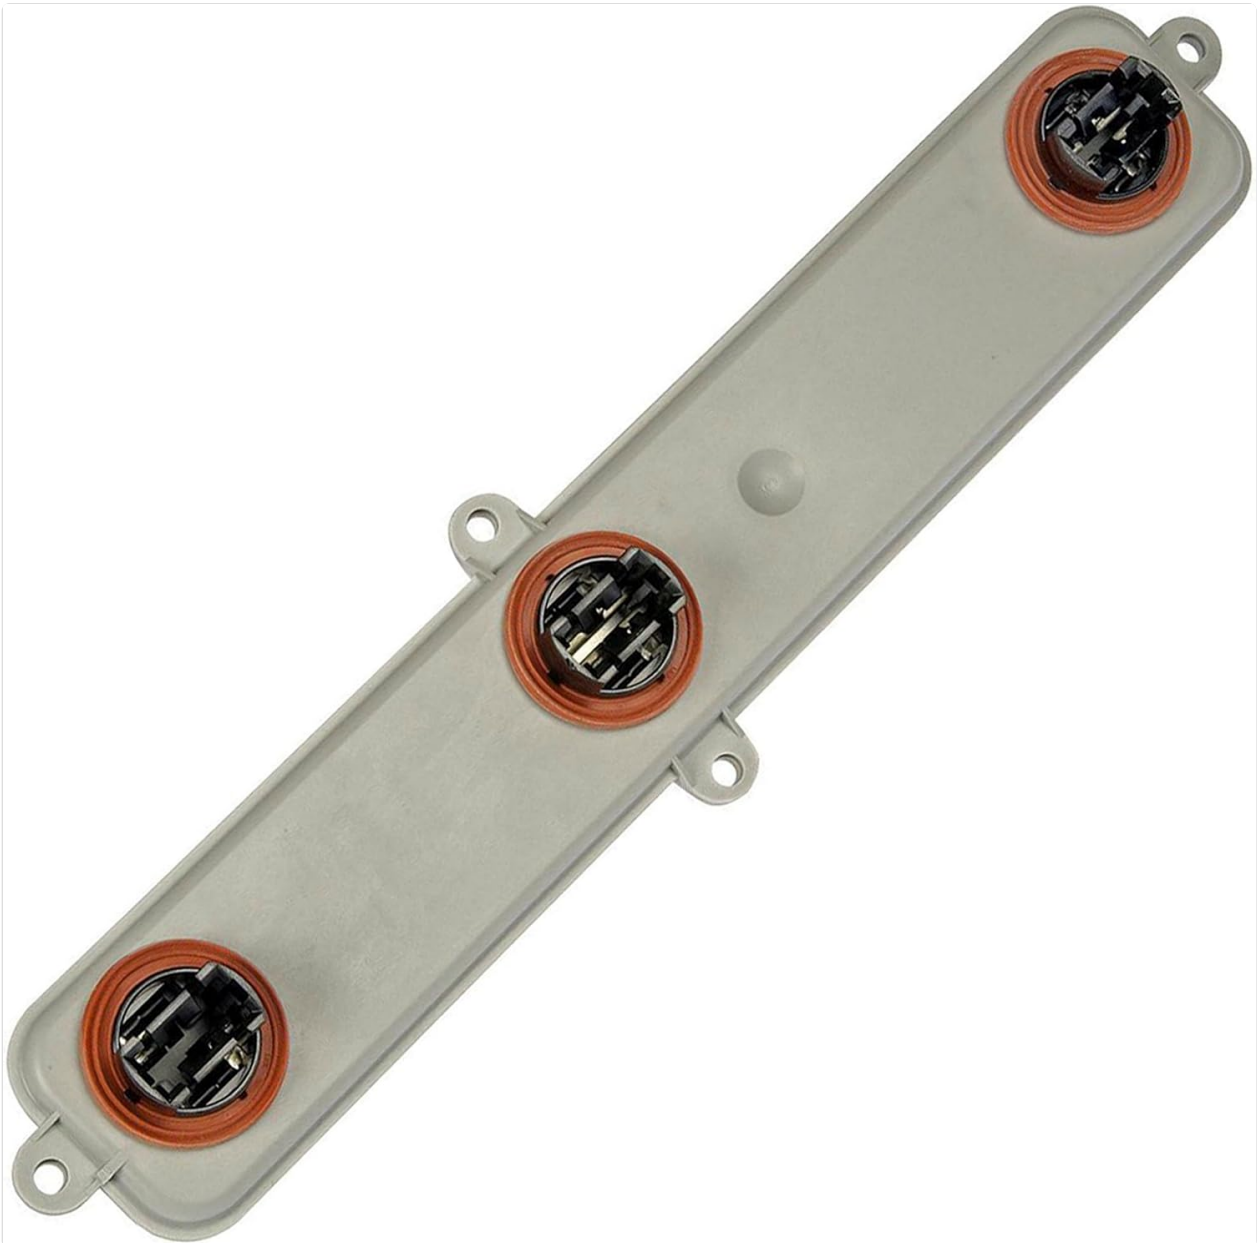
Image: The APDTY 034141 Tail Lamp Light Bulb Socket Holder Circuit Board, showing its elongated shape with three bulb sockets and mounting points.

The APDTY 034141 Tail Lamp Light Bulb Socket Holder Circuit Board is a direct replacement component designed for specific Dodge Ram pickup models. This circuit board is essential for the proper functioning of your vehicle's tail lamps, providing the necessary electrical connections for the light bulbs. It is engineered to be compatible with both the rear left and right tail lamp assemblies.

This product is a premium OE style circuit board that includes new rubber seals to ensure a secure and weather-resistant fit. It is designed to use standard 3057 tail light bulbs, ensuring compatibility with common automotive lighting components.
