## Eagle K181-5606

# Eagle Upper Stainless Steel Coolant Tube for Kenworth T600 Models

OEM Part Number K181-5606 Replacement

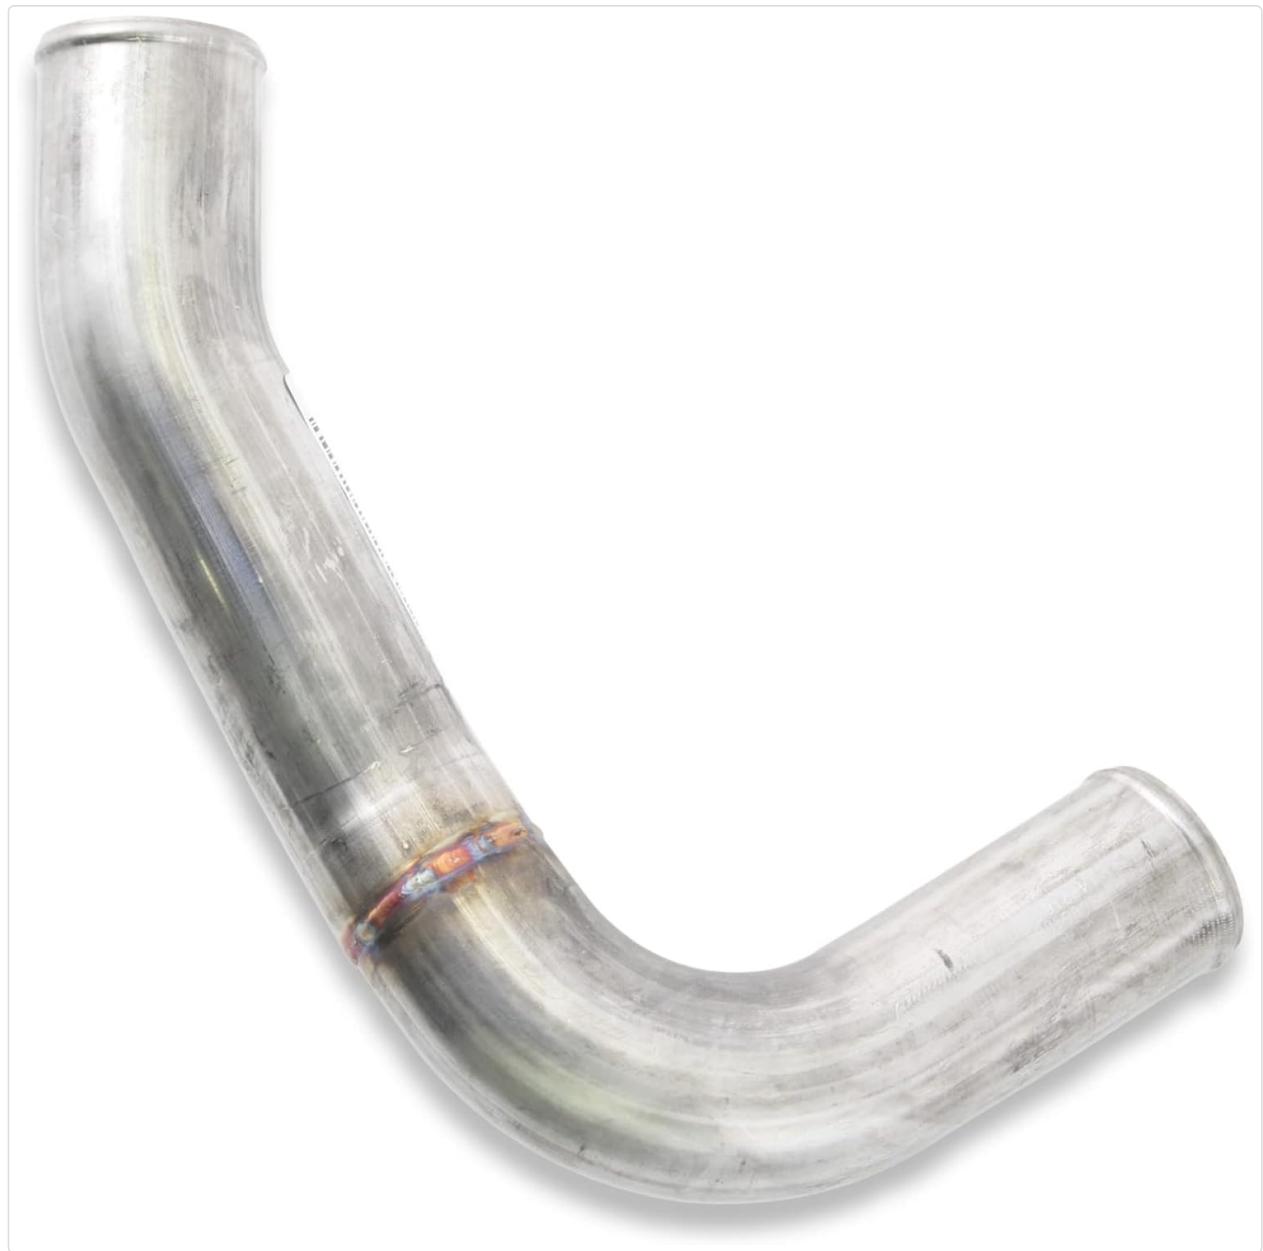
Figure 1: Main view of the Eagle Upper Stainless Steel Coolant Tube. This image displays the curved stainless steel tube with visible weld marks, indicating its robust construction.

Constructed from high-quality 304 stainless steel with TIG welded joints and 100% mandrel bends, this coolant tube offers enhanced durability and corrosion resistance compared to standard components. It features machined fittings for a precise connection.

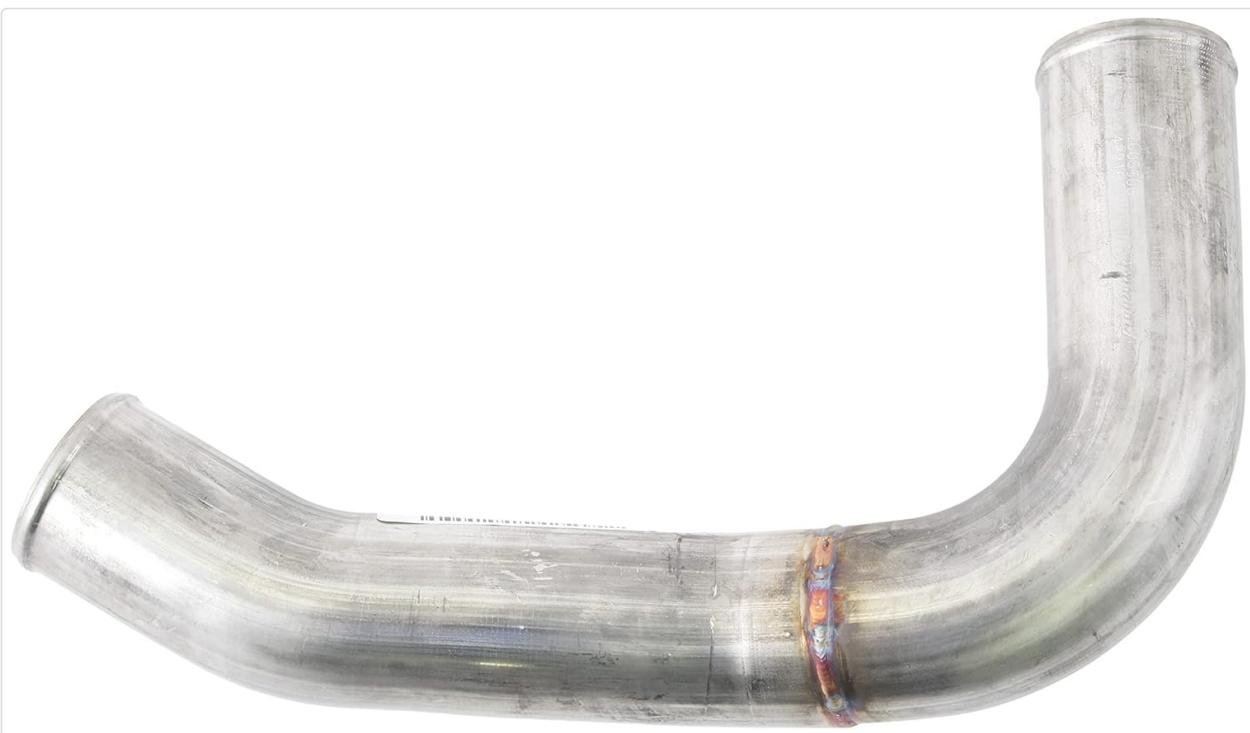
Figure 3: Side profile of the stainless steel coolant tube, illustrating its curvature and connection ends. This view is helpful for understanding the tube's orientation during installation.

1. Locate the existing upper coolant tube on your Kenworth T600.
2. Carefully loosen and remove the clamps securing the old coolant tube.
3. Remove the old coolant tube. Inspect the connection points for any debris or damage.
4. Position the new Eagle Stainless Steel Coolant Tube, ensuring it aligns correctly with the connection points.
5. Secure the new tube using appropriate clamps. Ensure all connections are tight to prevent leaks.
6. Refill the cooling system with the manufacturer-recommended coolant.
7. Bleed the cooling system to remove any trapped air, following your vehicle's specific procedure.
8. Start the engine and check for any leaks. Monitor coolant levels and engine temperature during initial operation.

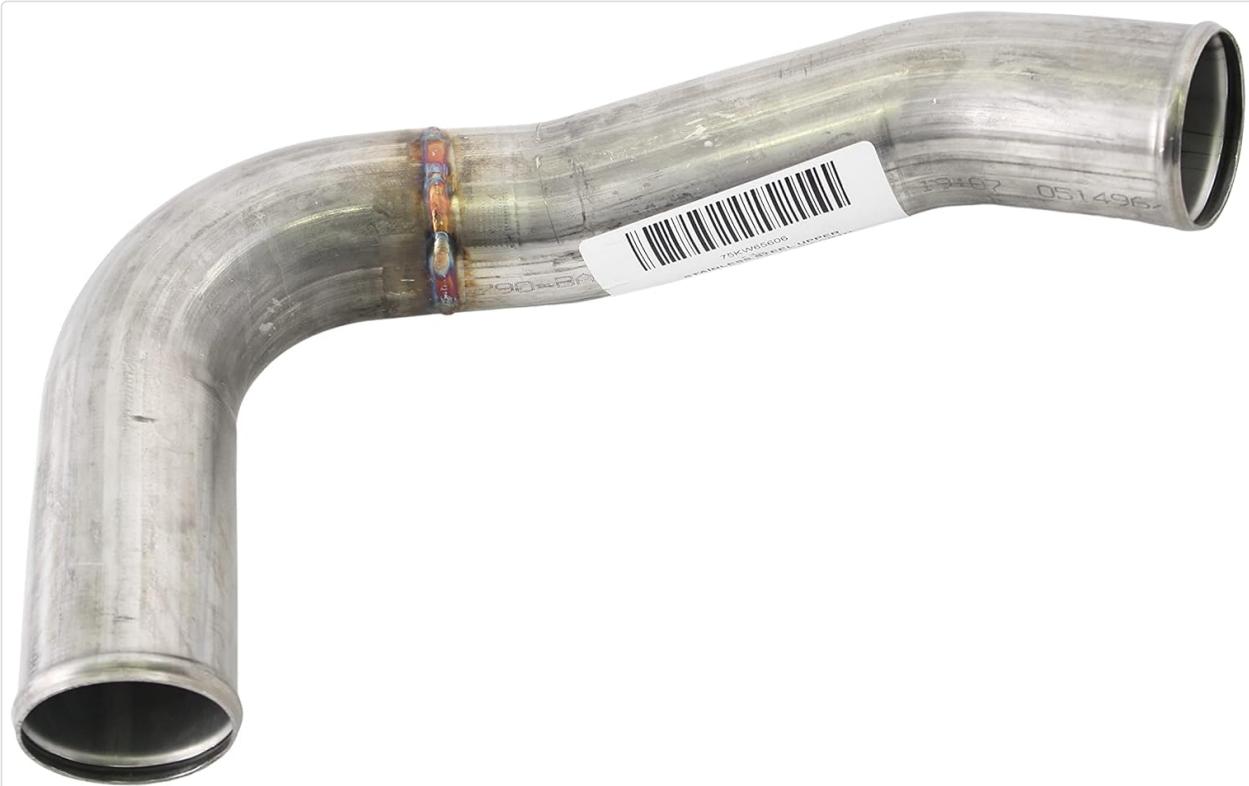
Figure 4: An angled view of the coolant tube, showing its full length and the barcode label. This image provides another perspective of the product's design and finish.
