Buderus 63002411

Buderus Burner Door Insulation Manual

Models: G105U, G115U | Part Number: 63002411

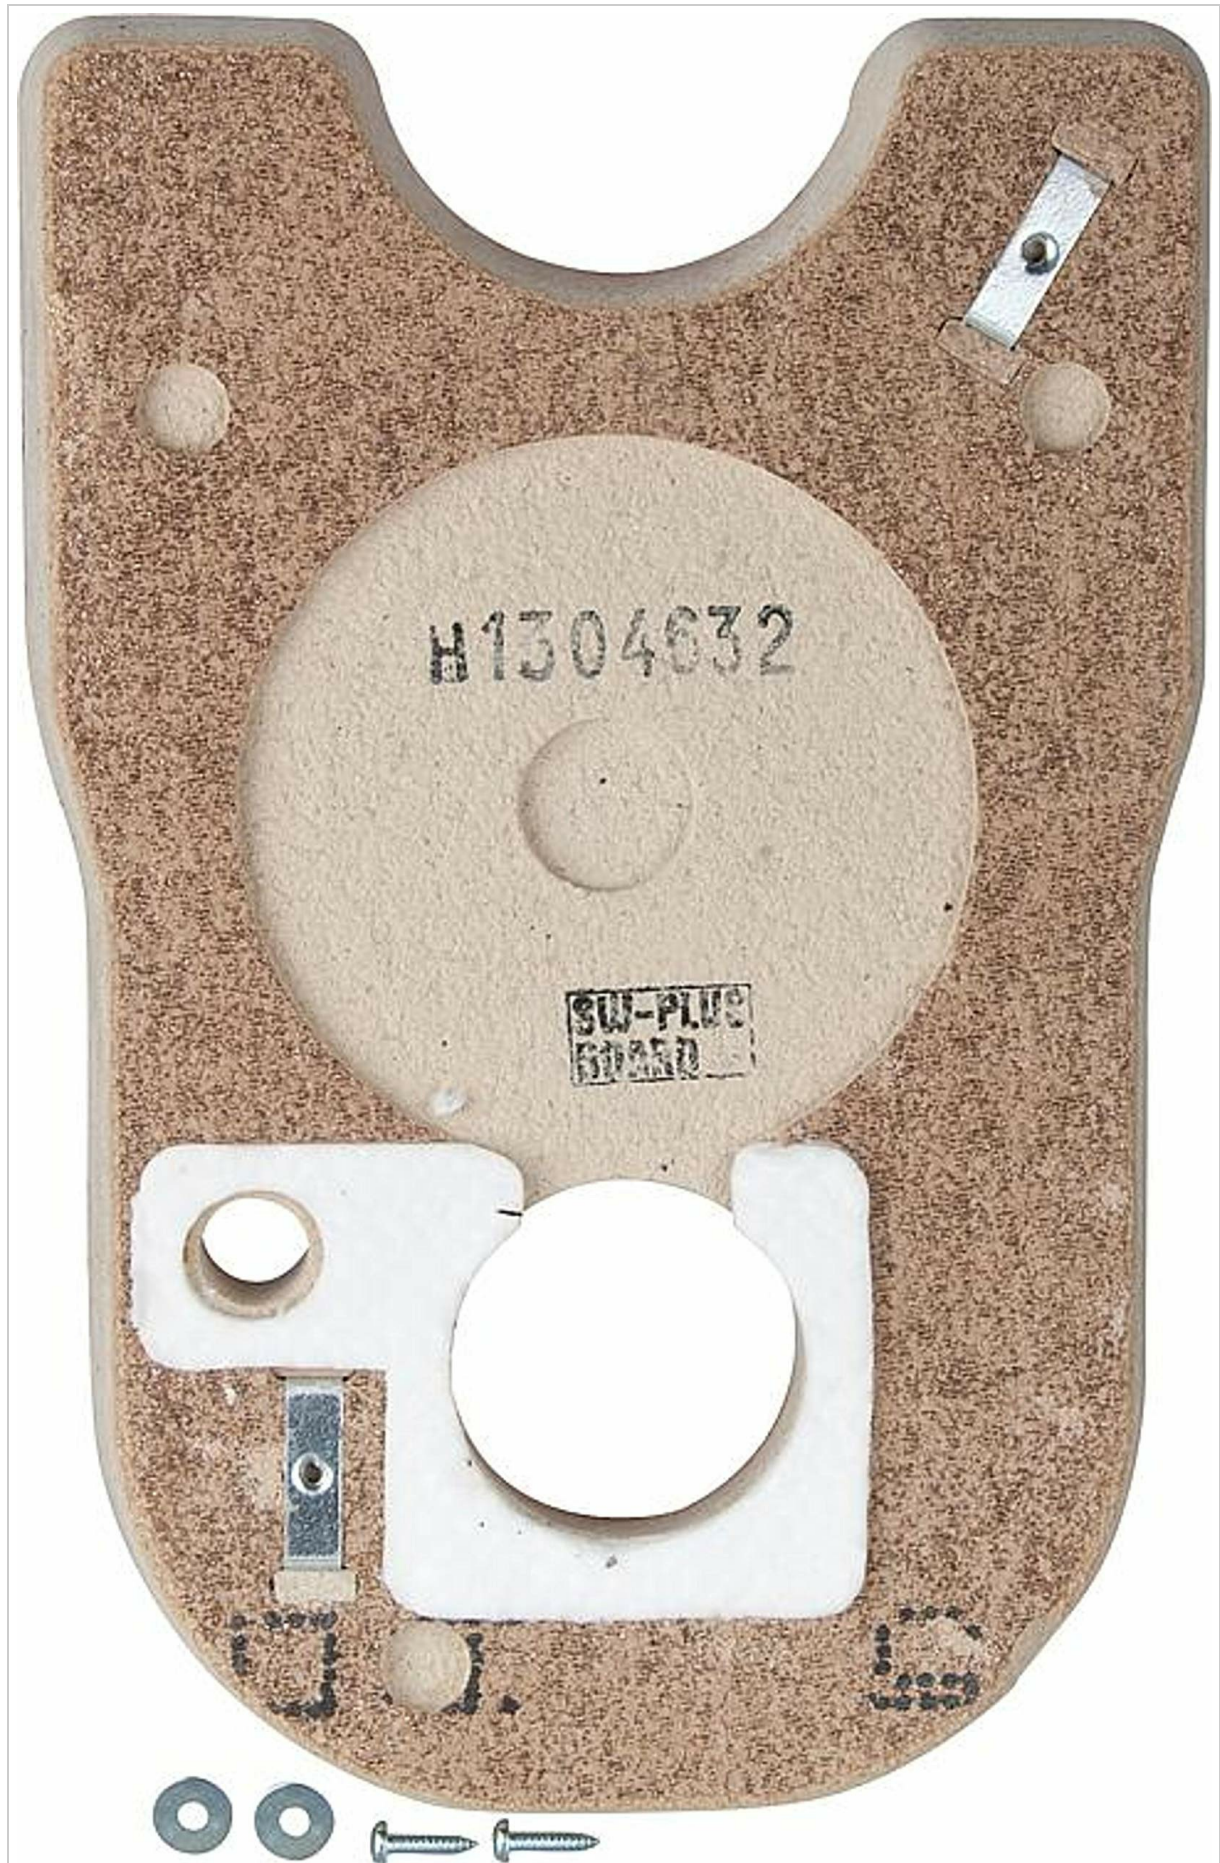
Figure 1: Buderus Burner Door Insulation (Part No. 63002411). This image displays the Buderus Burner Door Insulation, a precisely shaped ceramic fiber component designed for thermal protection. It features a central circular opening and specific cutouts to fit the burner door assembly of Buderus G105U and G115U boilers. The surface shows a light beige, textured finish with markings 'H1025723' and '63002411' (implied from product info) indicating its part number and manufacturing details. Small metal clips are visible, suggesting attachment points for secure installation.

The Buderus Burner Door Insulation (Part No. 63002411) is a critical thermal barrier designed to fit precisely within the burner door of compatible Buderus boilers. Its specific shape and material composition are engineered to withstand high temperatures and prevent heat loss, contributing to the boiler's efficiency and longevity.

- 4. Clean Surface:** Clean the surface where the new insulation will be placed, ensuring it is free from debris, rust, or old adhesive residues.
- 5. Position New Insulation:** Carefully place the new Buderus Burner Door Insulation (Part No. 63002411) into the designated area on the burner door. Ensure it aligns correctly with any mounting points, cutouts, or pins. The insulation is designed for a precise fit.

- 6. Secure Insulation:** If the design includes clips, screws, or other fasteners, secure the insulation firmly in place. Do not overtighten if using screws, as the material can be brittle.
