Bilstein 22-236296 Shock Absorber User Manual

Model: 22-236296 | Brand: Bilstein

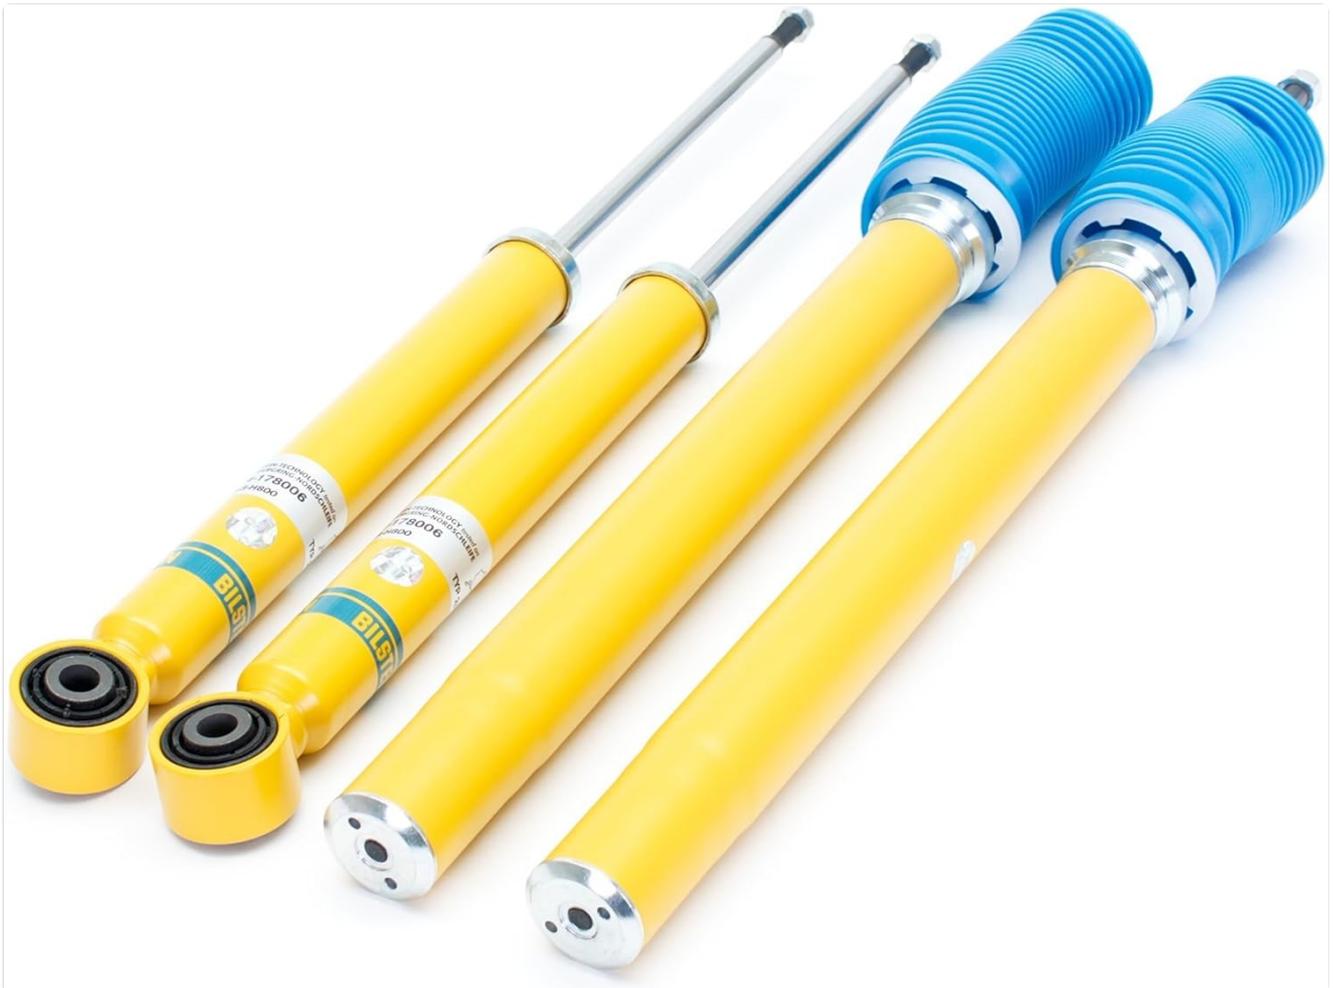
This image displays four Bilstein shock absorbers, model 22-236296. Two of the shocks are equipped with blue corrugated dust boots, while all four feature the distinctive yellow body and Bilstein branding. These components are designed for vehicle suspension systems.
