Hot Spring Spas Ozone Check Valve 1044101 Instruction Manual

Model: 1044101

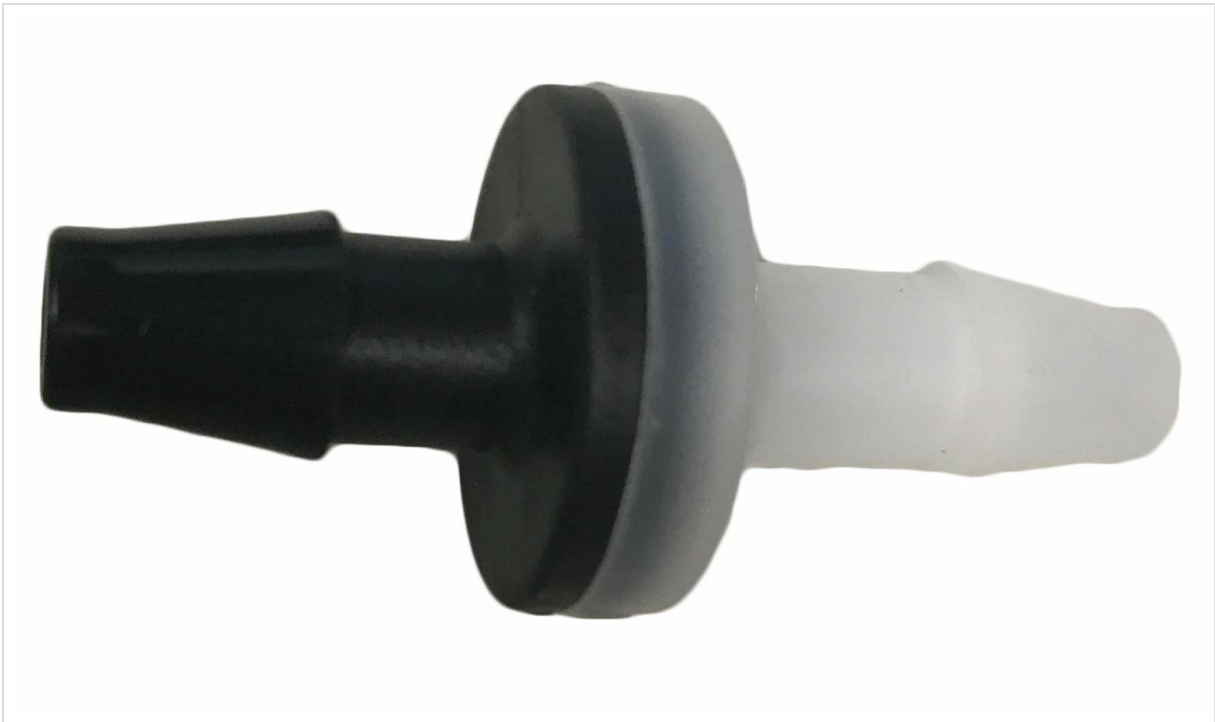
Figure 1: Hot Spring Spas Ozone Check Valve 1044101. This image displays the compact, cylindrical check valve with two barbed ends for hose connections. The valve is typically white or clear plastic.

The Hot Spring Spas Ozone Check Valve 1044101 is a critical component in your hot tub's ozone sanitation system. Its primary function is to allow ozone gas to flow into the spa water while preventing water from flowing back into the ozonator. Over time, check valves can degrade, leading to inefficient ozone injection or potential damage to the ozonator from water backflow. This valve replaces part number 34658 and is designed for 3/16" tubing connections.

Once installed, the Hot Spring Spas Ozone Check Valve 1044101 operates automatically as part of your hot tub's ozone system. When the ozonator is active, it produces ozone gas which is then drawn through the check valve and injected into the spa water. The check valve's internal mechanism opens to allow this one-way flow of gas. When the ozonator is off, or if there is any back pressure from the water, the valve closes to prevent water from entering the ozonator, protecting it from damage.
