# APDTY 134025 AC Air Conditioning Condenser Assembly User Manual

Model: 134025

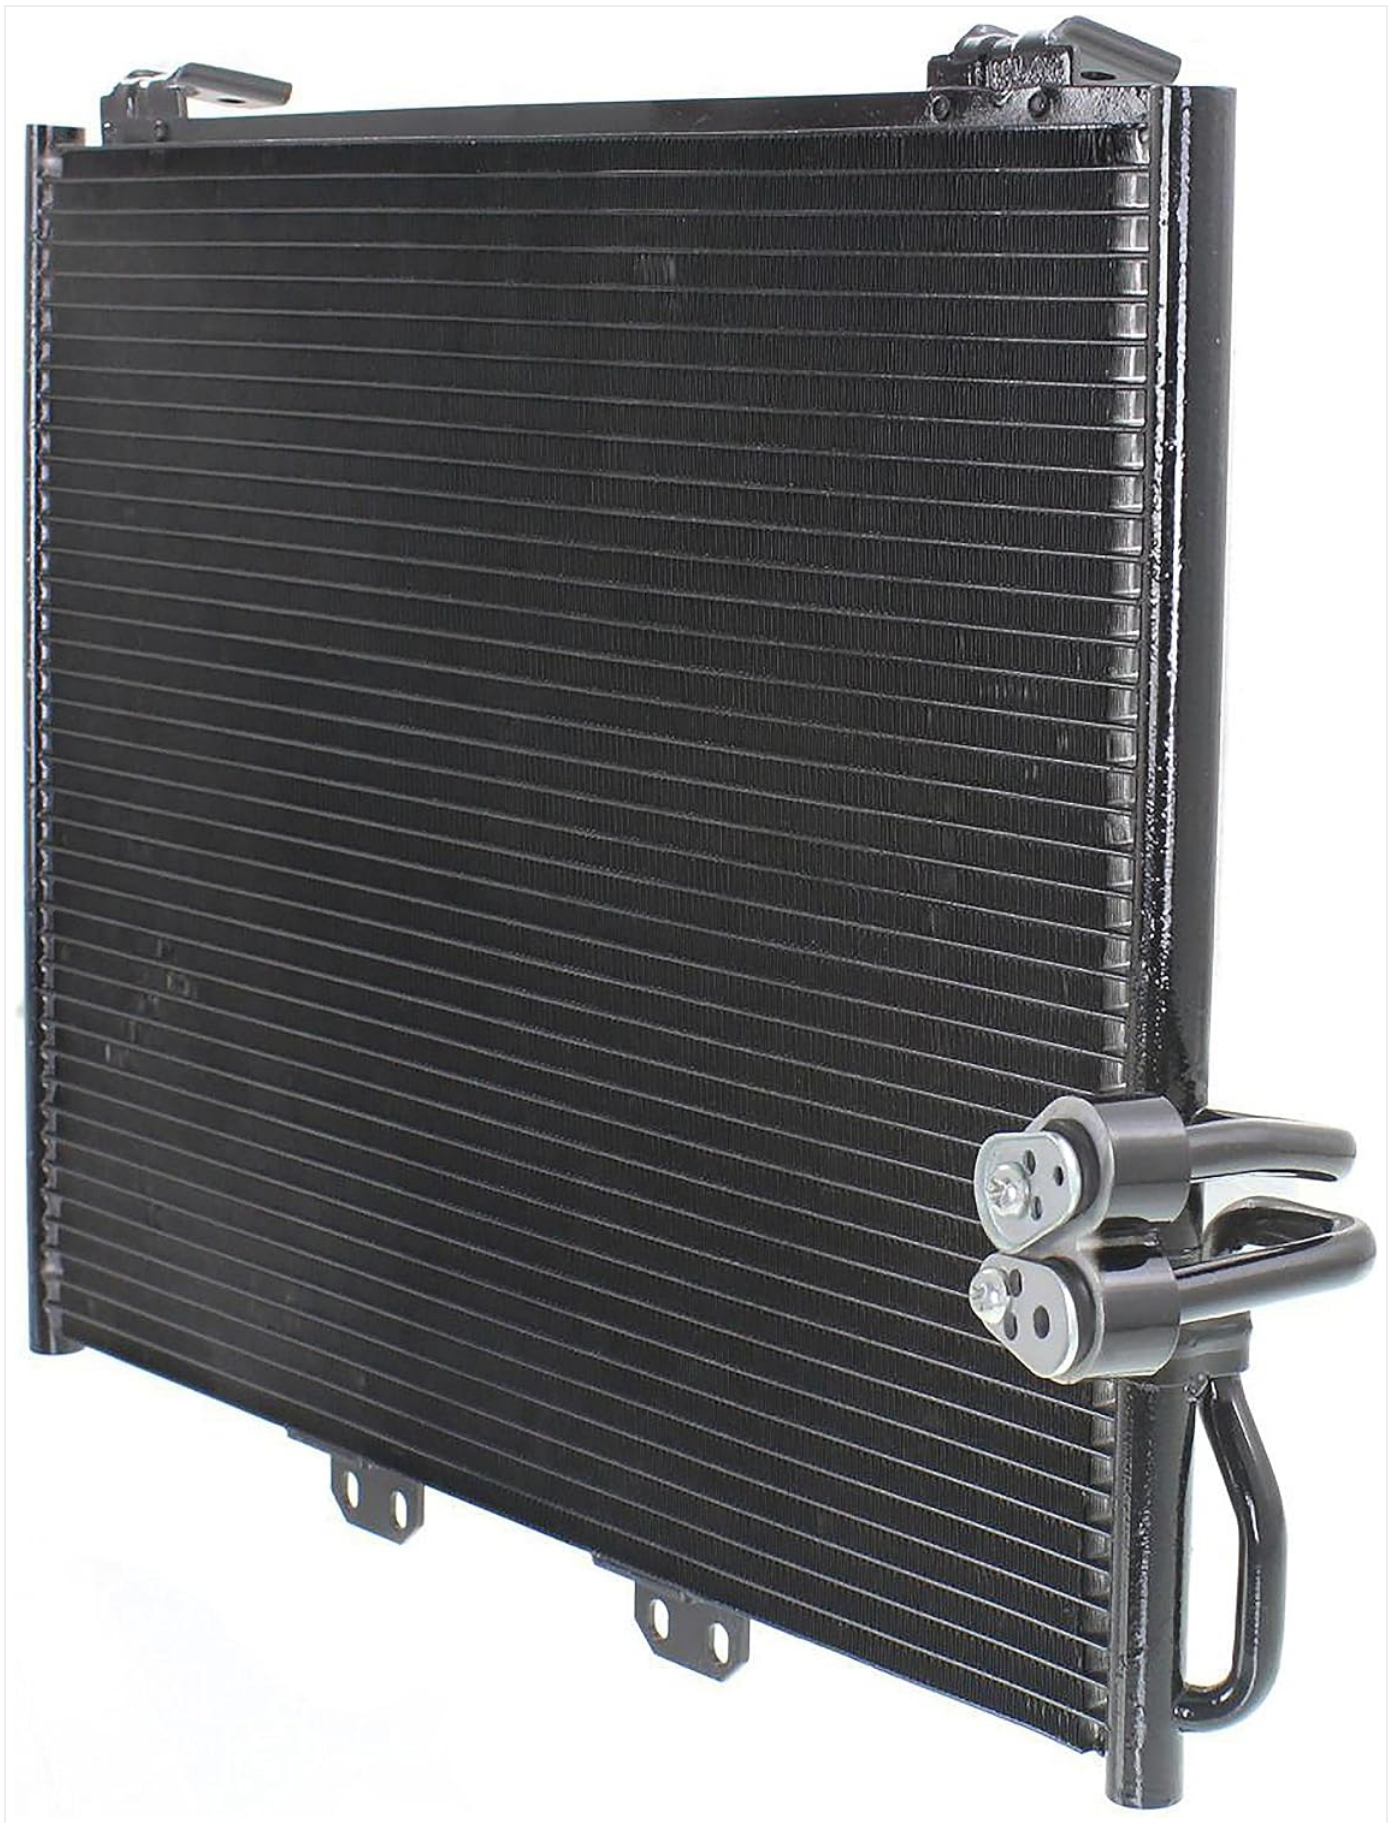
Figure 1: APDTY 134025 AC Air Conditioning Condenser Assembly. This image shows the full condenser unit, highlighting its finned structure and connection ports.

The AC condenser is a heat exchanger located at the front of the vehicle, typically in front of the radiator. Its primary function is to cool down the hot, high-pressure gaseous refrigerant that comes from the AC compressor. As the refrigerant flows through the condenser's tubes and fins, heat is transferred to the cooler ambient air passing over it (aided by the vehicle's cooling fan or airflow during driving). This process causes the refrigerant to condense from a gas into a high-
