# Husqvarna Genuine Revolution Blade Cap Assembly Instruction Manual

Model: 586638501

This manual provides instructions for the Husqvarna Genuine Revolution Blade Cap Assembly, part number 586638501. This component is an original equipment manufacturer (OEM) part designed for specific Husqvarna lawn tractor models. It plays a crucial role in the mower deck's blade system, helping to secure the blades and ensure proper operation.

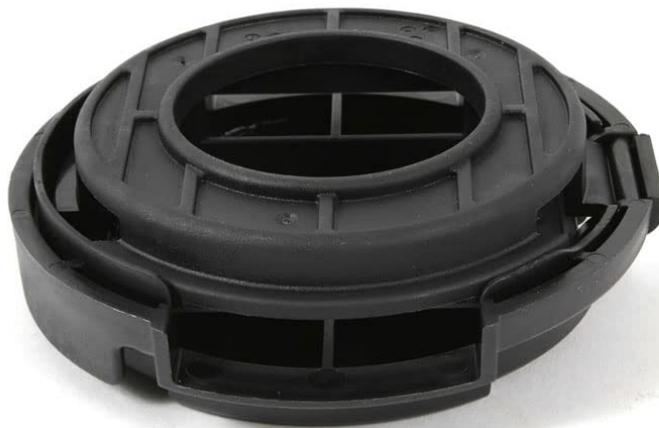
Figure 1: Top view of the Husqvarna Genuine Revolution Blade Cap Assembly.

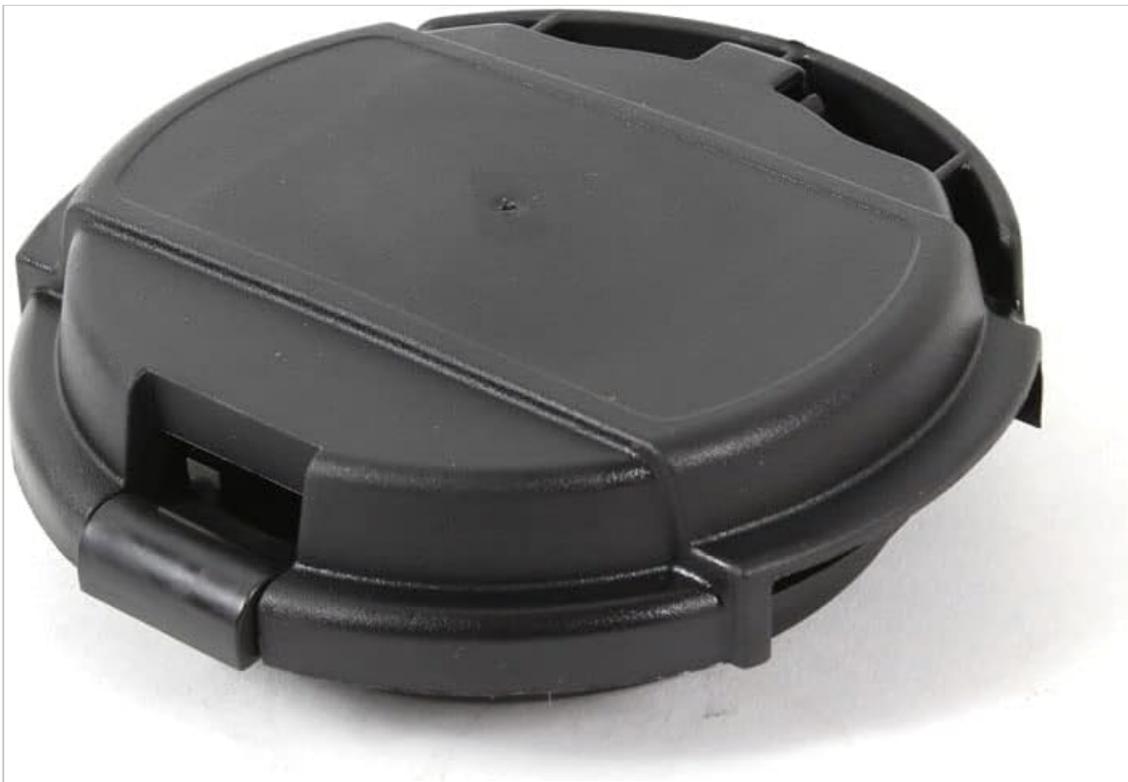
Figure 2: Side view illustrating the locking clips of the blade cap assembly.

4. **Secure the Cap:** Press the cap firmly into place until the locking clips engage. It may require significant pressure to fully secure the clips. Ensure all clips are fully seated and locked to prevent the cap from dislodging during operation.

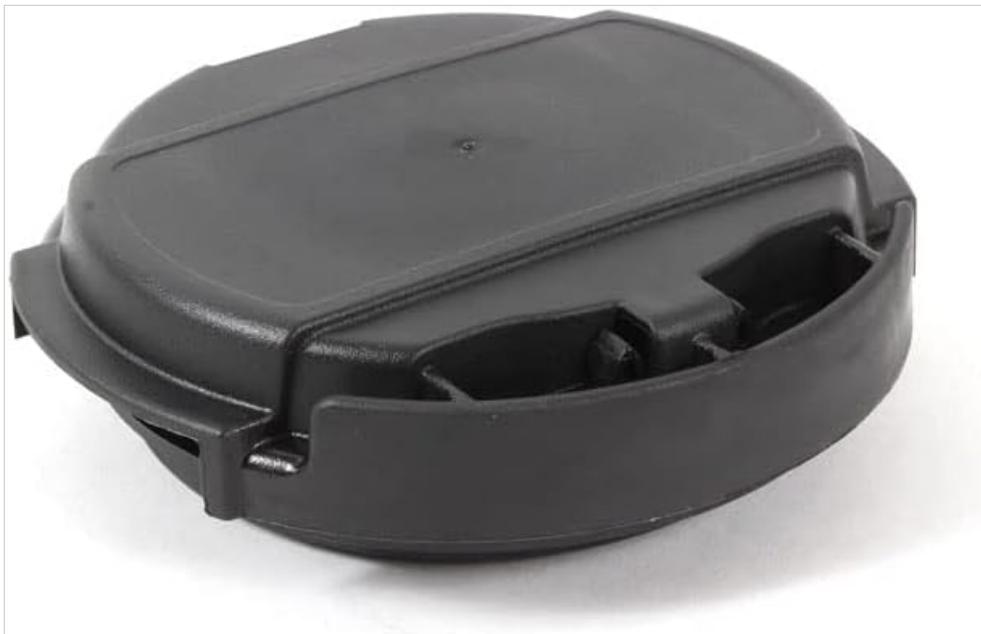
Figure 3: Bottom view revealing the internal structure of the blade cap assembly.
