HD Switch Lower Crankshaft Oil Seal Instruction Manual

This manual provides instructions for the installation and maintenance of the HD Switch Lower Crankshaft Oil Seal. This precision-engineered component is designed to prevent oil leakage from the lower crankshaft area of compatible engines, ensuring optimal engine performance and longevity.

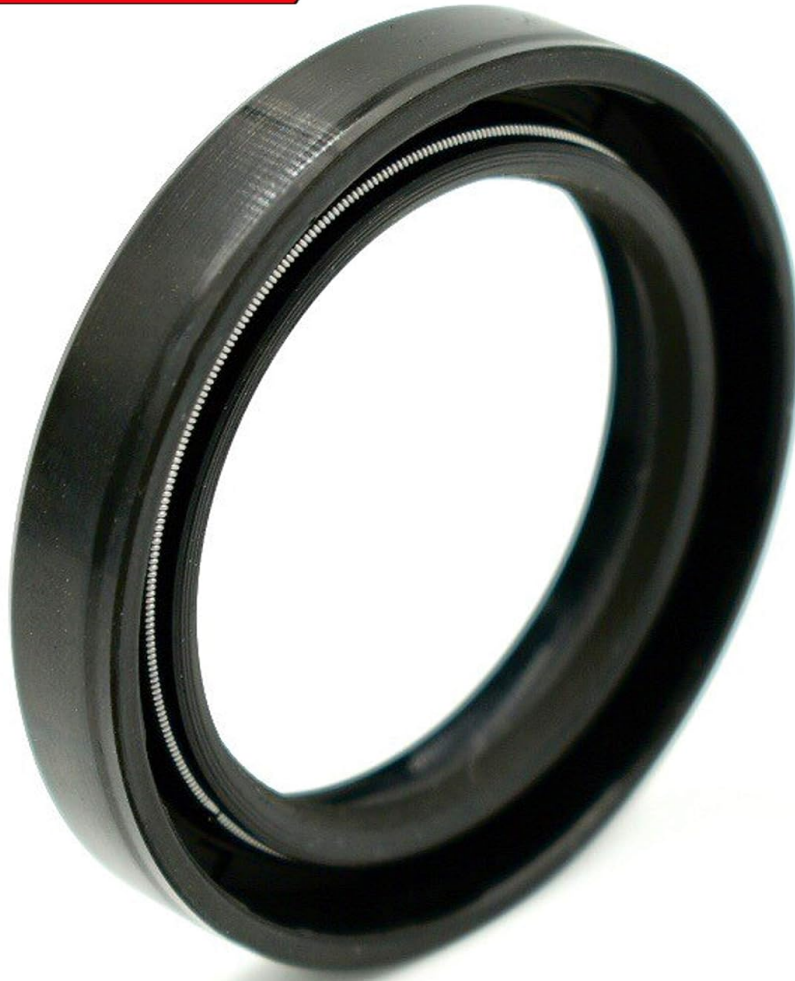
Image: HD Switch Lower Crankshaft Oil Seal. This image displays the black rubber and metal construction of the oil seal, designed for a secure fit.

- **Brand:** HD Switch
- **Material:** High-quality, durable sealing compounds
- **Design:** Precision machined with spring-loaded sealing element for optimal protection against dirt, dust, and water.
- **Compatibility:** Replaces seals for Kawasaki FB460V, FC400V, FC401V, FC420V, FC540V, and compatible Scag, Toro, Exmark engines.
