# UpStart Components W10258275 Bimetal Fuse Replacement Instruction Manual

Brand: UpStart Components | Model: W10258275

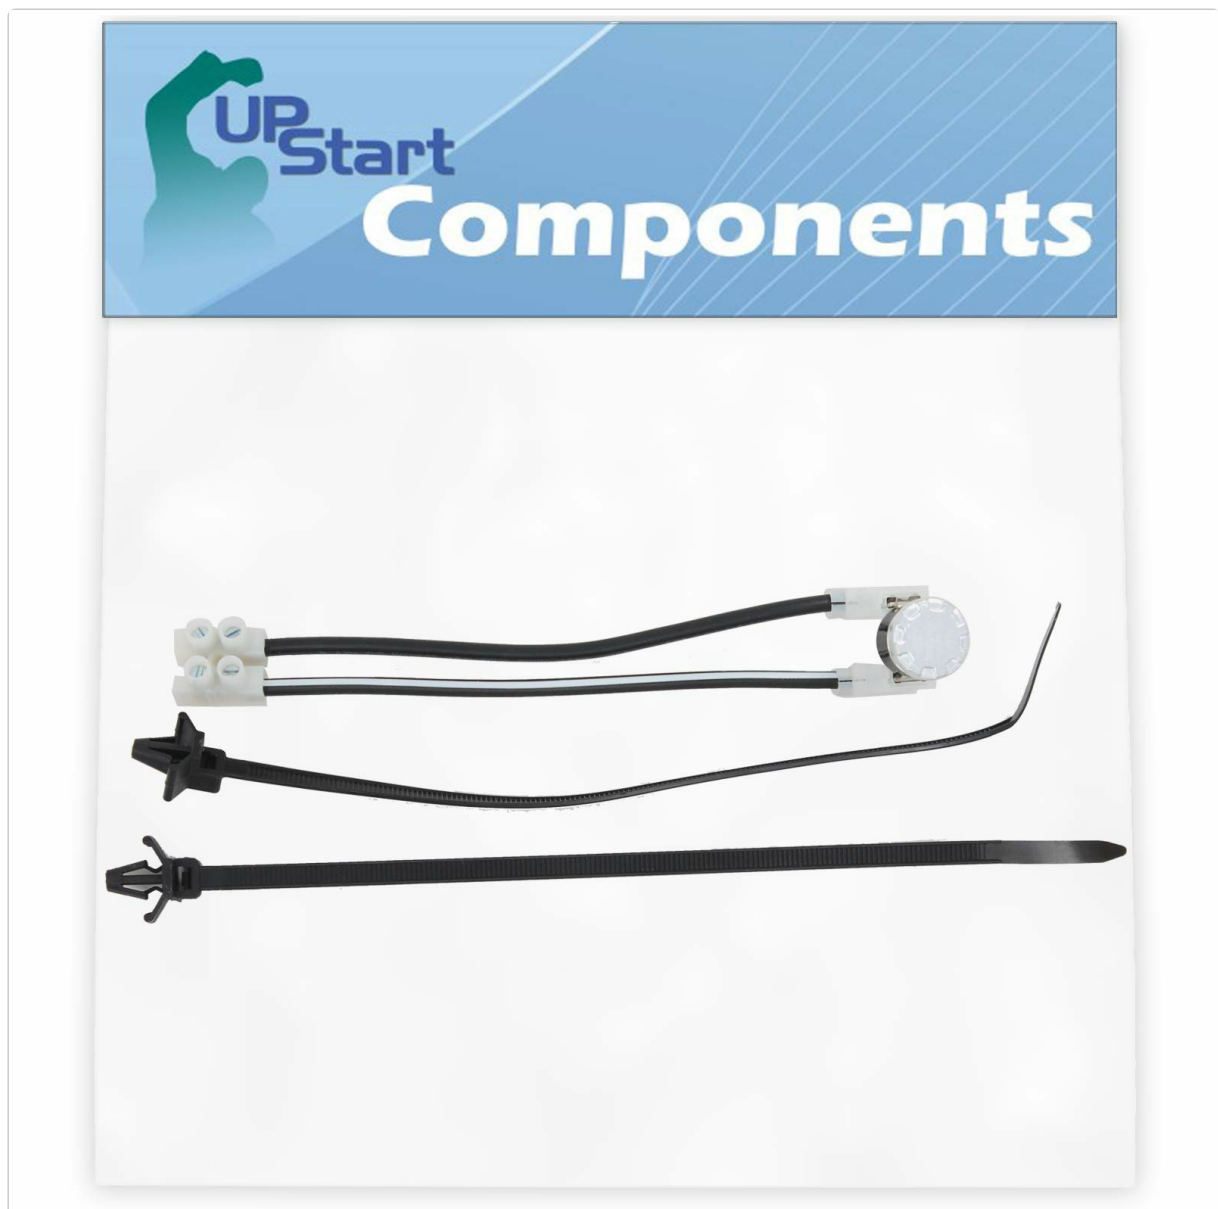
Image: The UpStart Components W10258275 Bimetal Fuse Replacement kit, including the bimetal fuse with pre-attached

wiring harnesses and two black zip ties for secure mounting.

4. **Remove Old Fuse:** Carefully disconnect the wires from the old fuse. Cut any zip ties or release clips holding it in place.
5. **Install New Fuse:** Connect the wires to the new UpStart Components W10258275 Bimetal Fuse. Ensure the connections are firm. Use the provided zip ties to secure the new fuse in the same location as the old one, ensuring it does not interfere with any moving parts or wiring.
