# CCIYU 932-306 Front Drive Shaft CV Joint Rebuild Kit User Manual

*Model: 106775-5210-1032526471*

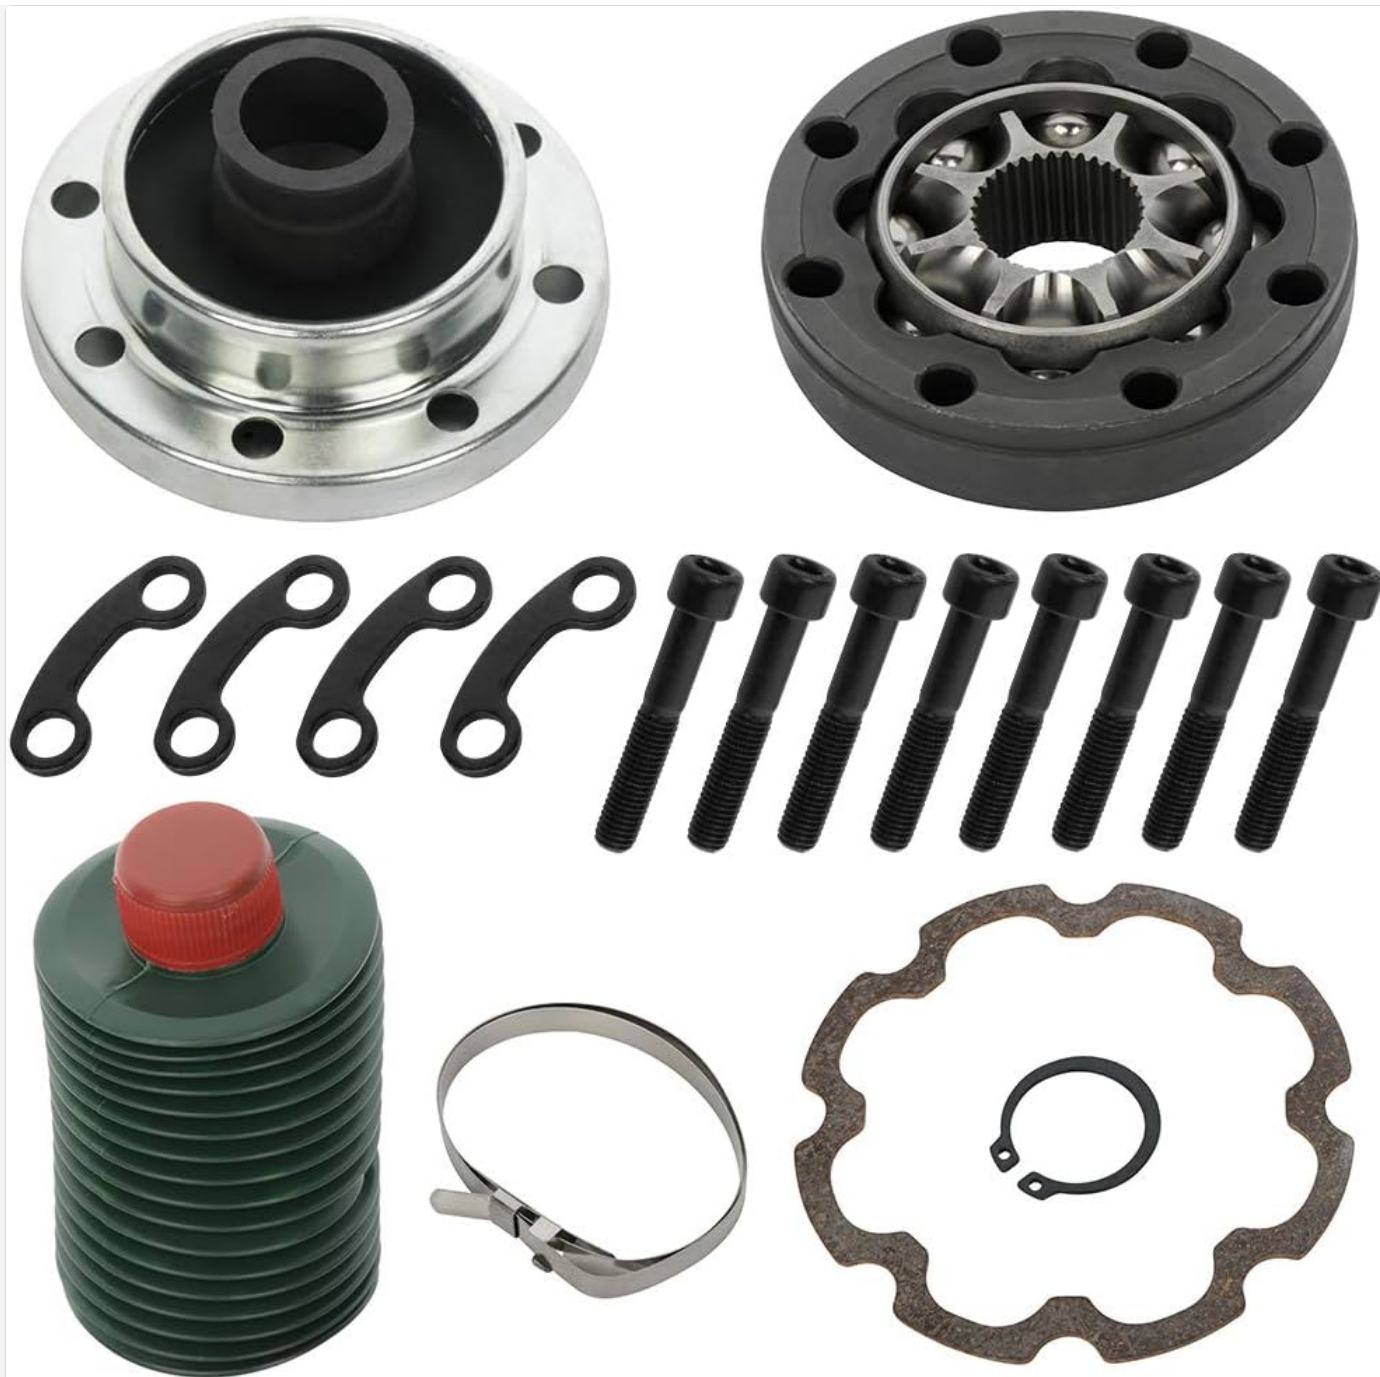
**Figure 1:** Overview of the CCIYU 932-306 Front Drive Shaft CV Joint Rebuild Kit, showing all included parts such as the CV joint, boot, clamps, grease, and hardware.

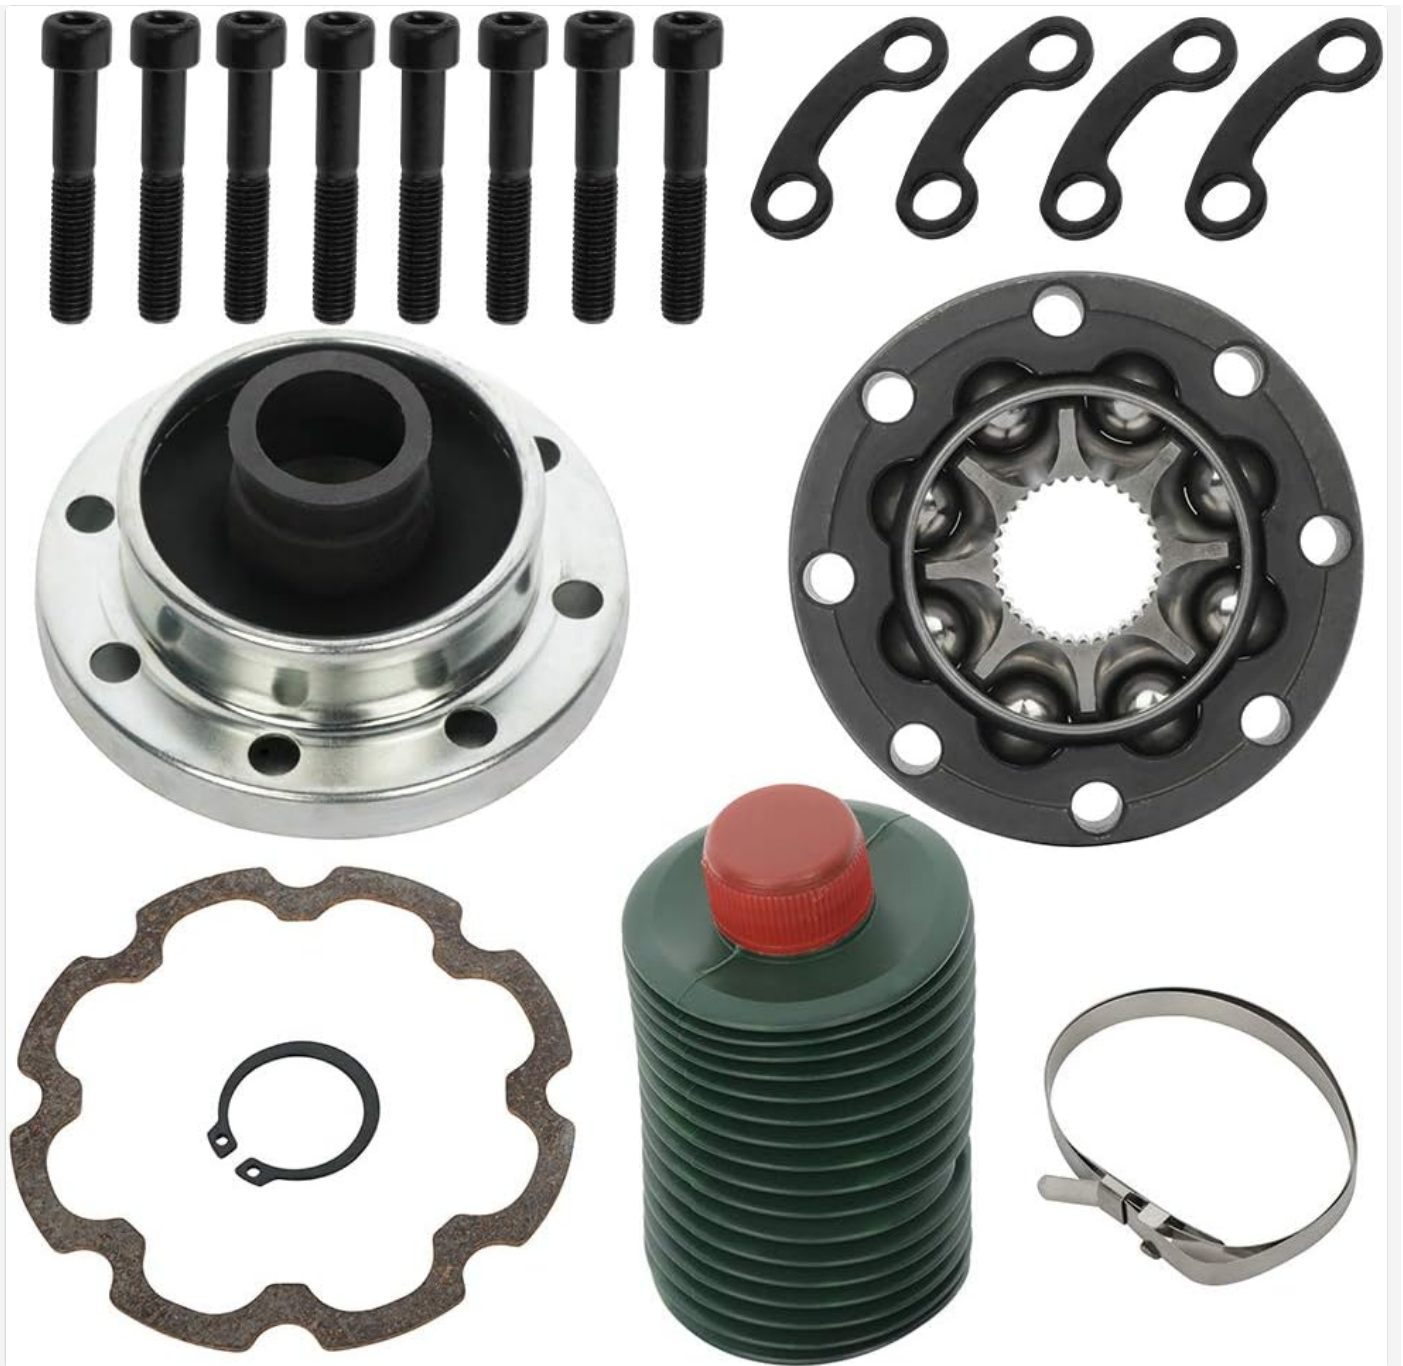
**Figure 2:** A closer look at the individual components of the rebuild kit, including the CV joint, boot, and various fasteners.

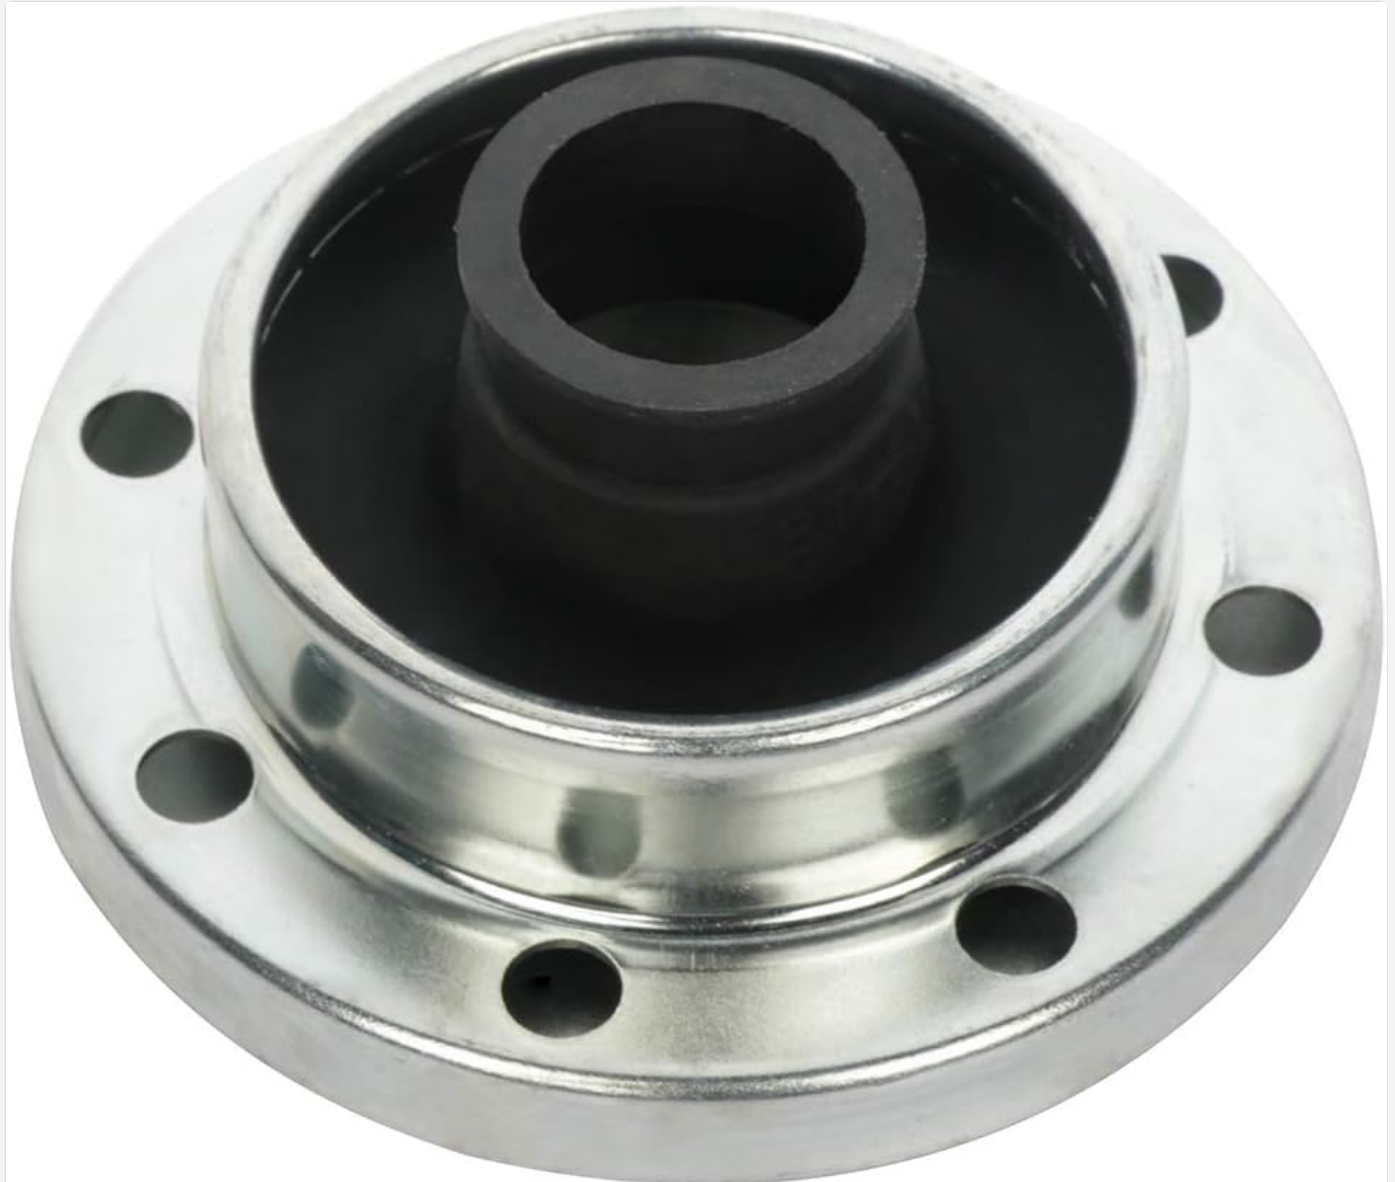
**Figure 3:** The CV joint housing, which contains the internal components and connects to the drive shaft.

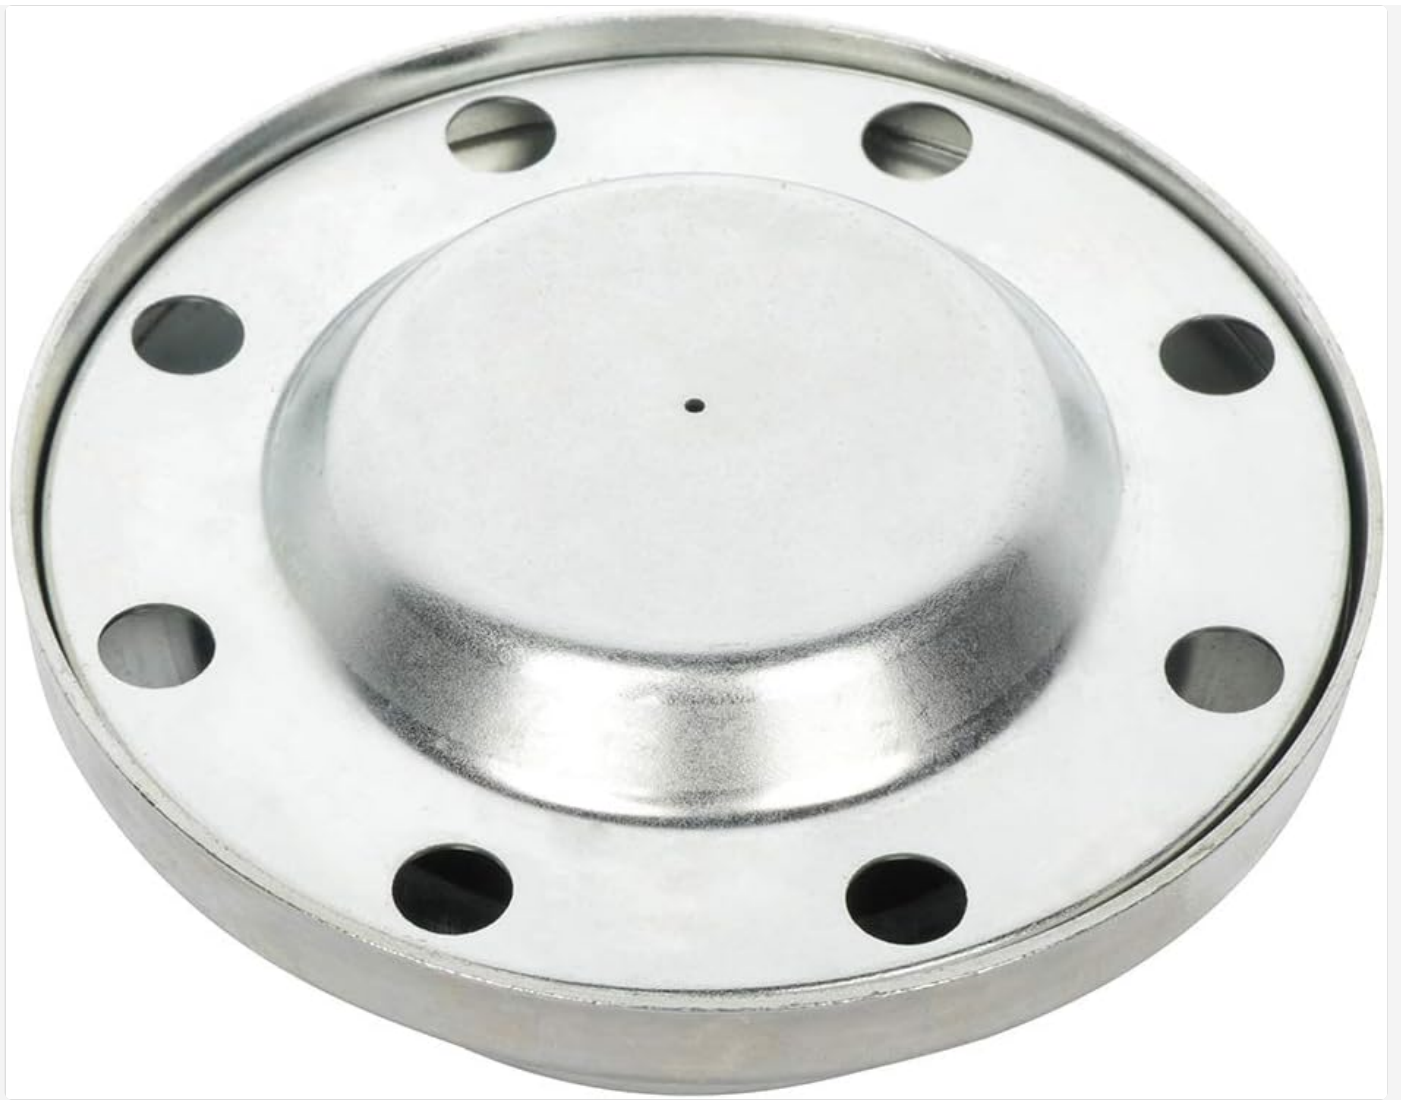
**Figure 4:** The underside of the CV joint housing, showing the mounting points.

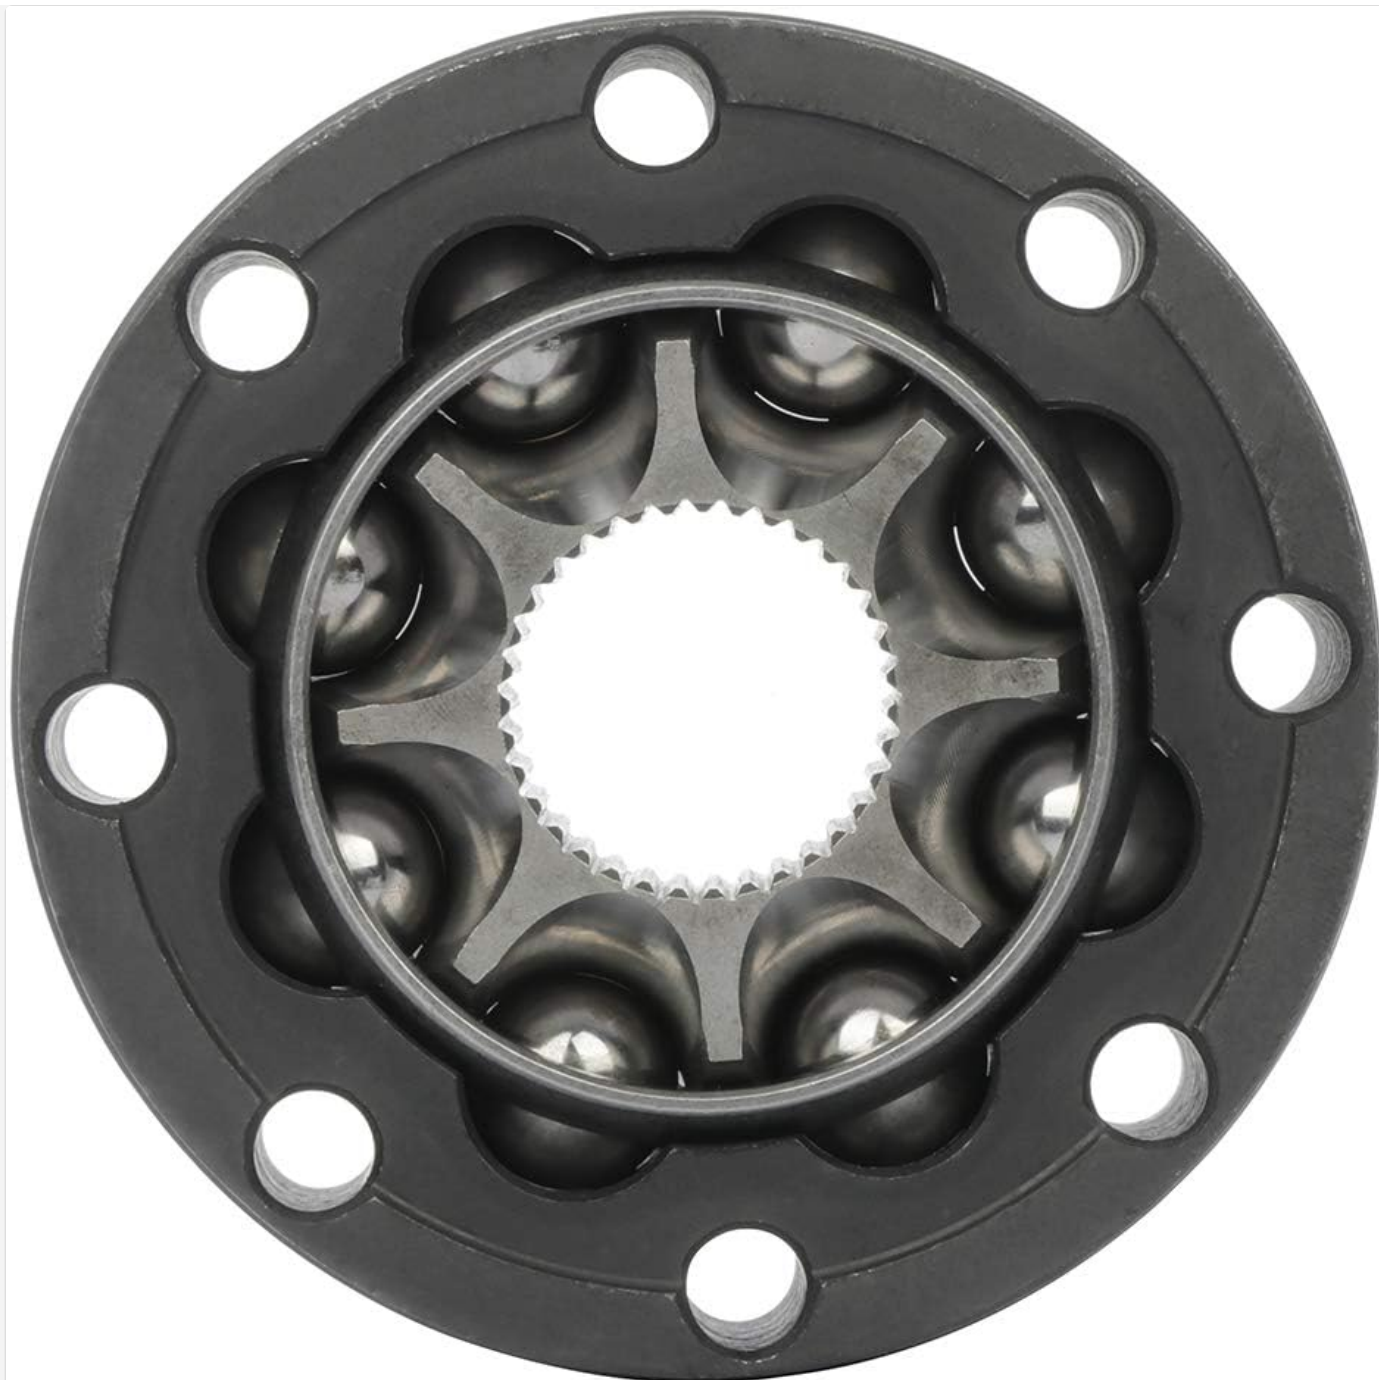
**Figure 5:** An internal view of the CV joint, highlighting the ball bearings and splined shaft for power transmission.

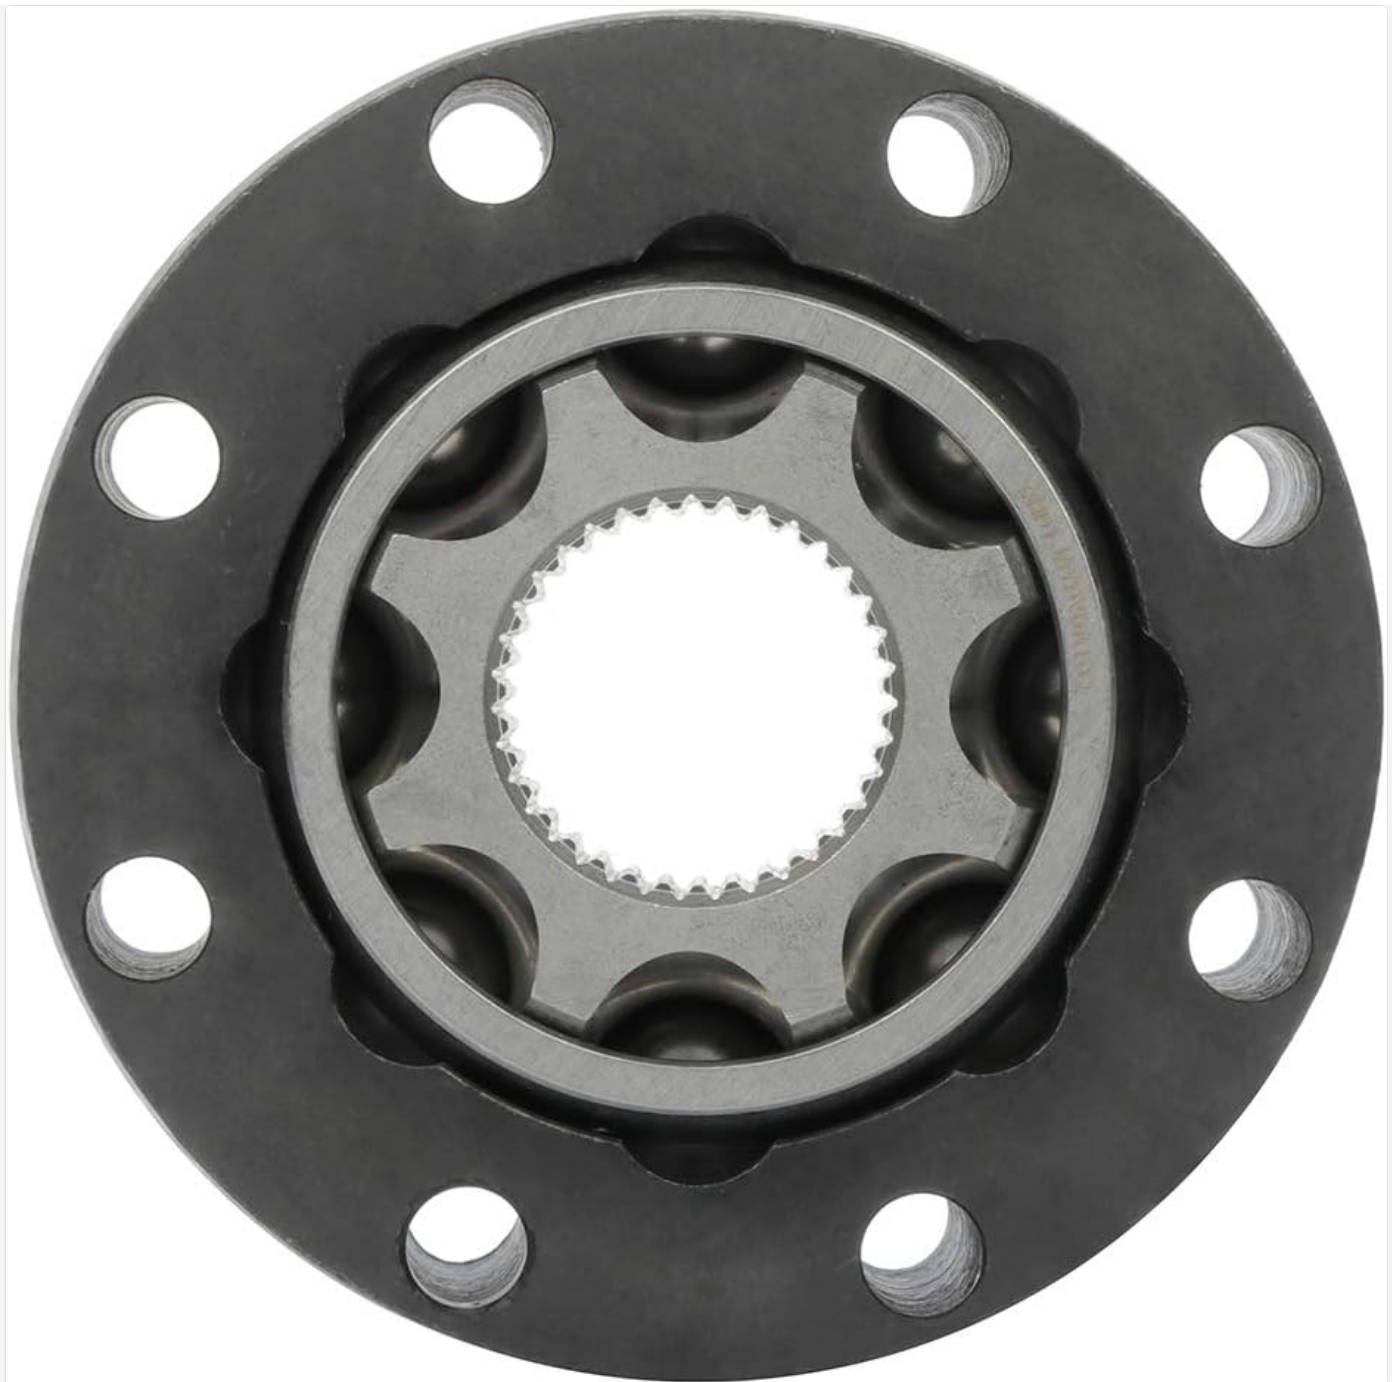
**Figure 6:** Side profile of the CV joint, showing its compact design.

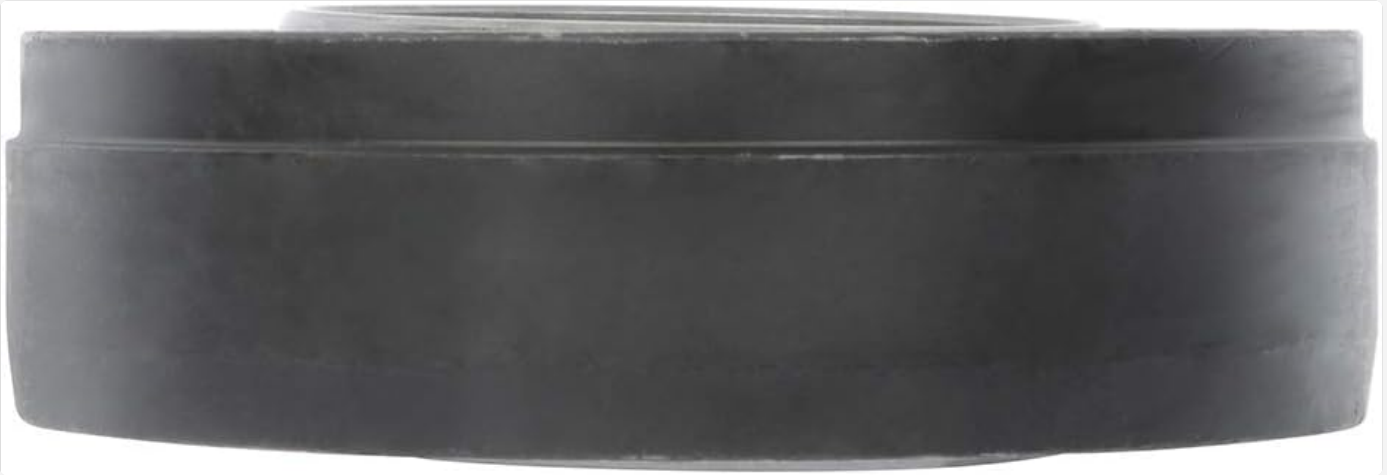
**Figure 7:** A circlip, essential for securing the CV joint on the drive shaft.

6. **Assemble CV Joint:** Carefully slide the new CV joint onto the drive shaft spline. Use the circlip to secure it in place.
7. **Reinstall Drive Shaft:** Reconnect the drive shaft to the differential and transmission, ensuring all bolts are tightened to manufacturer specifications.
