ALLIANCE LAUNDRY SYSTEMS G582P3

ALLIANCE LAUNDRY SYSTEMS Elbi Valve Diaphragm Kit

Model: G582P3

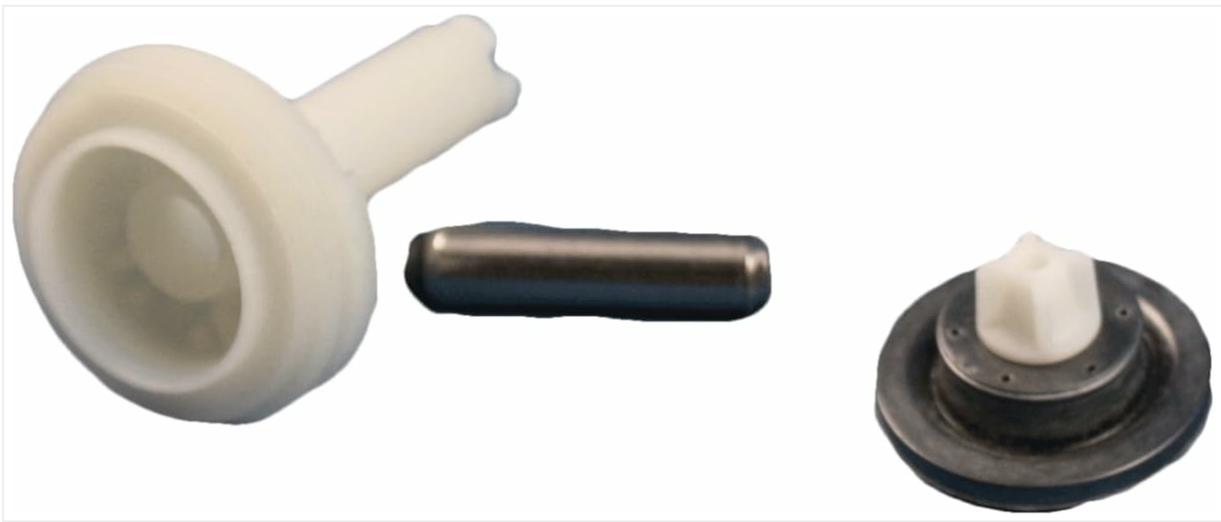
Figure 1: The ALLIANCE LAUNDRY SYSTEMS Elbi Valve Diaphragm Kit (G582P3). This image shows the replacement diaphragm, which is a crucial component for regulating water flow in laundry system valves.

The Elbi valve diaphragm is a critical component that regulates the flow of water into the laundry appliance. When installed correctly, it flexes to open and close water passages in response to pressure changes or solenoid activation, ensuring precise water delivery for various wash cycles. The diaphragm's integrity is essential for preventing leaks and maintaining efficient water control.
