Product Instruction Manual

Hobart 886610 Wash Arm End Plugs

Model: 886610

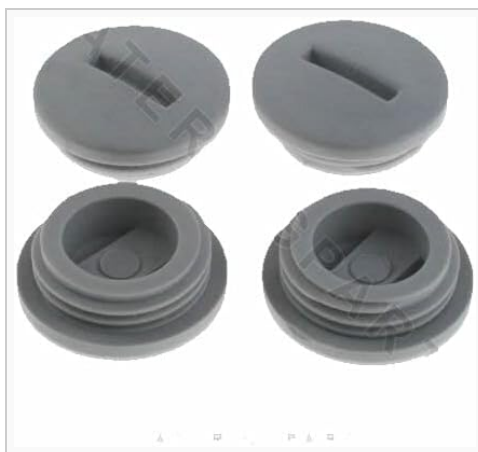
Figure 1: Four Hobart 886610 Wash Arm End Plugs. The image displays two plugs from the top view, featuring a rectangular slot, and two plugs from the bottom view, showing the threaded base.

- Direct replacement for Hobart Part Number: 886610 and OEM part number: 324785.
- Designed for wash arm application.
- Diameter: 28mm.
- Height: 10mm.
- Quantity: 4 plugs per pack.

These wash arm end plugs are passive components designed to seal the ends of the wash arms, directing water flow through the spray nozzles. Proper installation ensures optimal water pressure and coverage during the wash cycle. No specific operating procedures are required for the plugs themselves beyond ensuring they are correctly installed.
