> Dorman 528-030 Front Passenger Side Lower Suspension Control Arm and Ball Joint Assembly User Manual

Dorman 528-030 Front Passenger Side Lower Suspension Control Arm and Ball Joint Assembly

Brand: Dorman | **Model:** 528-030

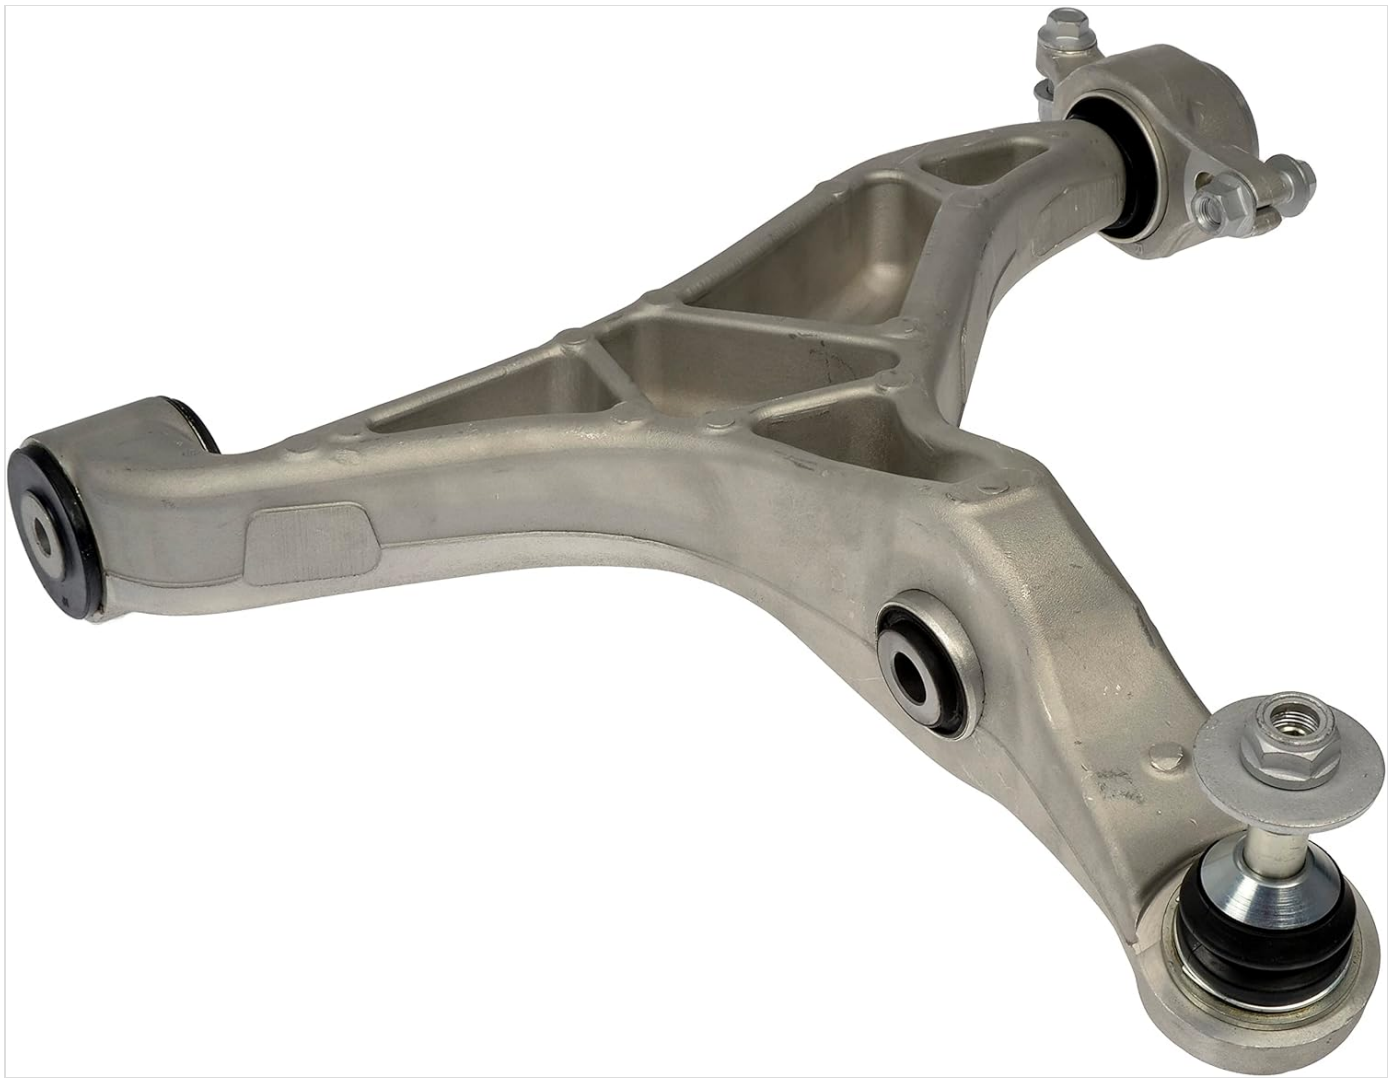
Image: Front view of the Dorman 528-030 control arm assembly, showcasing the main structure and pre-installed ball joint.

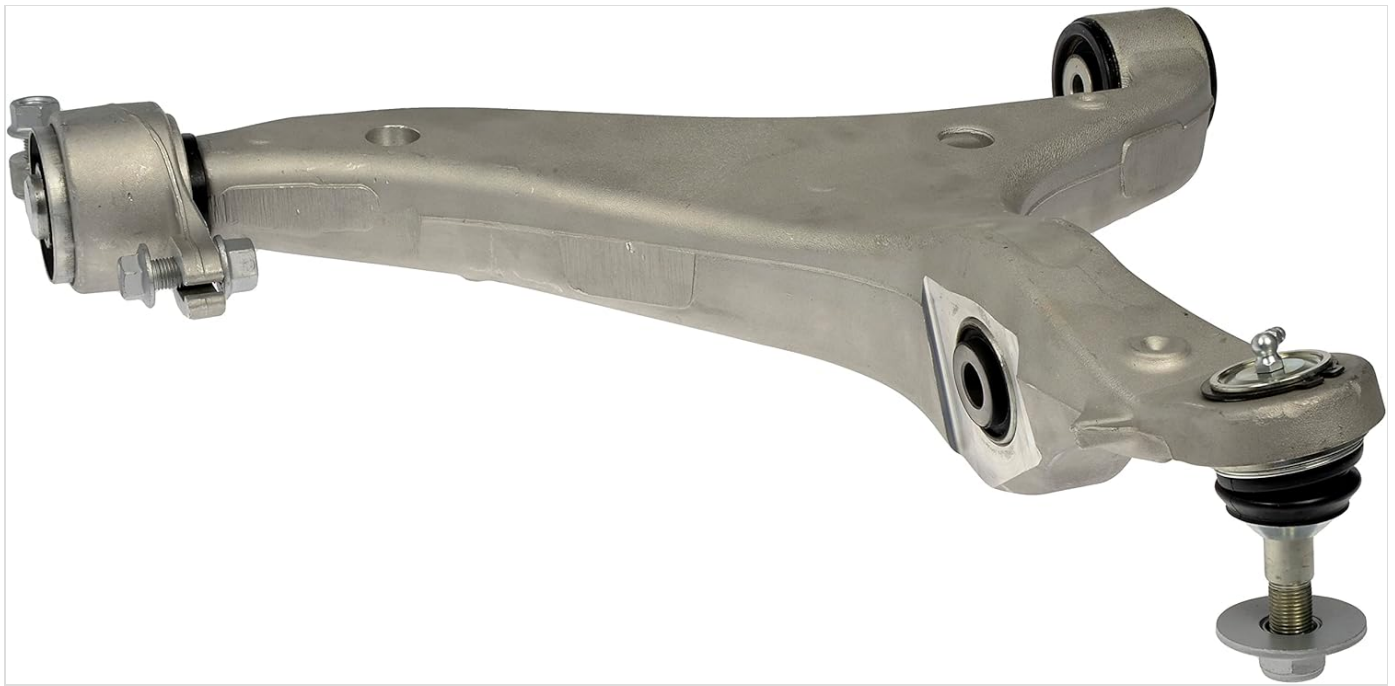
Image: Bottom view of the Dorman 528-030 control arm assembly, providing an alternative perspective of its construction and components.

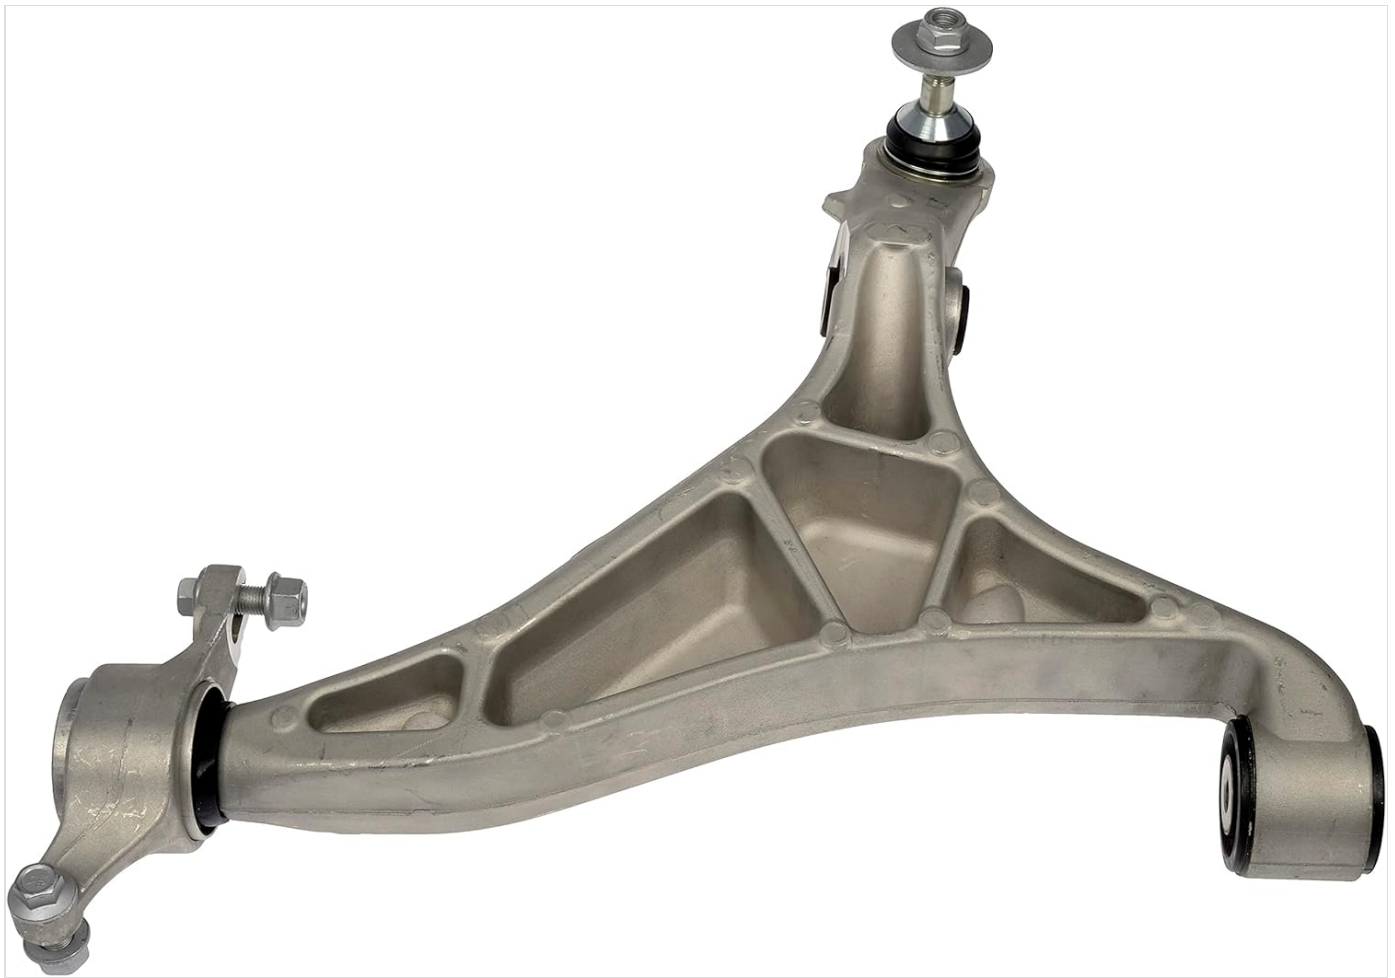
Image: Side view of the Dorman 528-030 control arm, illustrating the various mounting points for secure installation within the vehicle's suspension system.

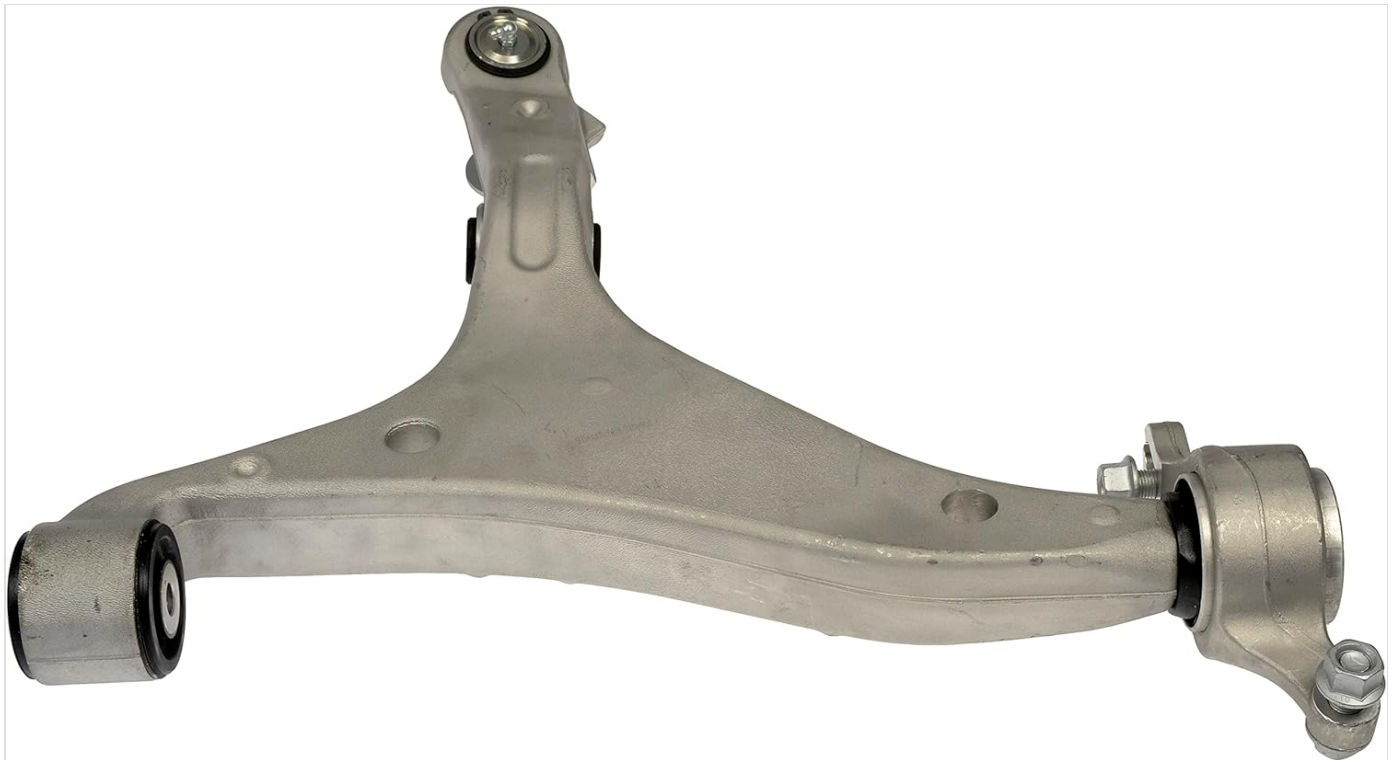
Image: Top view of the Dorman 528-030 control arm, emphasizing its robust construction and design for vehicle suspension.

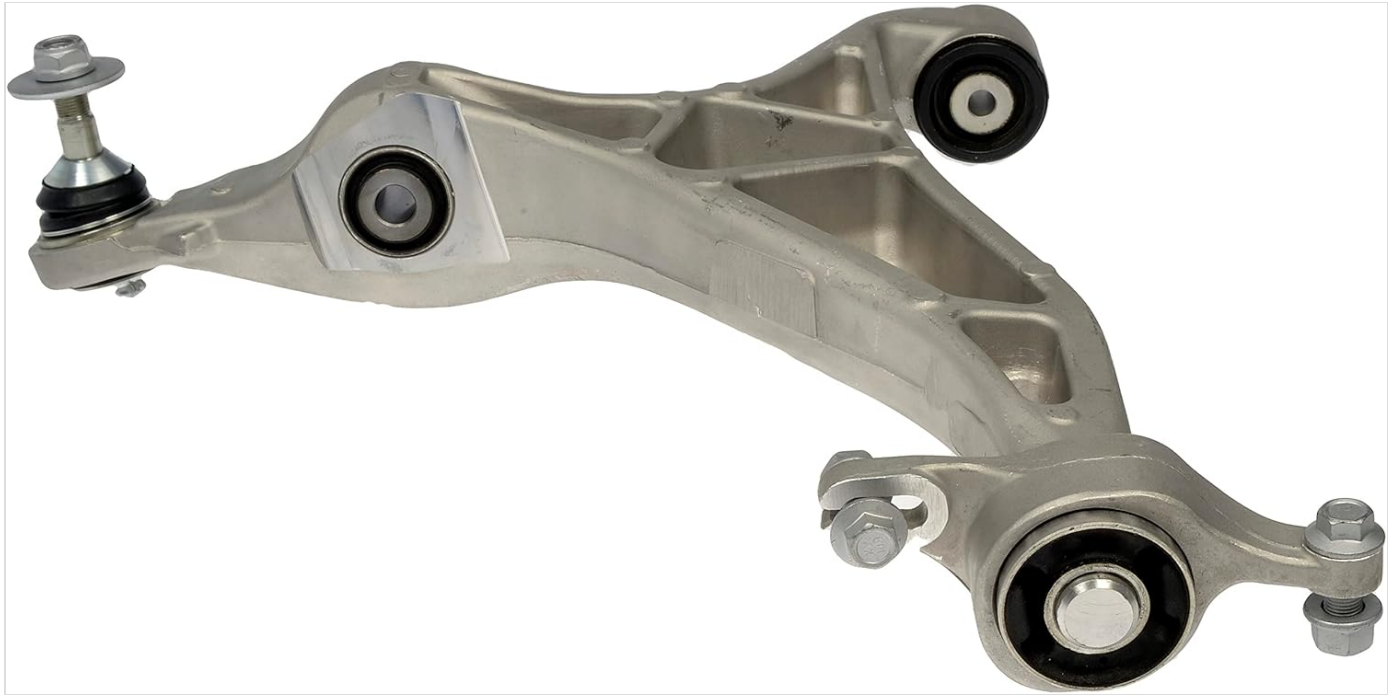
Image: An additional view of the Dorman 528-030 control arm, providing a closer look at the integrated ball joint and its connection points.
