Owigit Stainless Steel Washer Bellow Instruction Manual

Model Compatibility: MFW9700SQ1, MFW9800TQ0, MFW9600SQ1, MHWE300VF00, MHWE500VW11, WFW9451XW00, MHWE400WW01

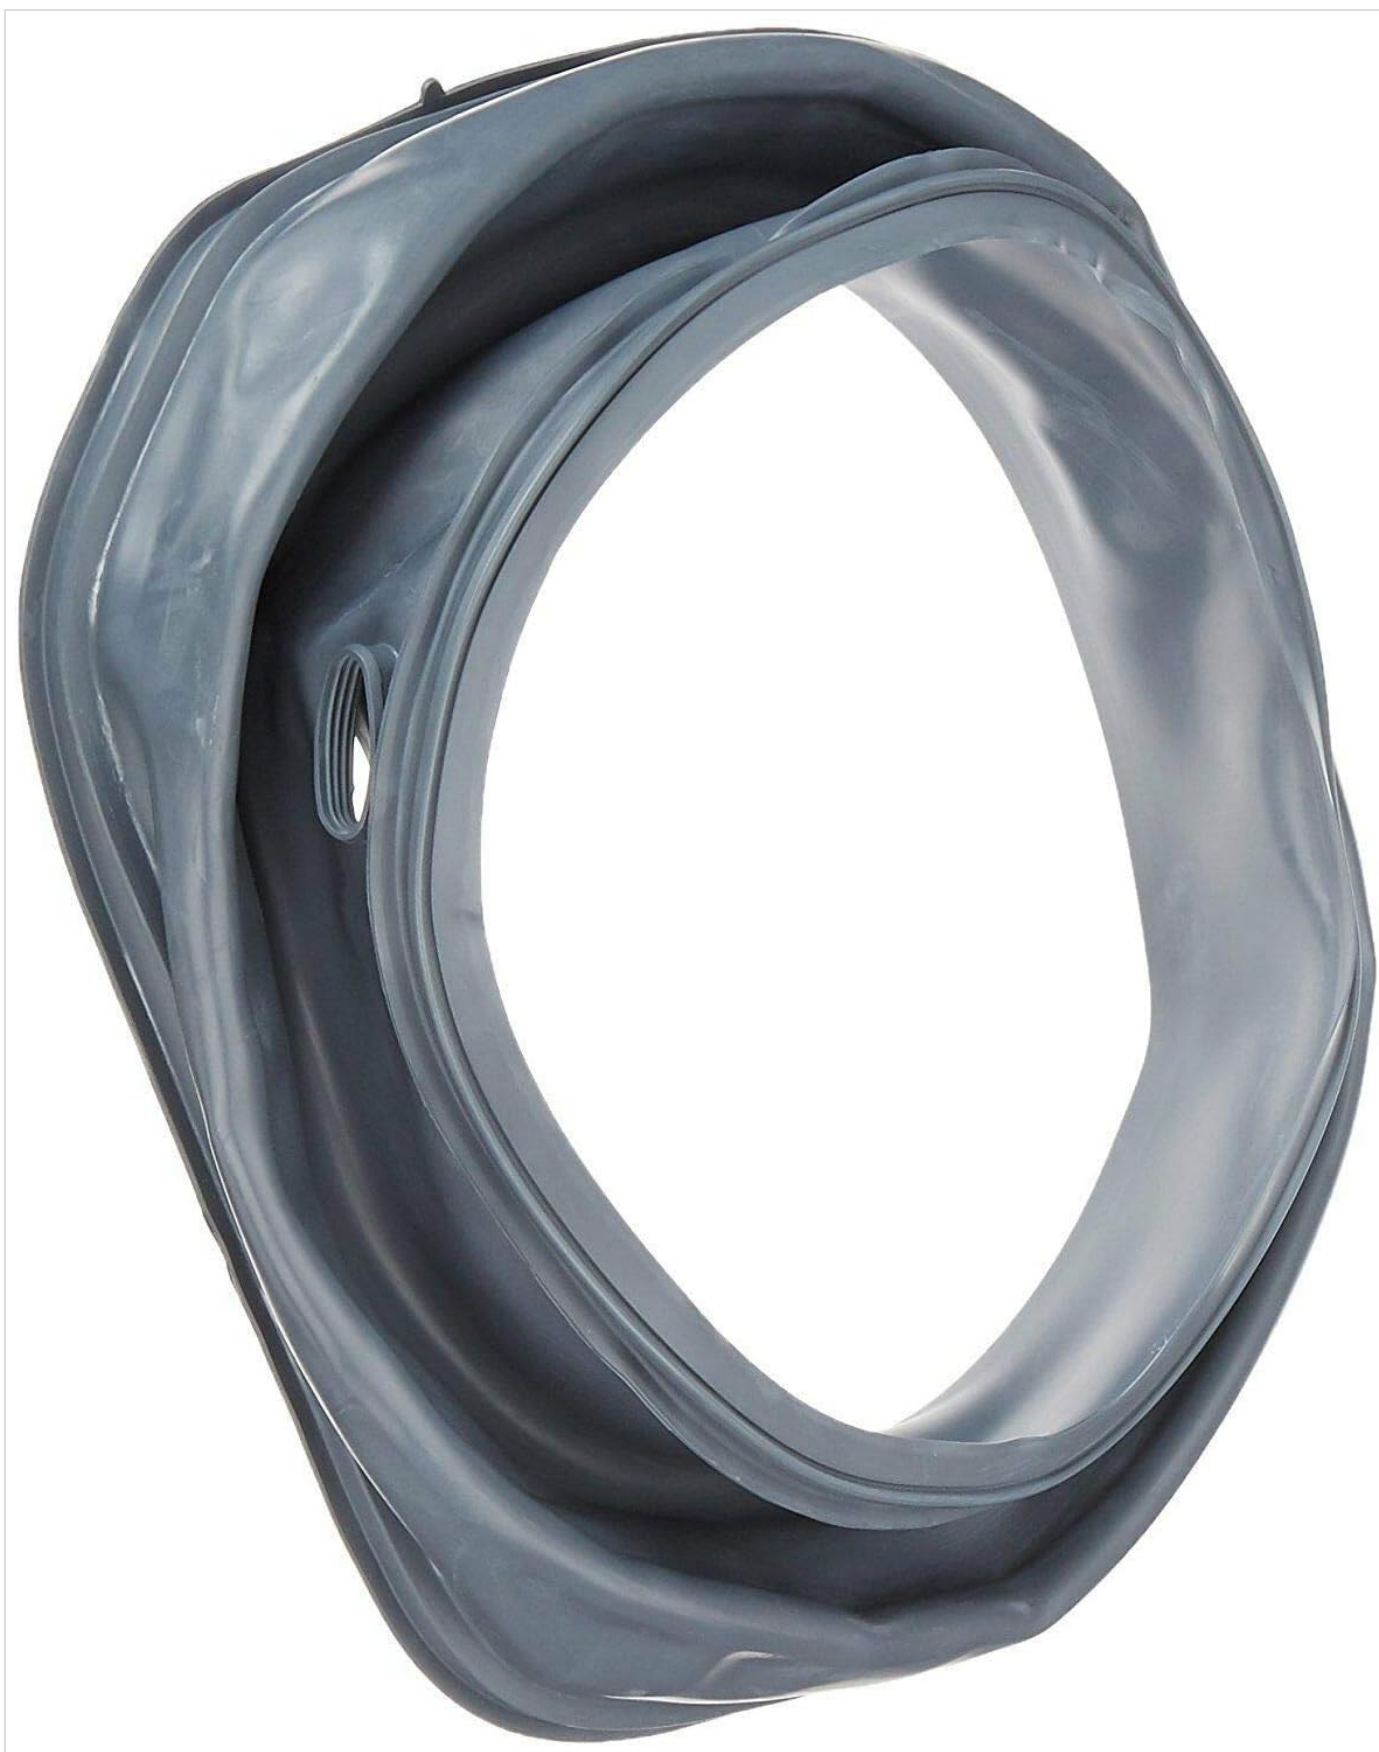
Image: The Owigift Stainless Steel Washer Bellow, shown in its grey, flexible material. This component forms a crucial seal around the washing machine door opening.

The washer bellow, also known as the door boot seal, is a critical component that creates a watertight seal between the washing machine's outer tub and the door opening. Its primary function is to prevent water from leaking out of the machine during wash cycles. It also helps to dampen vibrations and can sometimes include channels for water circulation or drainage.
