Rointe ASBPN01

Rointe ASBPN01 Perimeter Tape 150mm x 25m for Ceramic Floors User Manual

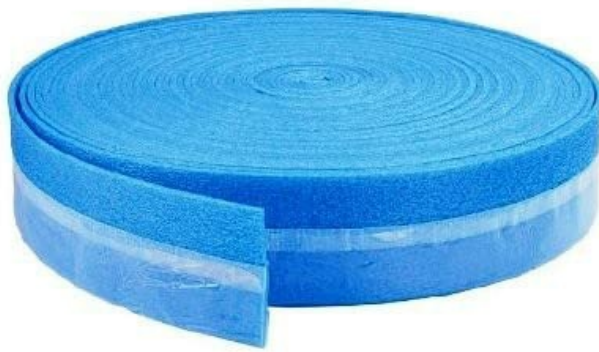
Image of the Rointe ASBPN01 Perimeter Tape, showing a roll of the 150mm wide tape ready for installation.

The Rointe ASBPN01 Perimeter Tape is a specialized construction material designed for use with ceramic floor installations. This tape is installed around the entire perimeter of the vertical skirting board or wall base. Its primary function is to absorb the natural expansion and contraction of the flooring material, which helps prevent cracks, lifting, and other damage caused by thermal changes and structural movement. Additionally, it plays a crucial role in eliminating thermal bridges, enhancing the overall insulation and efficiency of the floor system, especially in conjunction with underfloor heating.
