Gugaguga 101237 Moen Compatible Cup Seal & Diverter Gate Instruction Manual

For Moen 3800 Series Tub Spouts

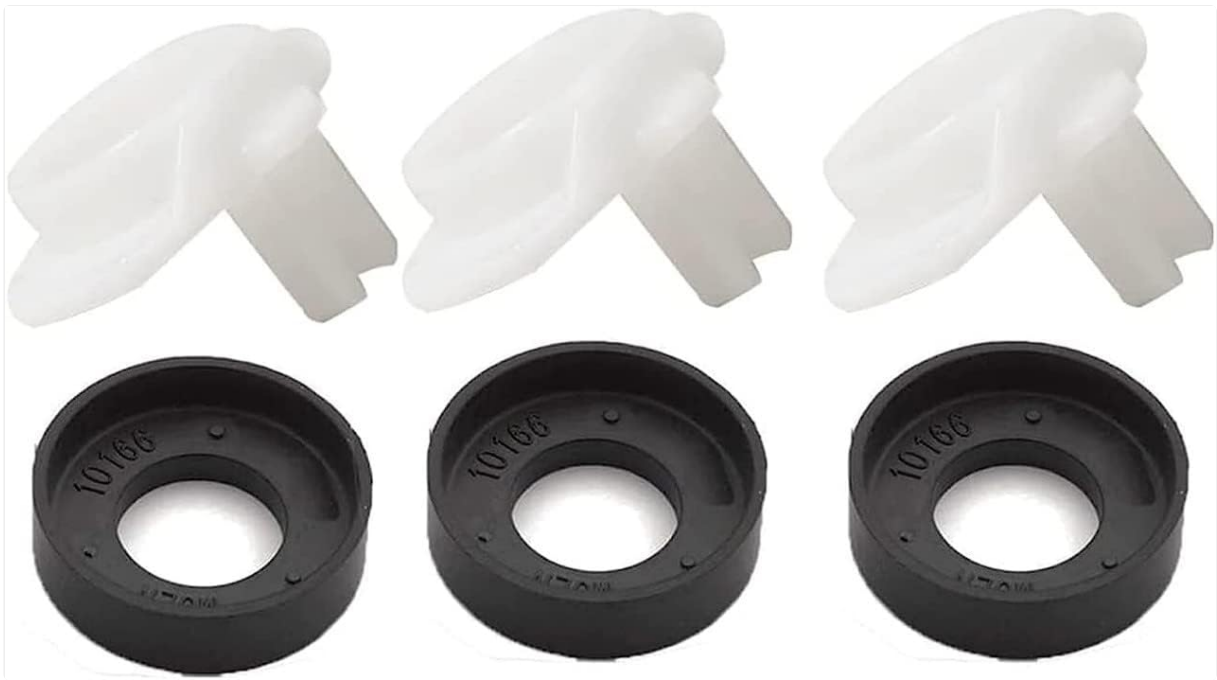
This image displays three complete sets of the replacement parts, each consisting of a white plastic diverter gate and a black rubber cup seal.

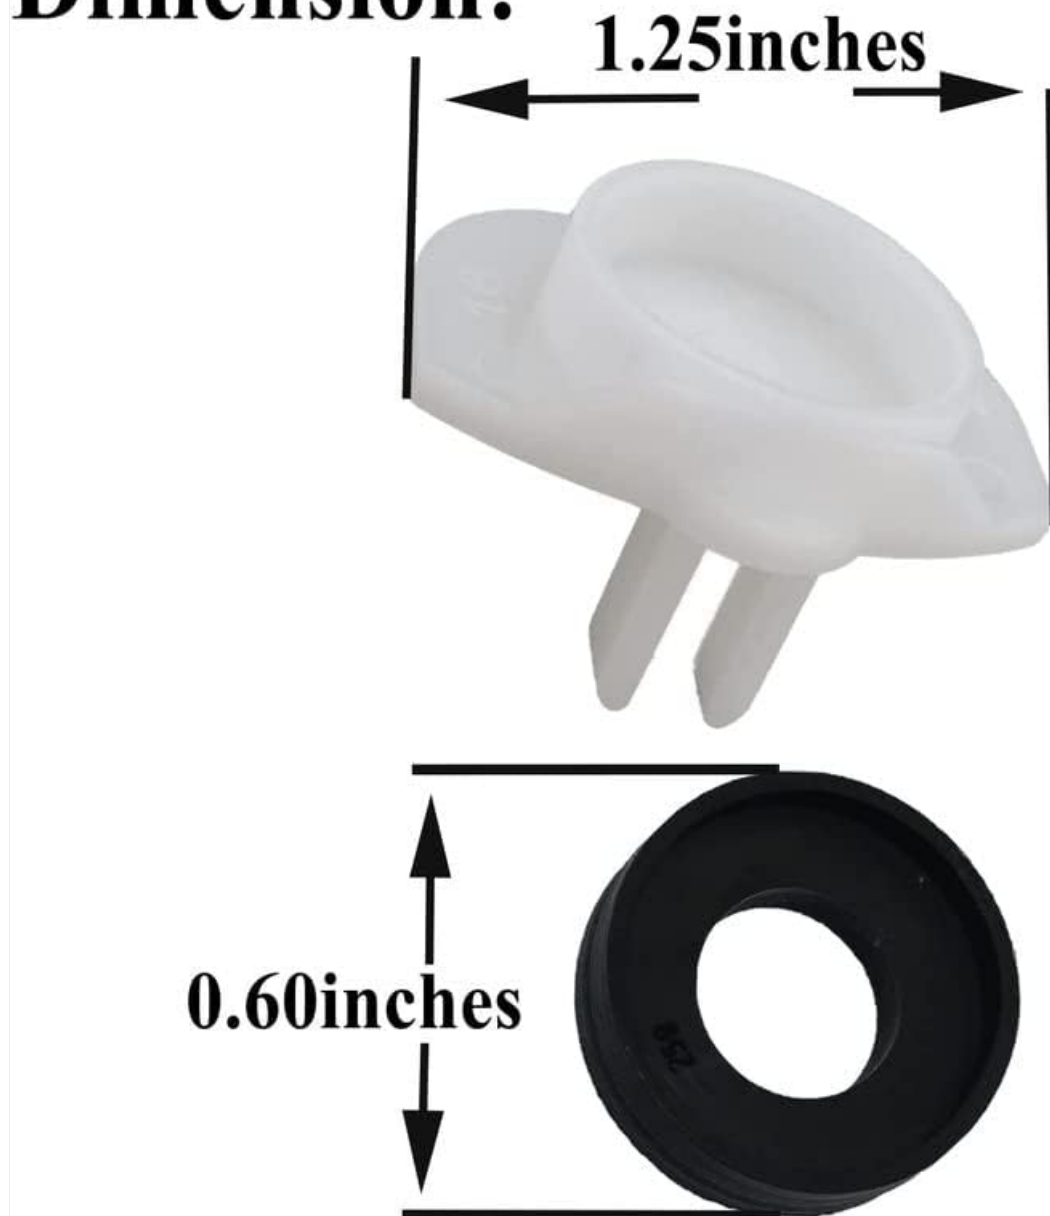
Dimension:

A diagram showing the approximate dimensions of the white plastic diverter gate (1.25 inches wide) and the black rubber cup seal (0.60 inches in diameter).

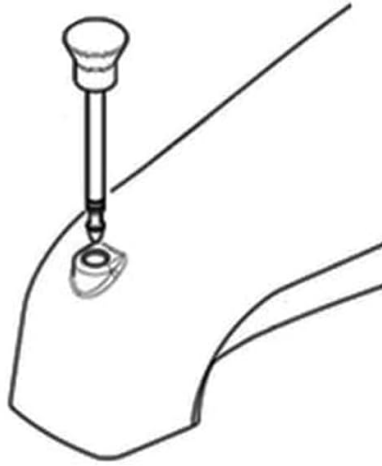
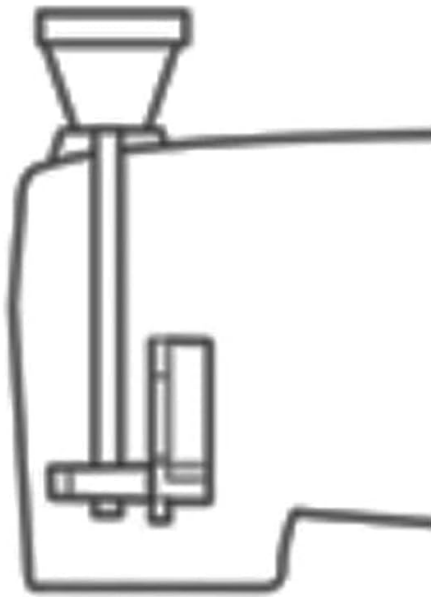
1. Insert the pole at the spout.

2. Assembly part and gaskets.

3. Put the assembly in the spout, jam the pole.

This four-panel image illustrates the installation process: 1. Inserting a tool into the spout. 2. Showing the new assembly parts. 3. Diagram of assembly inside the spout. 4. Text instructions for insertion and assembly.

1. **Prepare the Spout:** Use a screwdriver to carefully remove the old diverter part from the tub spout.
2. **Assemble New Parts:** Combine the new plastic diverter gate and the rubber cup seal. Ensure the rubber washer's opening is placed **inward** into the plastic gate for correct function.
3. **Insert into Spout:** Place the assembled new parts into the tub spout. Ensure it is seated correctly.
4. **Secure:** Re-insert the diverter rod or mechanism to secure the new parts in place.

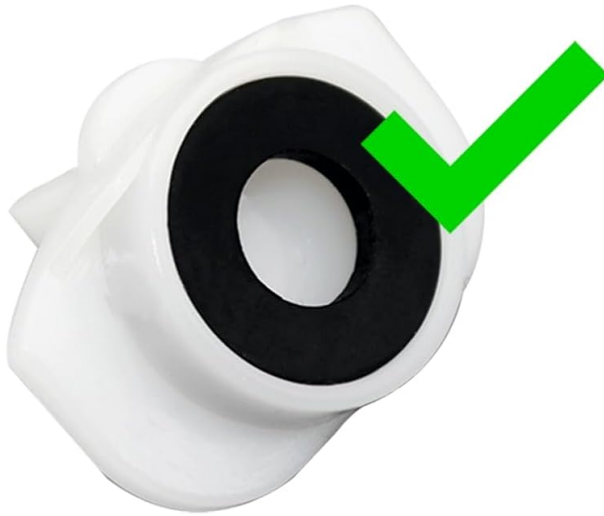
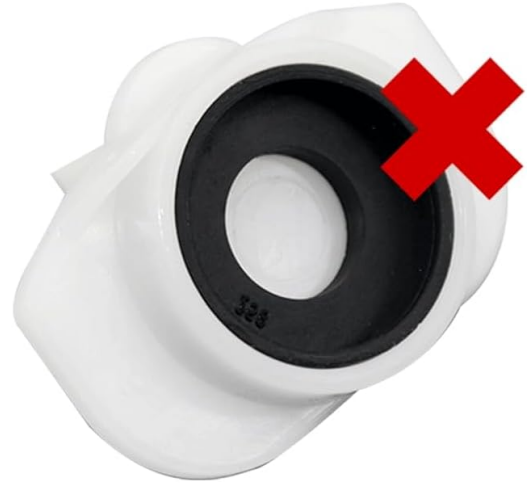
—The direction of the rubber washer

Correct Direction

- The washer opening is placed **Inward**

Wrong Direction

- The washer opening is placed **Outward**

An image demonstrating the correct (washer opening inward) and incorrect (washer opening outward) placement of the rubber washer within the diverter gate. Proper orientation is crucial for preventing leaks.

- **Washer Orientation:** Ensure the rubber washer is installed with its opening facing inward into the plastic diverter gate. Refer to the installation instructions and images.

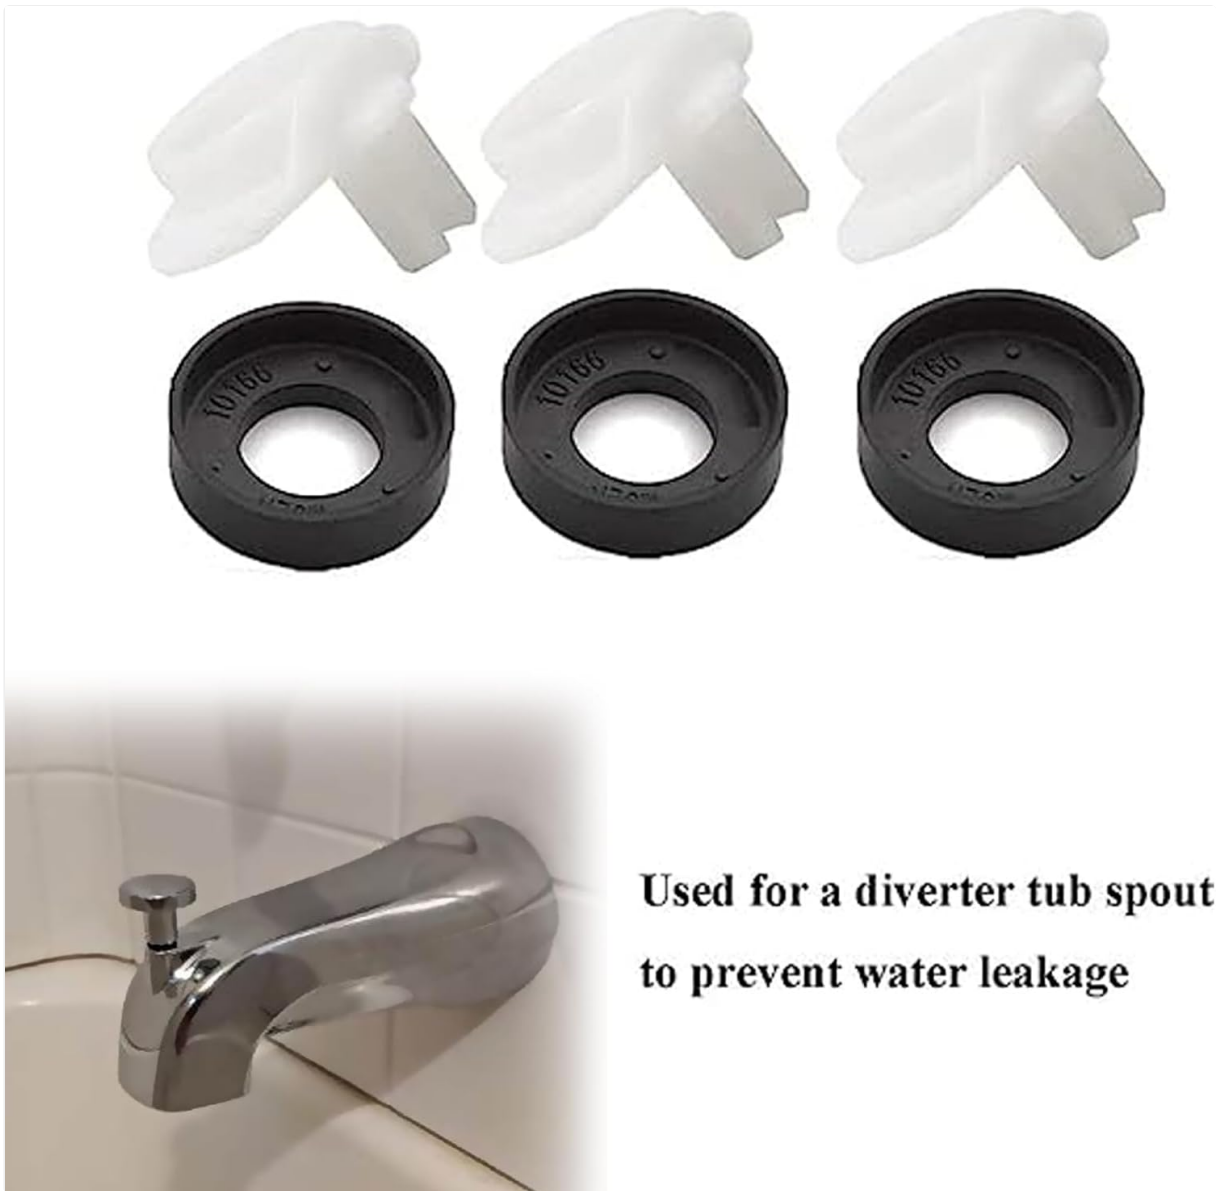
An image showing a tub spout with the diverter mechanism, illustrating how the replacement part functions to prevent water leakage and redirect flow.

Once installed, the diverter gate and cup seal work together to control water flow. When the diverter knob on your tub spout is pulled up, the gate moves to block the flow of water to the tub spout, redirecting it to the showerhead. Pushing the knob down returns the water flow to the tub spout.
