> Replacement Optical Pickup Unit for Technics SL-PG580A CD Player

EEEONE SL-PG580A

Replacement Optical Pickup Unit Instruction Manual

Model: Technics SL-PG580A Compatible Part

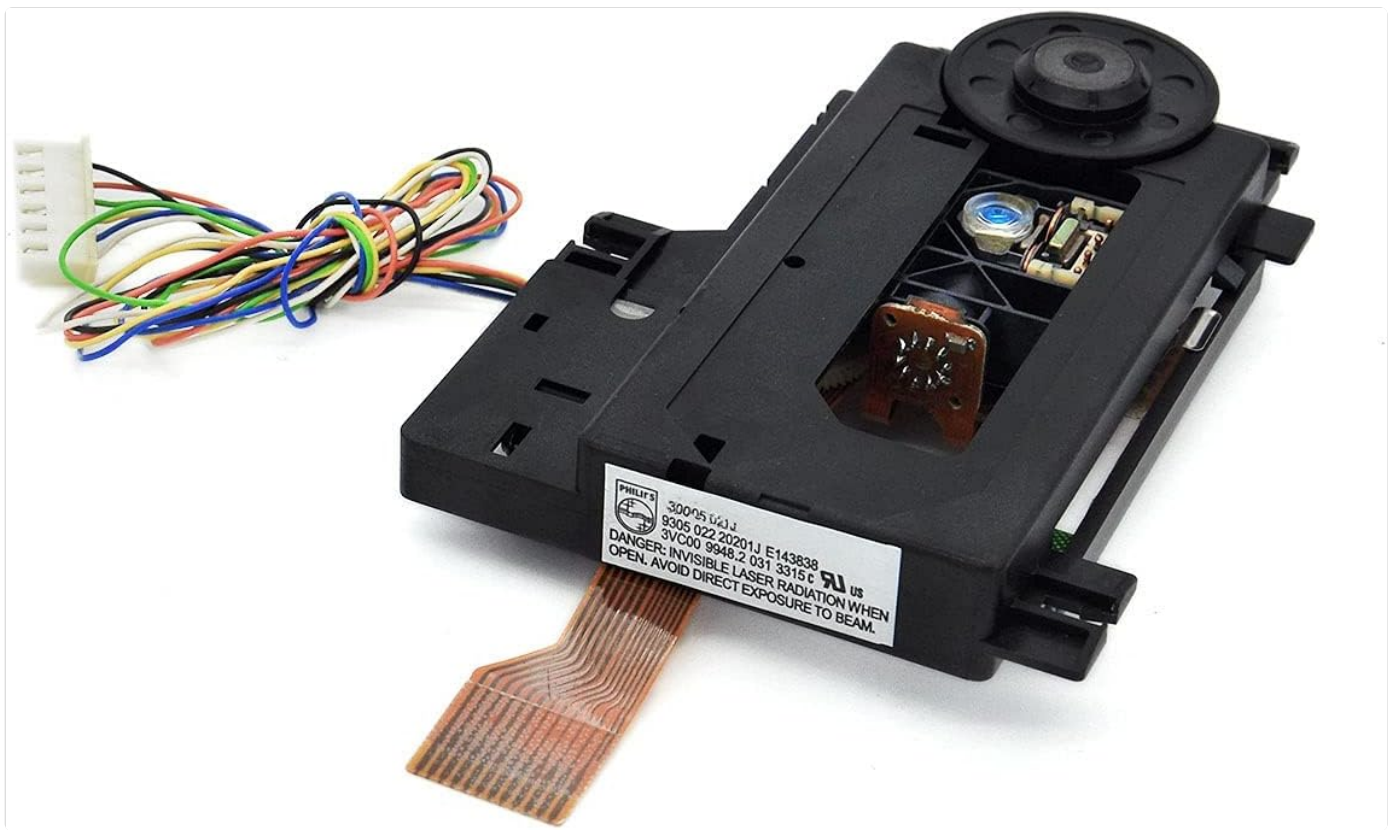
Figure 1: EEEONE Replacement Optical Pickup Unit. Note the warning label regarding invisible laser radiation.

- **Crucial Step: Remove the Anti-Static Solder Point.** New optical pickup units often come with a solder shorting point (usually a small blob of solder connecting two pads) to protect the laser diode from static discharge during shipping. This point **MUST** be carefully desoldered and removed before installation. Failure to do so will prevent the unit from functioning. Refer to the specific unit for the exact location, often near the

ribbon cable connector.
