Generic Fuel Tank Gas Cap Assembly 77300-06040 User Manual

Model: 6991705063763

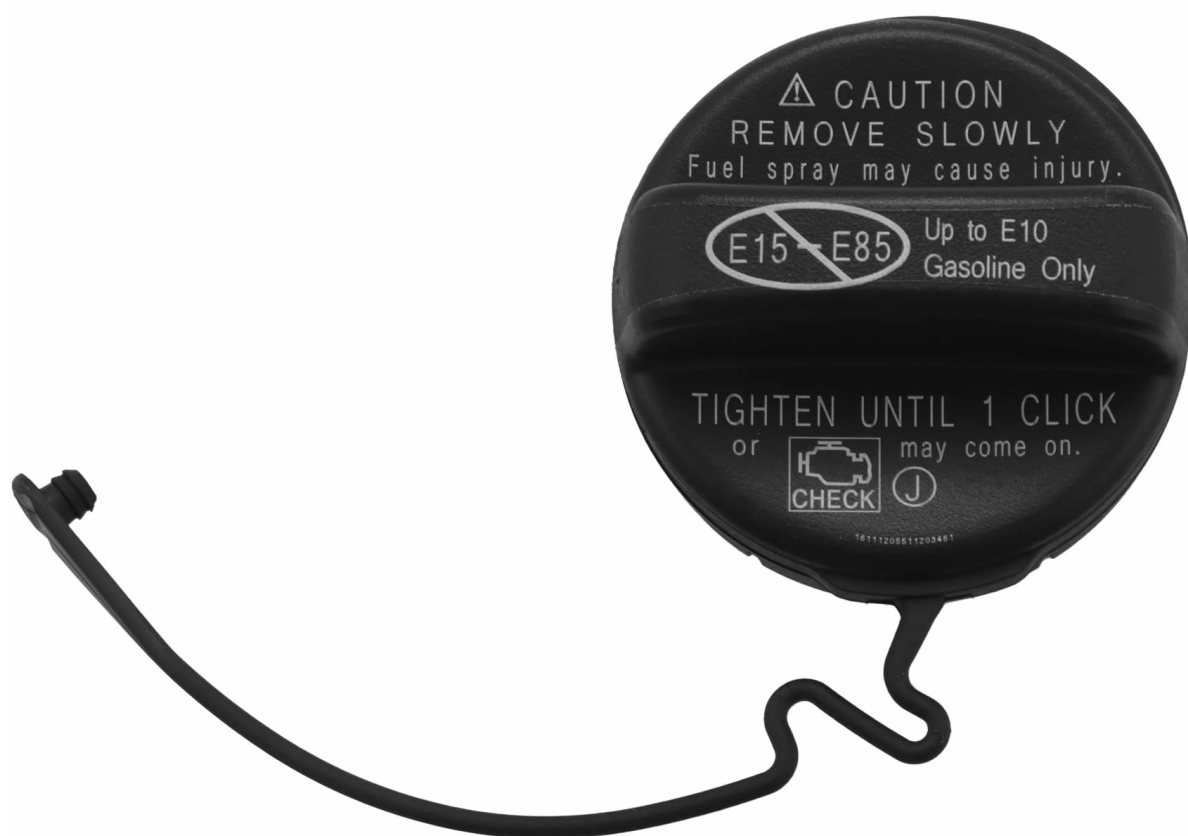
Figure 1: Top view of the fuel cap, showing the caution and tightening instructions.

- **Opening:** Turn the fuel cap counter-clockwise to loosen and remove it for refueling.
- **Closing:** After refueling, place the cap back onto the fuel filler neck. Turn it clockwise until you hear at least one click. This click indicates that the cap is properly sealed and will prevent fuel vapors from escaping and debris from entering the tank.

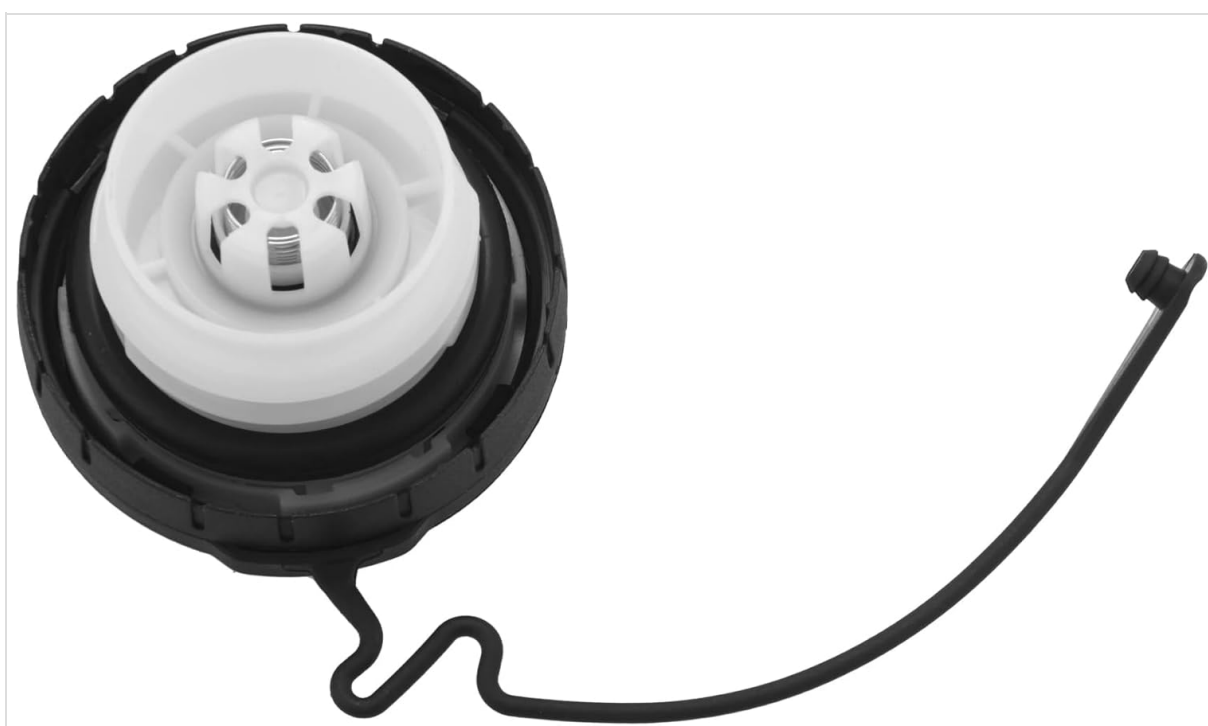
Figure 2: Underside view of the fuel cap, highlighting the sealing components.

The fuel tank gas cap assembly requires minimal maintenance. Periodically inspect the cap for any signs of wear, cracks, or damage to the sealing gasket. A damaged gasket can compromise the seal and lead to issues.

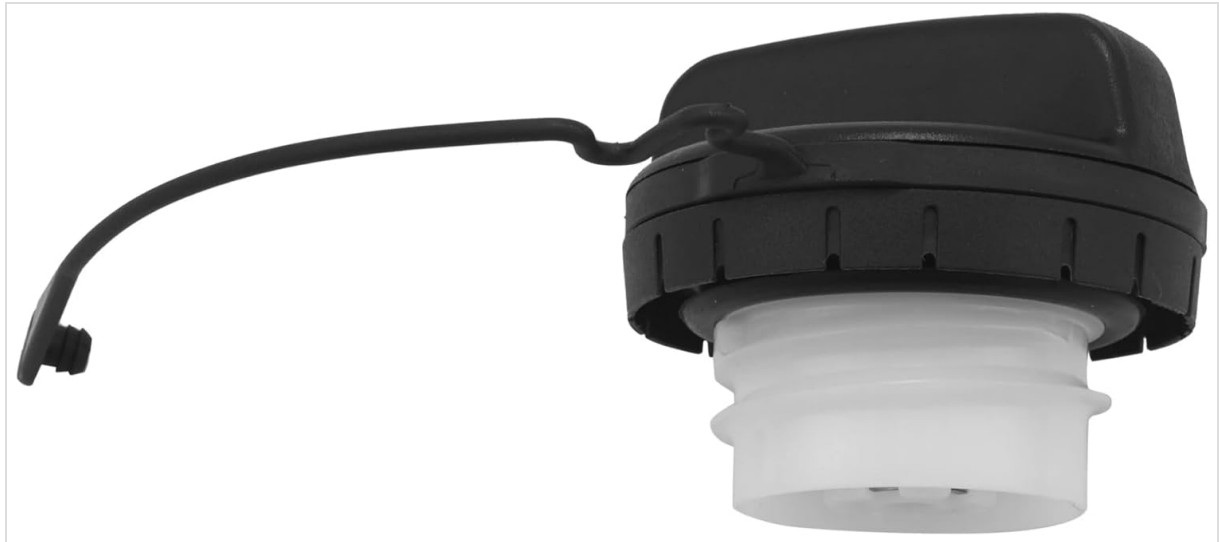
Figure 3: Side profile of the fuel cap.
