# Irnyso Replacement Lip Seal Oil Burner Pump Instruction Manual

Model: 3754734 (SP-367) | Brand: Irnyso

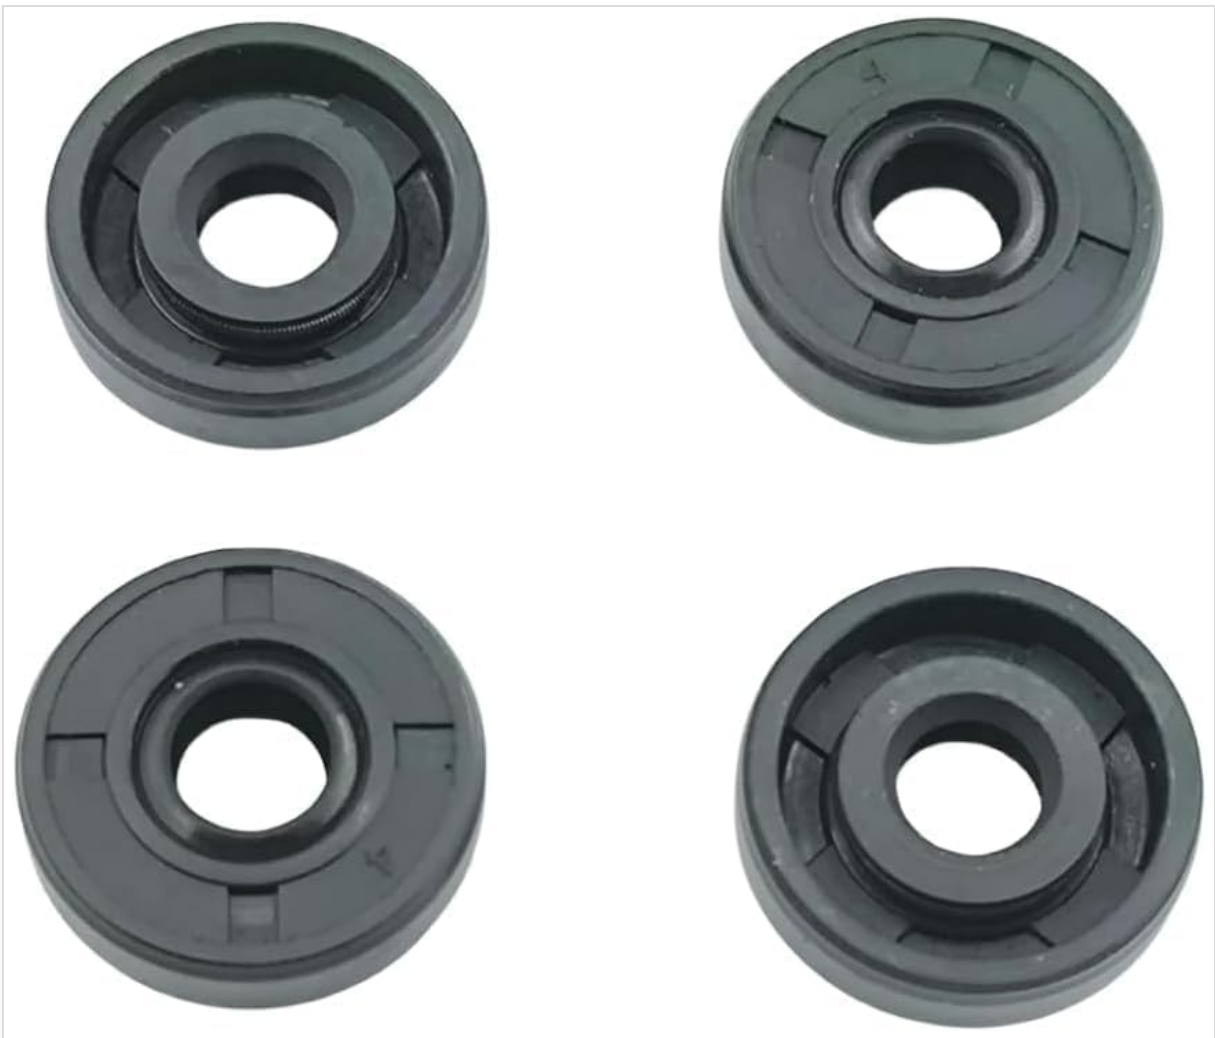
**Image 2.1:** A set of four Irnyso Replacement Lip Seals, showing their circular shape and central shaft hole. These seals are essential for preventing oil leaks in burner pumps.

- **Dimensions:** 7/8" Diameter x 1/4" Tall x 5/16" Shaft Hole
- **Material:** Durable, oil-resistant material for long-lasting performance.
- **Quantity:** Typically supplied in a 4-pack for convenience.

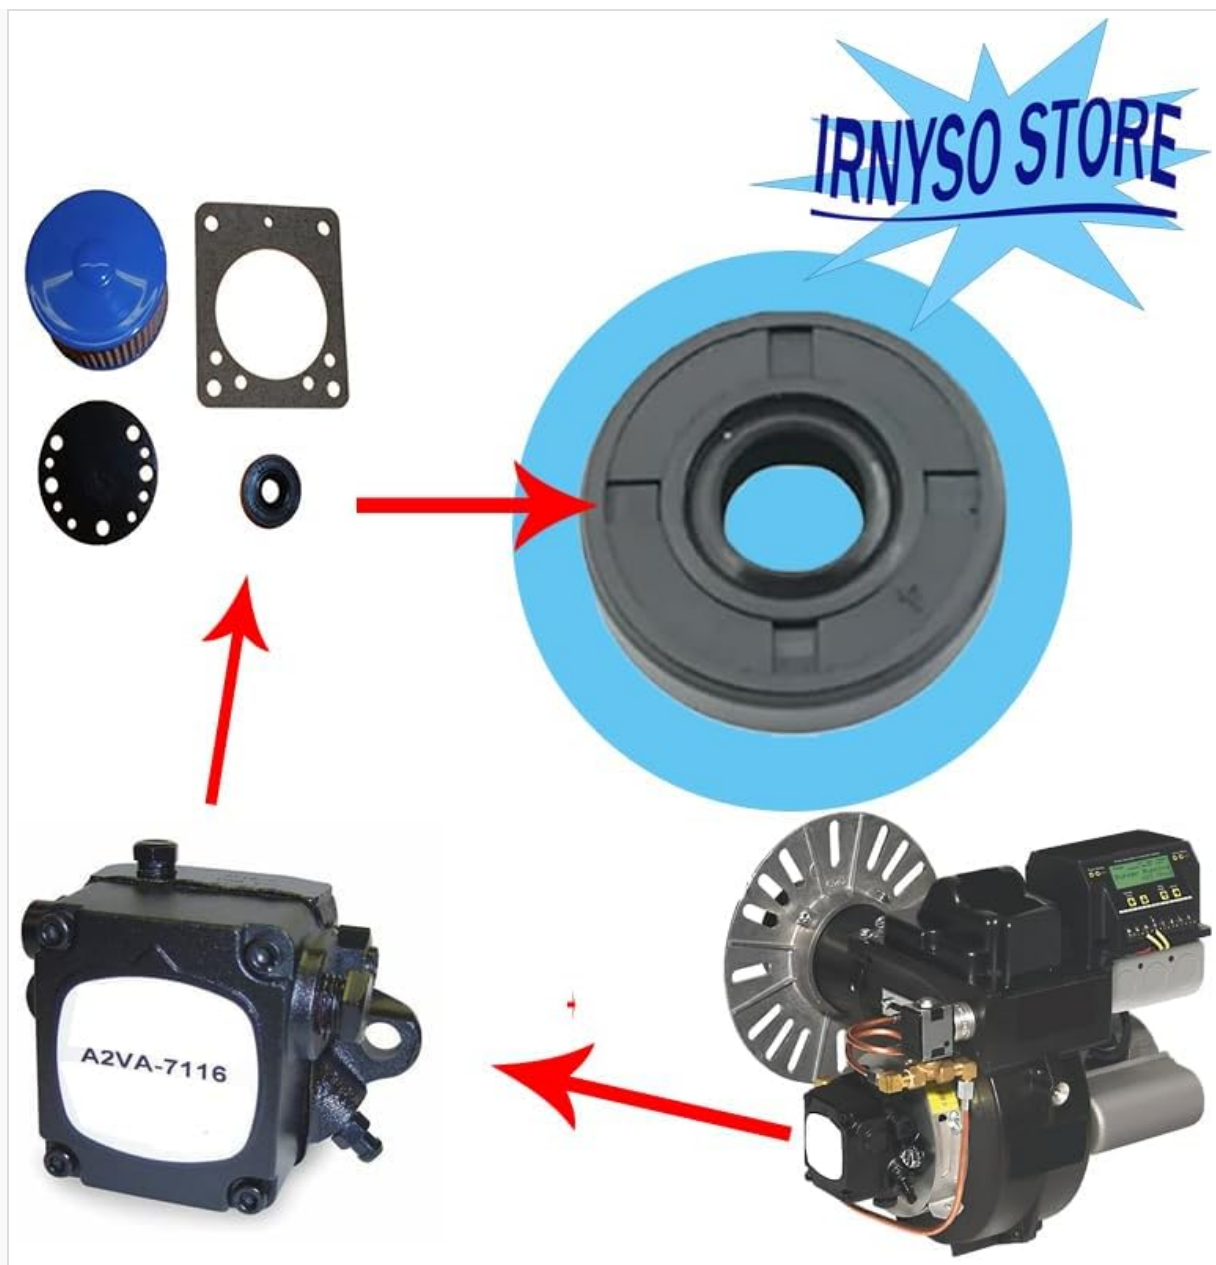
**Image 3.1:** A diagram illustrating the placement of the lip seal within an oil burner pump, which is connected to an oil burner unit. This visual aids in understanding the seal's function and location.

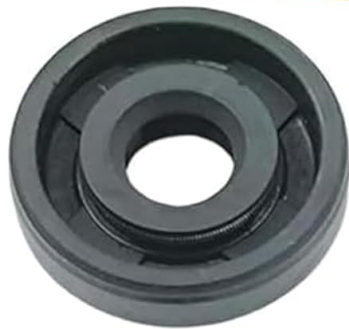
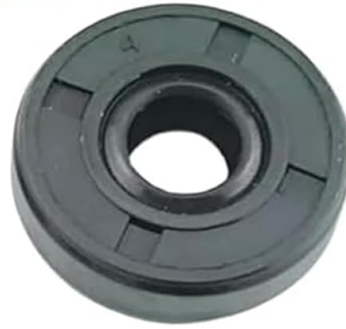
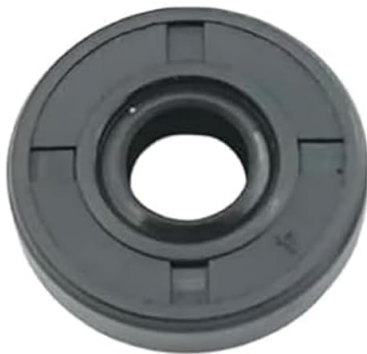
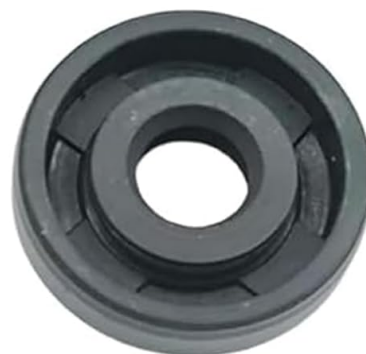
## Lip Seal Oil Burner Pump

High quality materials

**Image 4.1:** Another view of the four Irnyso Replacement Lip Seals, highlighting their quality, ease of installation, and versatile compatibility with burner pumps.
