Goodsby GFL-A906-MOTOR UNIT

Goodsby Replacement Motor Unit for LG CordZero A9 Series Vacuum Cleaner

Models: A900, A902, A905, A906, A907, A908

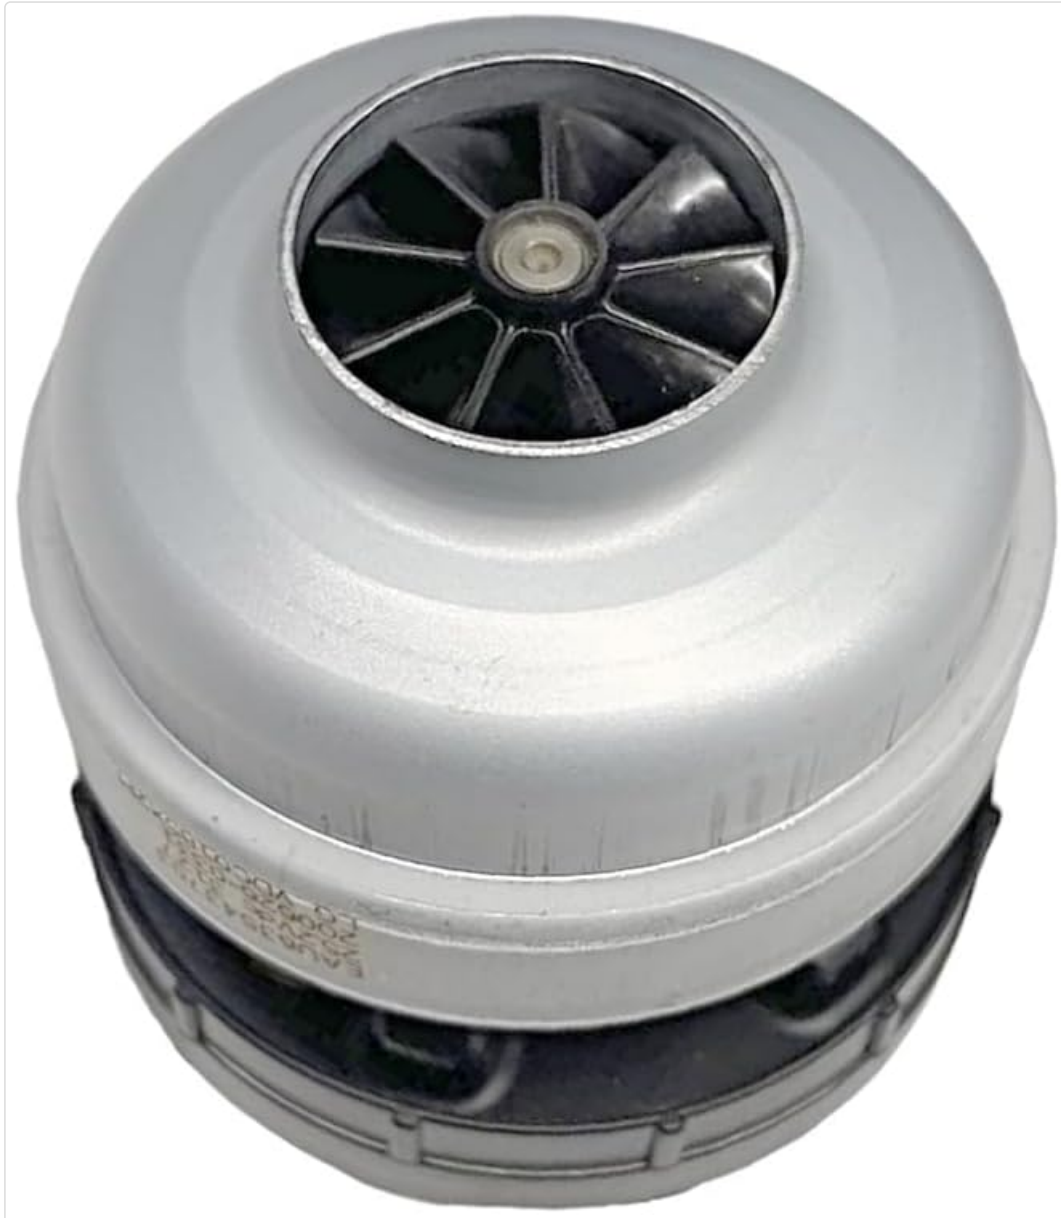
Image 1: Top view of the Goodsby Replacement Motor Unit, showing the fan intake and silver casing. This view is typical when the unit is installed within the vacuum's main body.

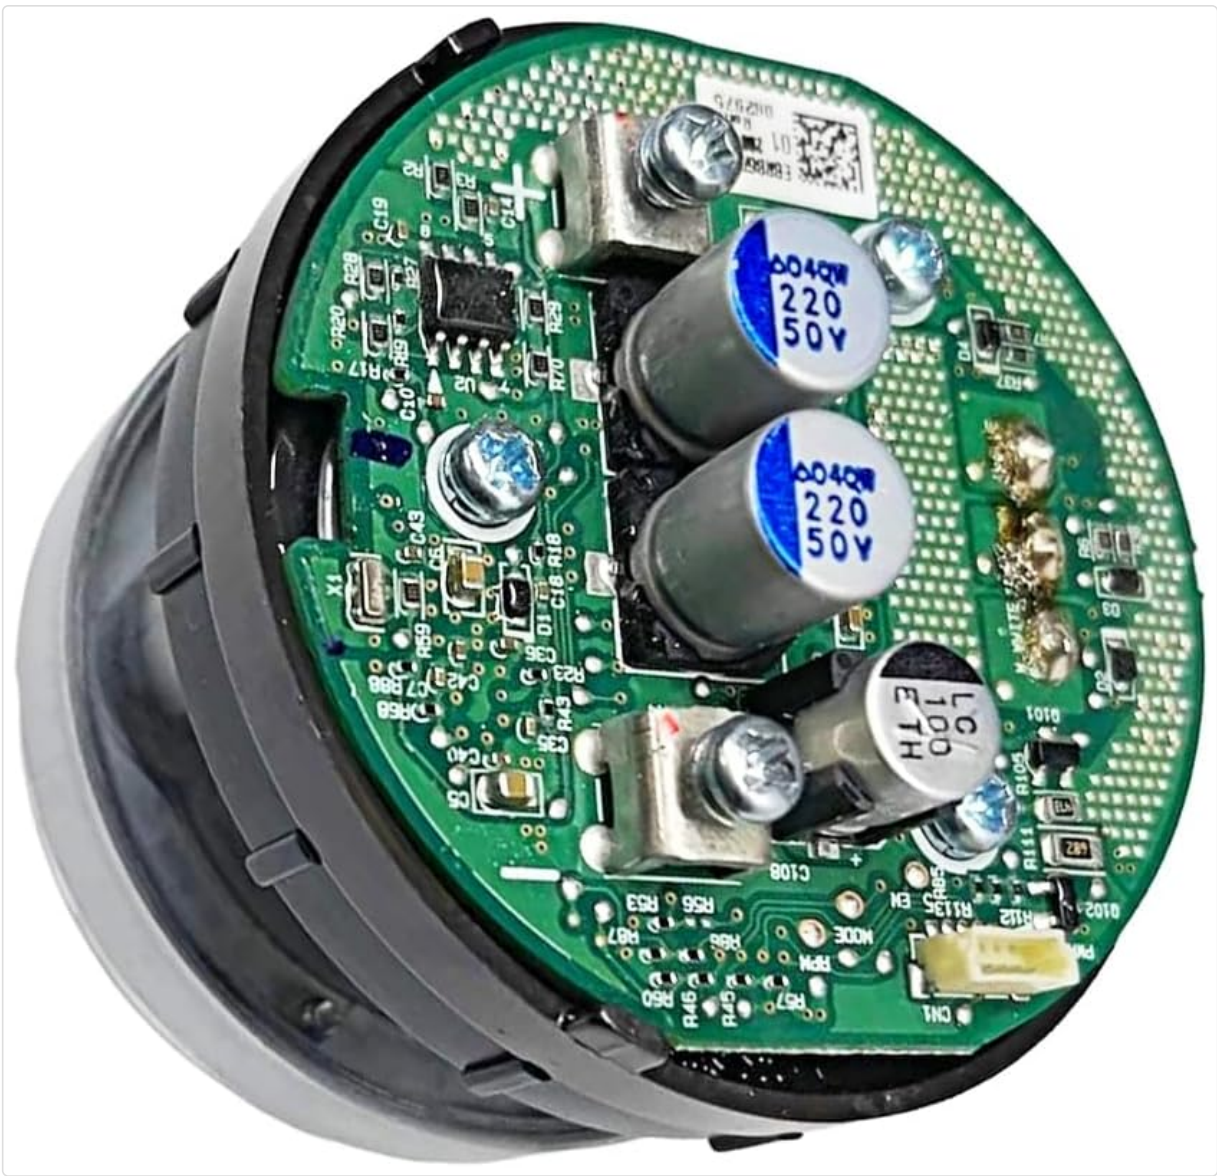
Image 2: Bottom view of the Goodsby Replacement Motor Unit, revealing the green circuit board with various electronic components, capacitors, and connection points. This side connects to the vacuum's internal wiring.
