## Selgo 1606415

# Selgo Replacement Dirty Tank Bottom Ring Cap User Manual

For Bissell ProHeat 2X Revolution Carpet Cleaners

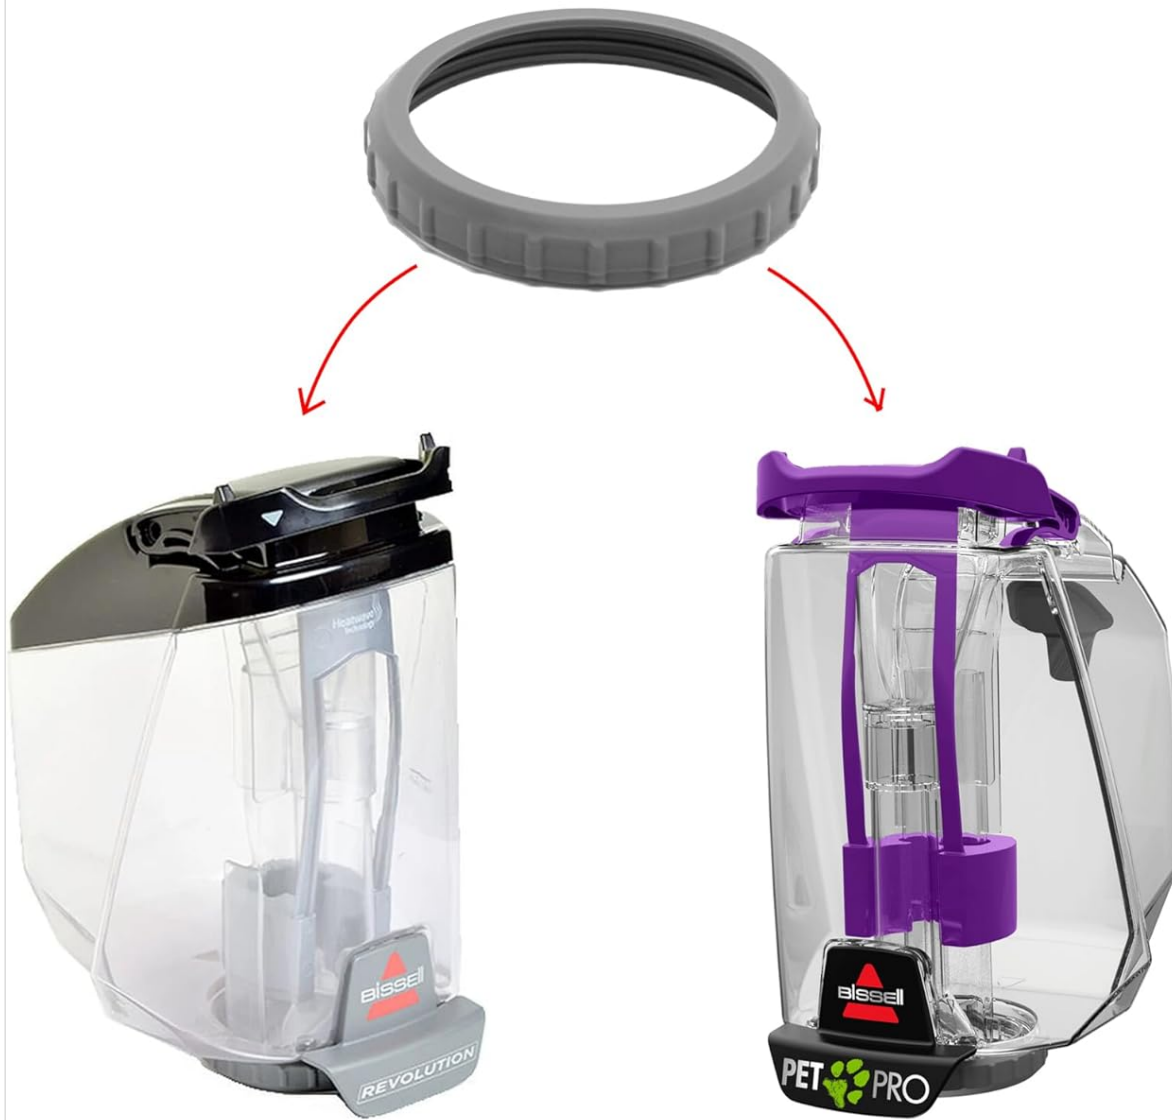
Model # 1617702

Model # 1633782

Figure 1: Compatible Dirty Tanks (Model #1617702 and Model #1633782)

- 1633782
- 1617702

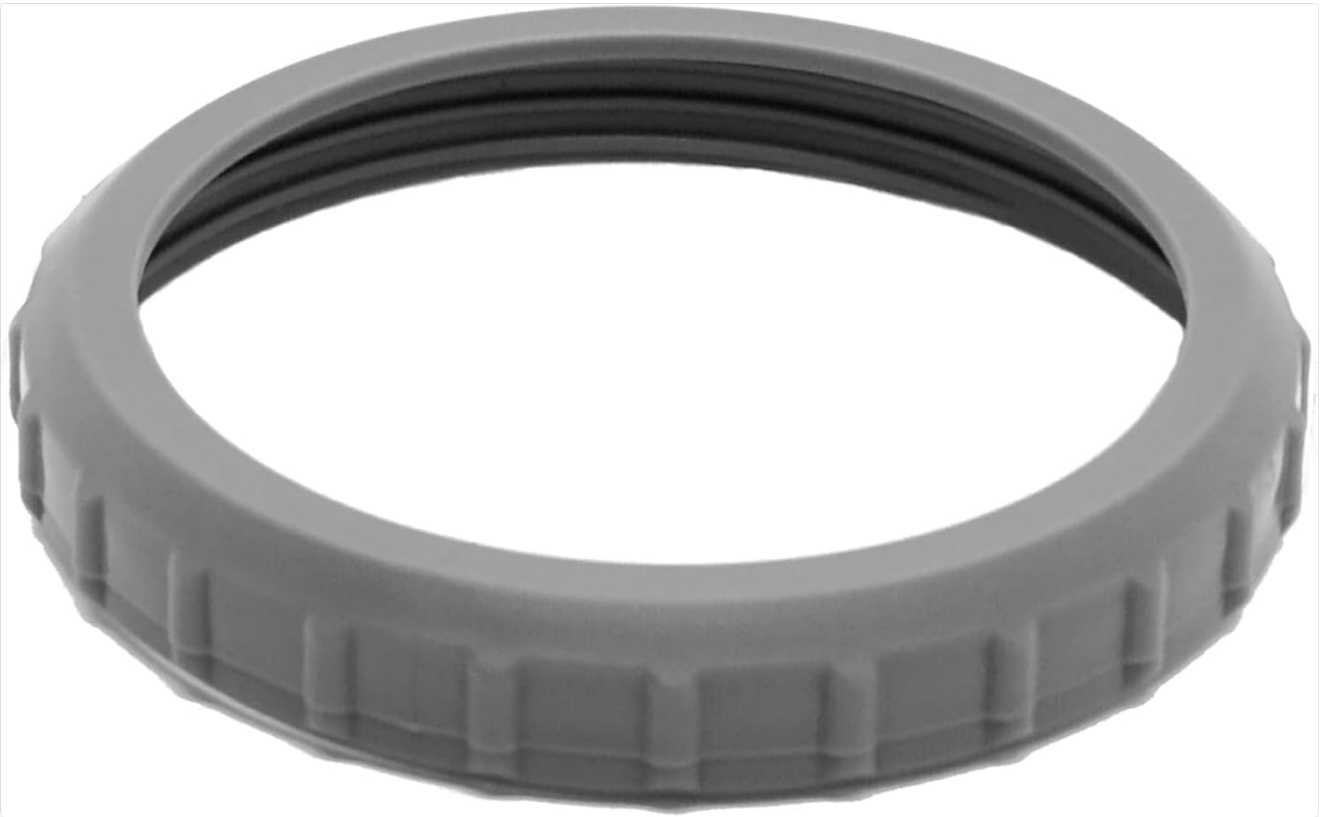
Figure 3: Selgo Replacement Dirty Tank Bottom Ring Cap

1. **Prepare the Tank:** Ensure the dirty tank is empty and clean. Remove it from the carpet cleaner.
2. **Remove Old Cap:** If an old cap is present, twist it counter-clockwise to loosen and remove it from the bottom of the dirty tank.
3. **Inspect New Cap:** Examine your new Selgo Replacement Dirty Tank Bottom Ring Cap for any damage.
4. **Attach New Cap:** Align the new ring cap with the threads on the bottom of the dirty tank.
5. **Secure the Cap:** Twist the cap clockwise until it is securely tightened. Ensure it forms a firm seal to prevent leaks. Do not overtighten.
6. **Reinstall Tank:** Place the dirty tank back into your Bissell ProHeat 2X Revolution Carpet Cleaner.

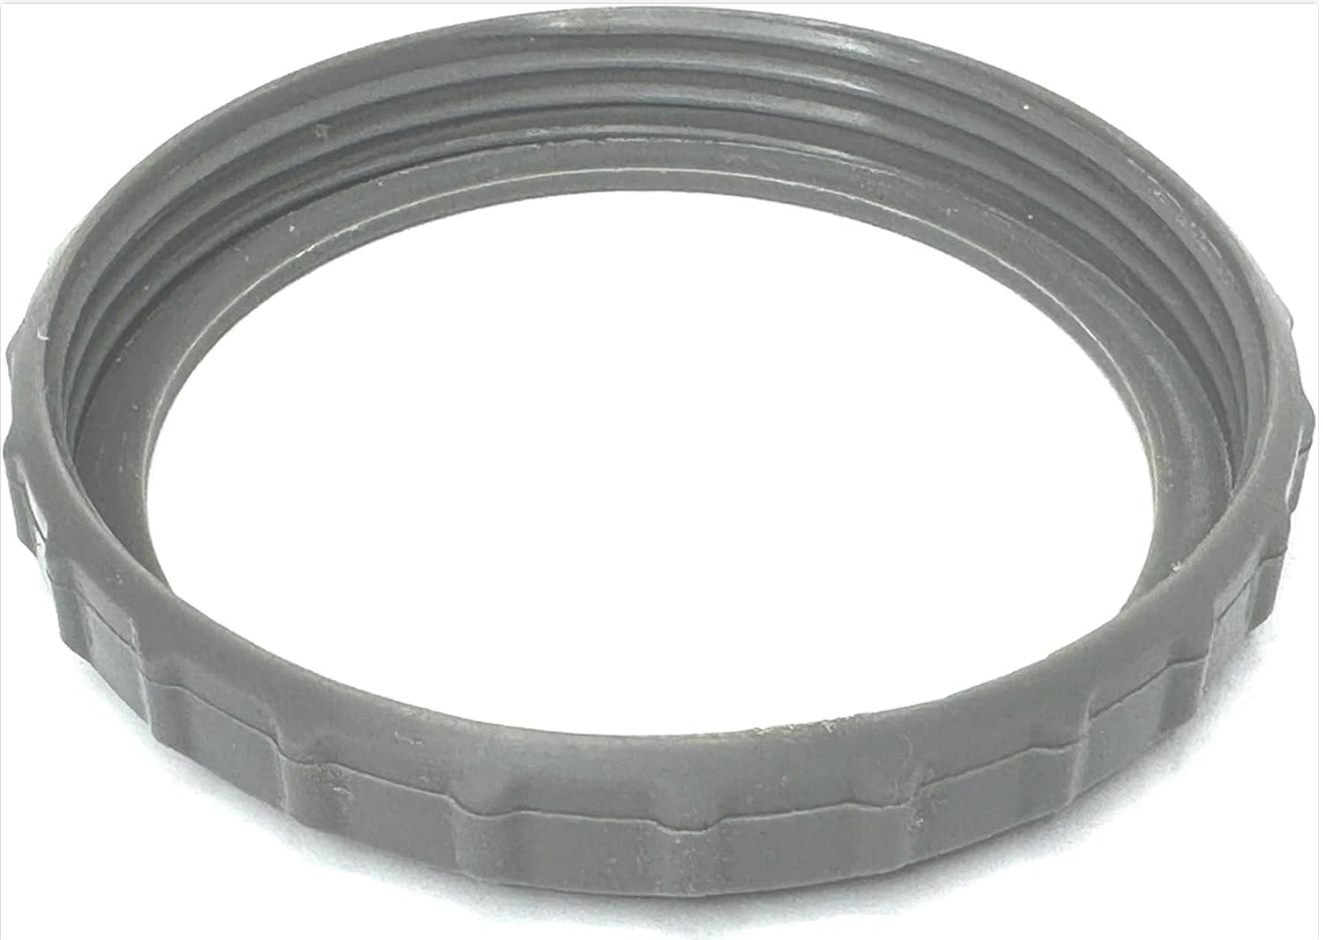
Figure 4: Underside of the Replacement Cap, showing threads for secure attachment

- **Cap Not Tightened:** Ensure the cap is securely twisted clockwise onto the dirty tank.
- **Debris in Seal:** Remove the cap and inspect the sealing surface of both the cap and the tank for any trapped debris (e.g., hair, lint, dried solution) that might be preventing a proper seal. Clean thoroughly.
- **Damaged Cap:** Inspect the cap for any visible cracks, deformities, or damage to the rubber gasket (if applicable) or threads. If damaged, the cap may need to be replaced.
- **Tank Damage:** Check the dirty tank itself for cracks or damage around the opening where the cap attaches.
