RP843003 Trailer Axle Oil Bath Hub User Manual

Model: 65f-F546A282 | Brand: Generic

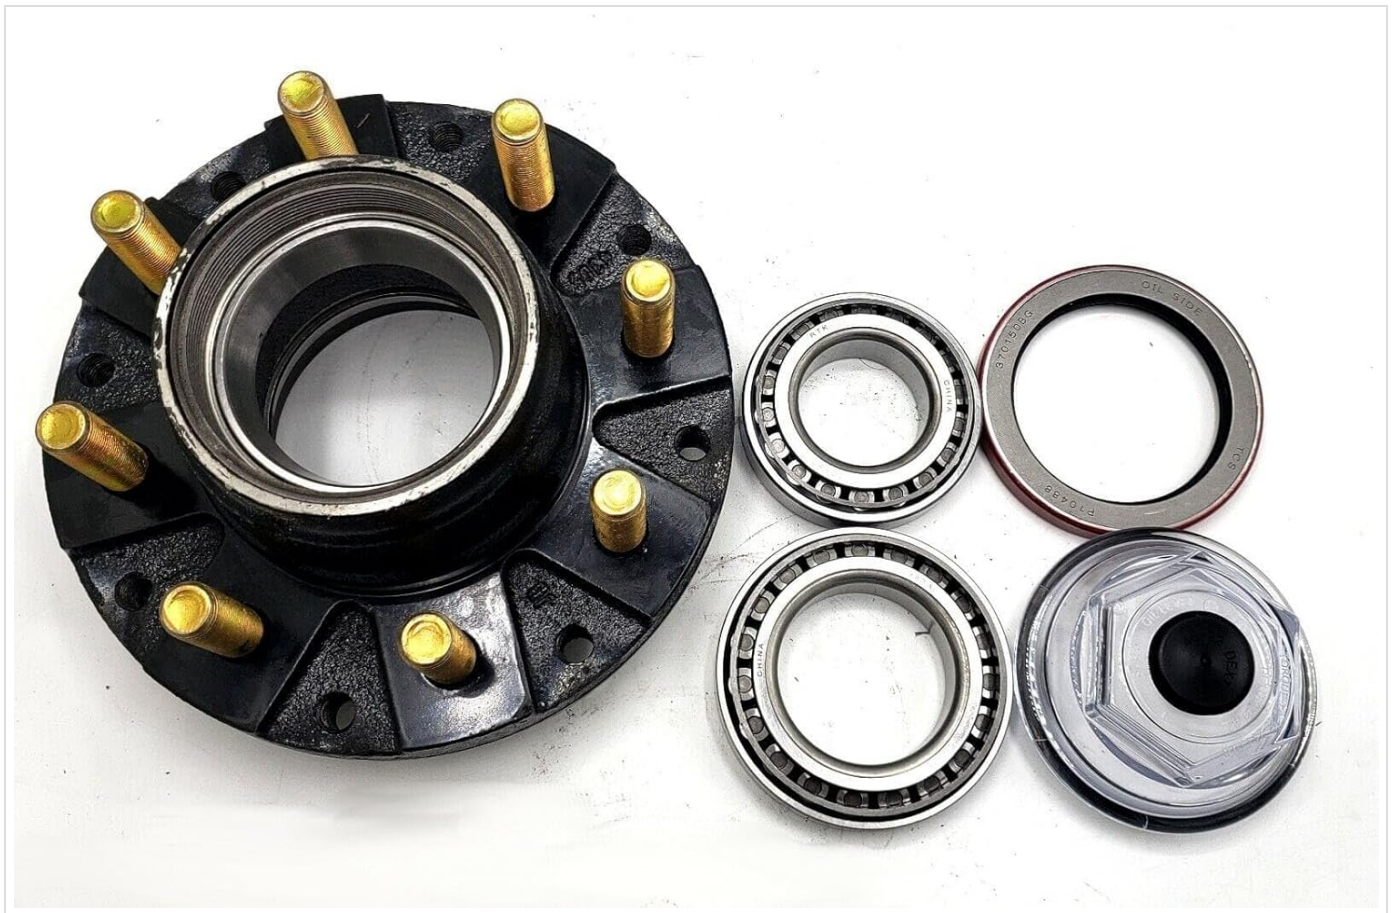
This image displays the complete RP843003 trailer axle oil bath hub kit. It includes the main hub assembly with eight wheel studs, two tapered roller bearings (inner and outer), a red-rimmed oil seal, and a clear plastic hub cap with a black center plug. These components are essential for proper installation and function of the trailer axle hub.

- **Hub Assembly:** The main cast iron body with 8 wheel studs.
- **Inner Bearing Cup (382A):** Pre-installed in the hub.
- **Outer Bearing Cone (25580):** Tapered roller bearing for the outer position.
- **Outer Bearing Cup (25520):** Pre-installed in the hub.
- **Oil Seal (10-51):** Essential for retaining lubricant and preventing contamination.
- **Hub Cap (021-088-00):** Protects the bearings and retains oil.
