**MOTO1988 1012515**

# MOTO1988 341cc Engine Rebuild Kit Instruction Manual

For Club Car Gas Golf Cart KF-82 Side Valve Engines (1986-1991)

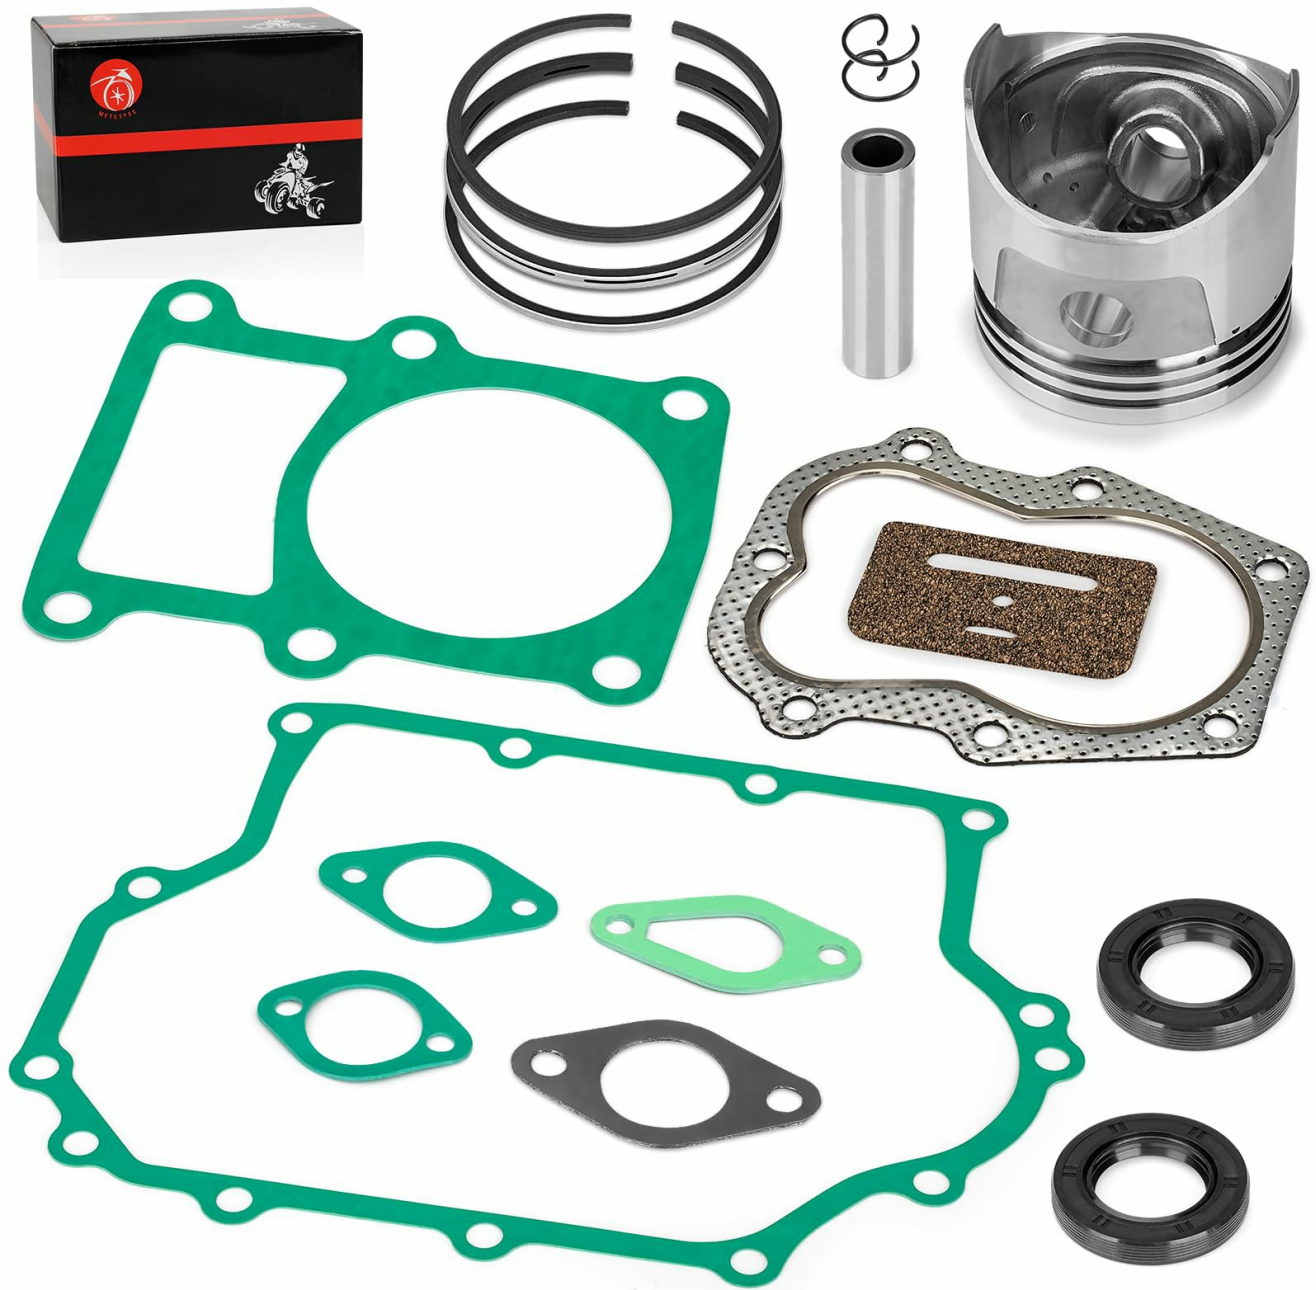
Image 1.1: Overview of the MOTO1988 341cc Engine Rebuild Kit components, including piston, rings, wrist pin, clips, and various gaskets.

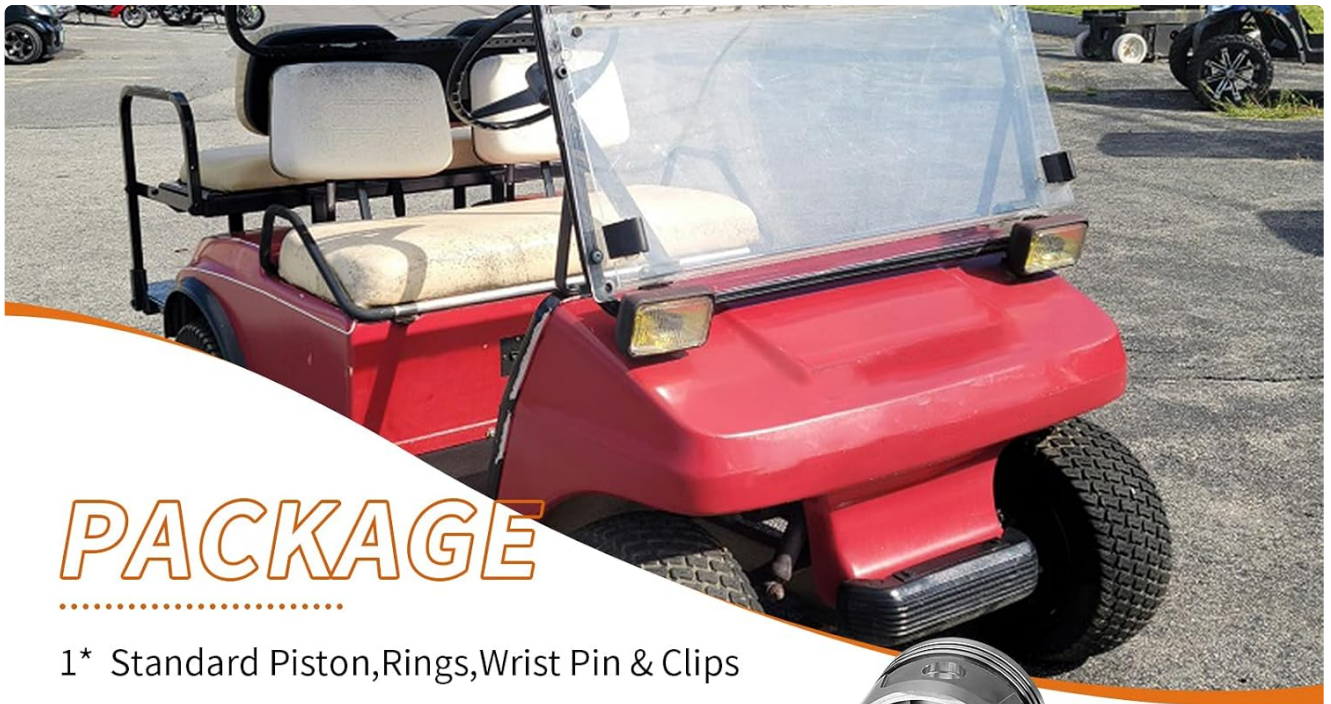
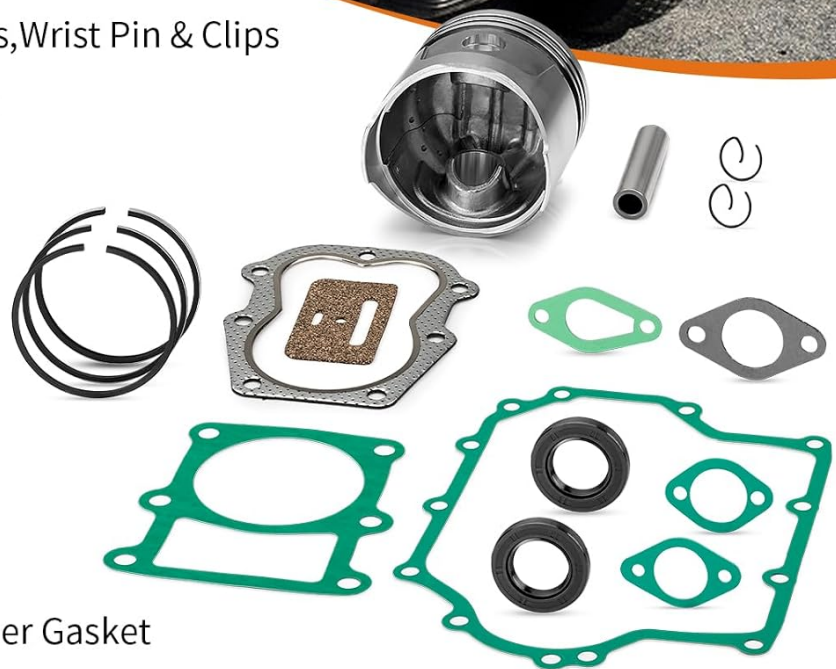
# PACKAGE

- 1\* Standard Piston,Rings,Wrist Pin & Clips
- 1\* Cylinder Head Gasket
- 1\* Cylinder Base Gasket
- 1\* Crankcase Gasket
- 1\* Exhaust Gasket
- 2\* Crankcase Seals
- 1\* Carburetor Gasket
- 1\* Pump Cover Gasket
- 1\* Tappet Cover Gasket
- 1\* Carburetor / Air Cleaner Gasket

Image 1.2: Visual representation of all components included in the rebuild kit, alongside a list of items.

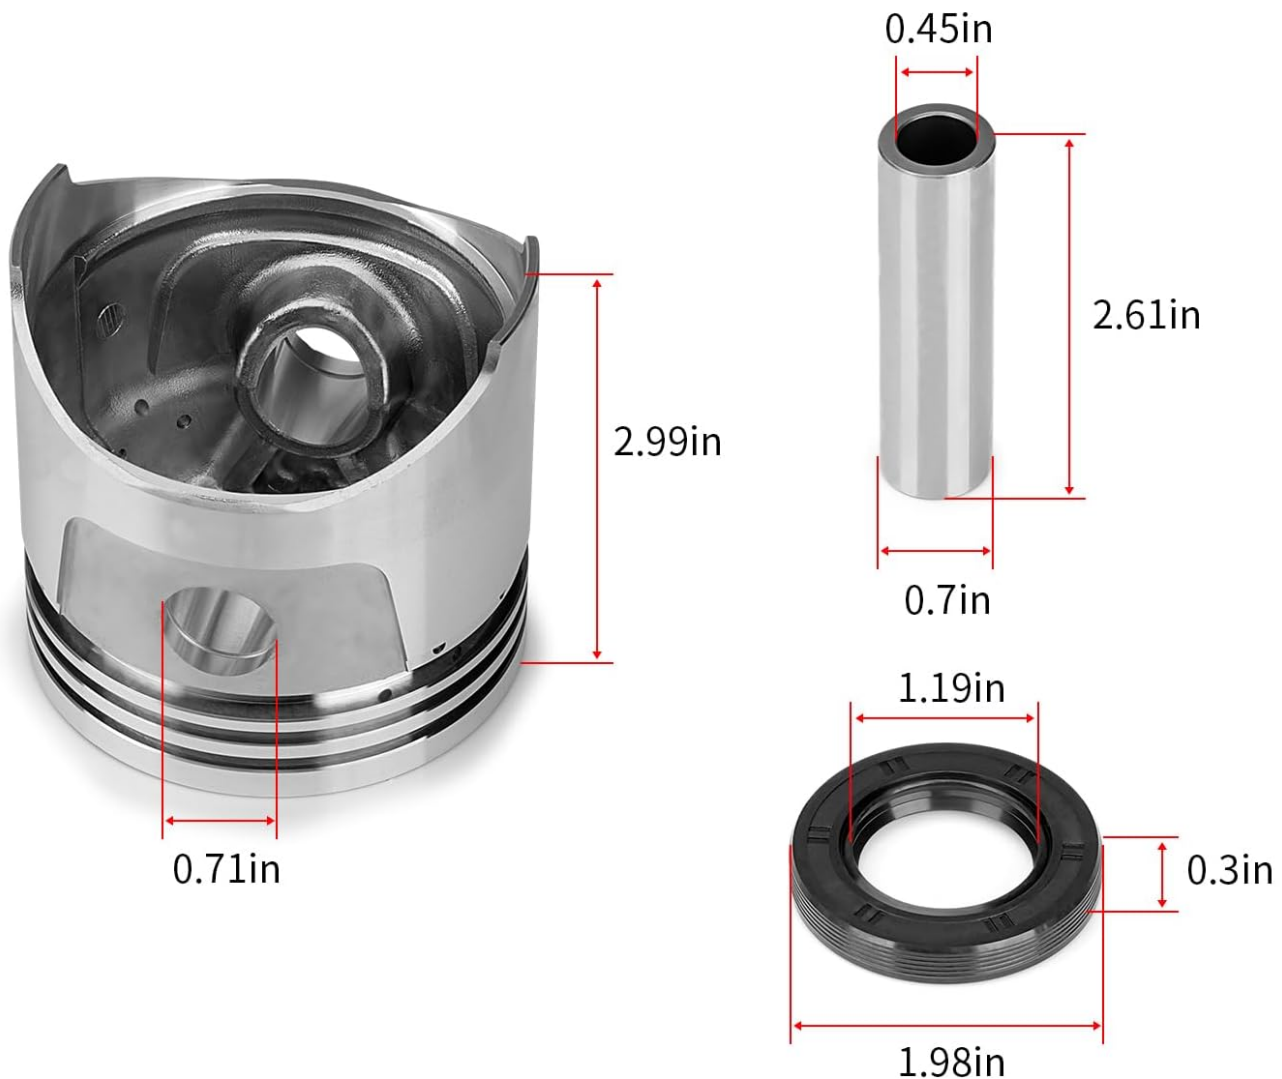
# PRODUCT DIMENSION

Please allow 1-3in measurement error

Image 6.1: Detailed dimensions for the piston, wrist pin, and crankcase seal included in the kit. Please allow for minor measurement errors (1-3 inches as indicated in the source image).
