**Innova 5210, 3360**

# Innova 5210 OBD2 Scanner & 3360 Thermal Camera User Manual

Comprehensive Guide for Diagnostic and Thermal Imaging Tools

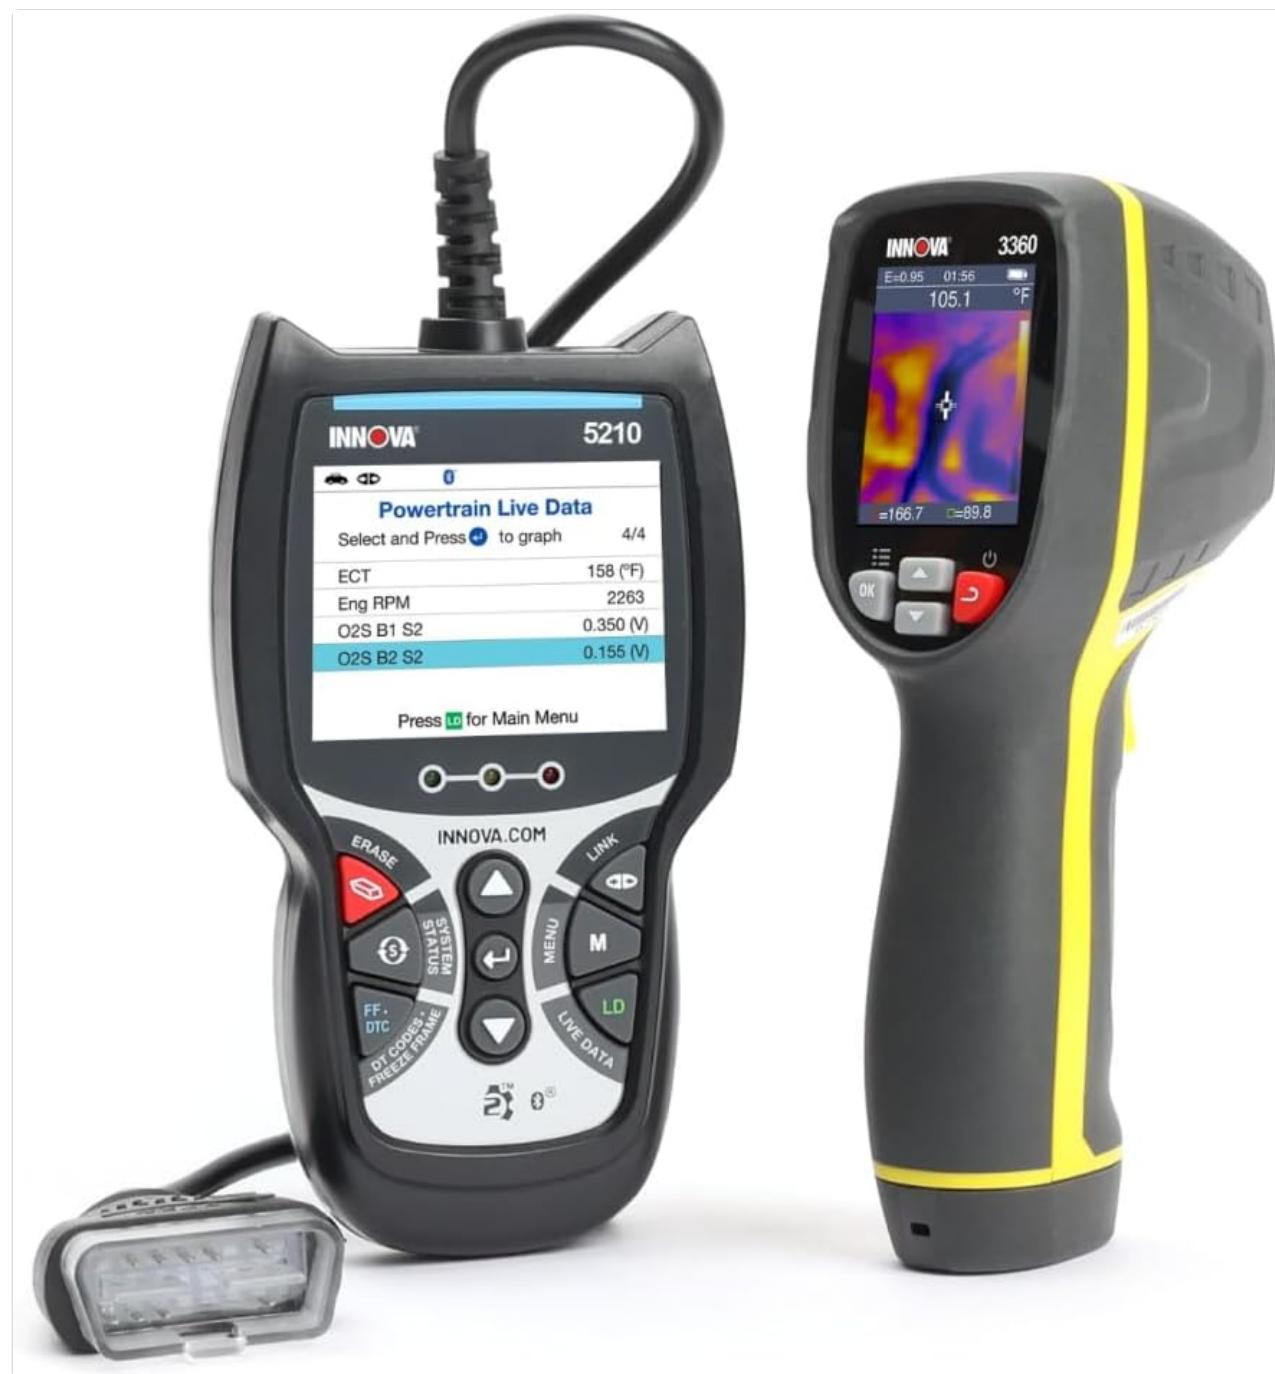
Image: The Innova 5210 OBD2 Scanner (left) displays powertrain live data, while the Innova 3360 Infrared Thermal Camera (right) shows a thermal image with temperature readings. Both devices are black and yellow, designed for automotive diagnostics.

- Live Data:** Access "Live Data" to view real-time sensor readings such as engine RPM, coolant temperature, and oxygen sensor voltages. This data is crucial for diagnosing intermittent issues.

- Thermal Imaging:** Point the camera at the area you wish to inspect. The screen will display a thermal image, highlighting temperature variations.
- Temperature Readings:** The display shows real-time temperature readings, including minimum, maximum, and center point temperatures.
- Applications:** Use the 3360 to detect hot spots in electrical wiring, identify engine overheating, locate leaks, or inspect HVAC components. It can also be used for home inspections.
