GeoTech Front Brake Rotor Model 2054097 Instruction Manual

For Ford Explorer Sport Trac, Ford Ranger, Mazda B3000, Mazda B4000 (2001-2011)

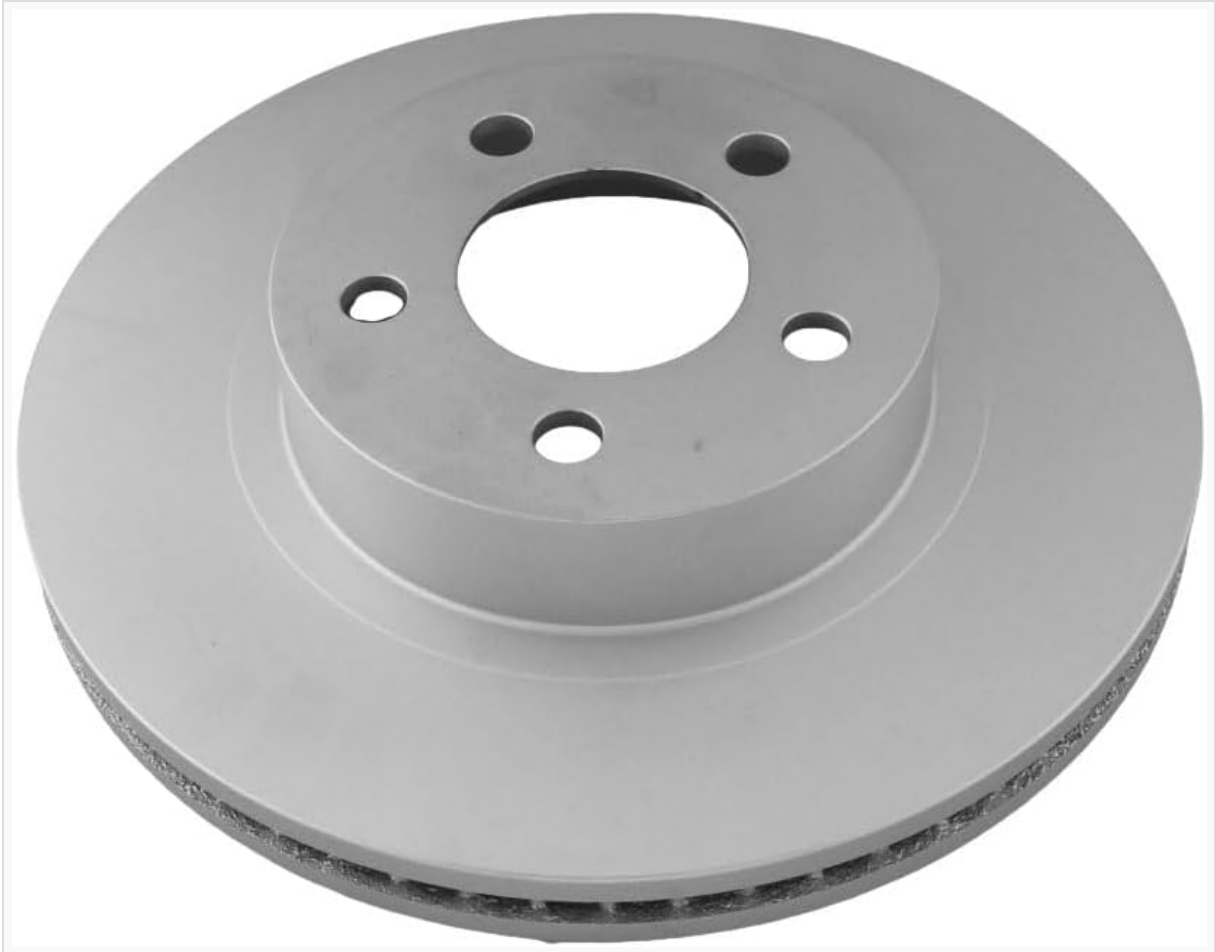
This image displays the GeoTech Front Brake Rotor from a top-down perspective, highlighting the smooth braking surface and the central mounting hub with bolt holes. This view is typical for initial inspection of the rotor's condition.

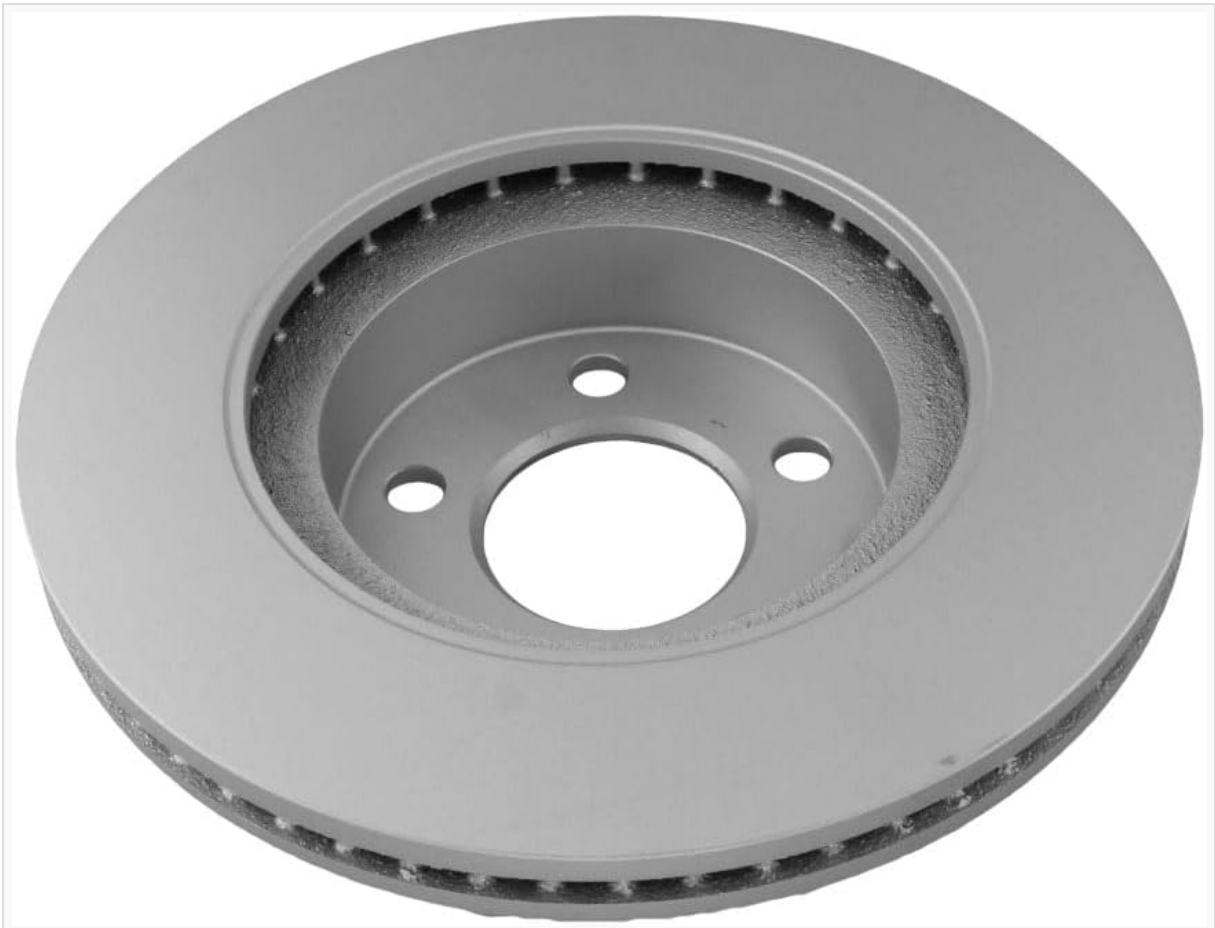
This image presents an angled view of the GeoTech Front Brake Rotor, showcasing its vented design. The internal fins are visible, which are crucial for dissipating heat generated during braking, ensuring consistent performance and
