TopHomer PLP111

TopHomer 5-Way Outlet Cross Female Pipe Fitting (1-inch)

Model: PLP111

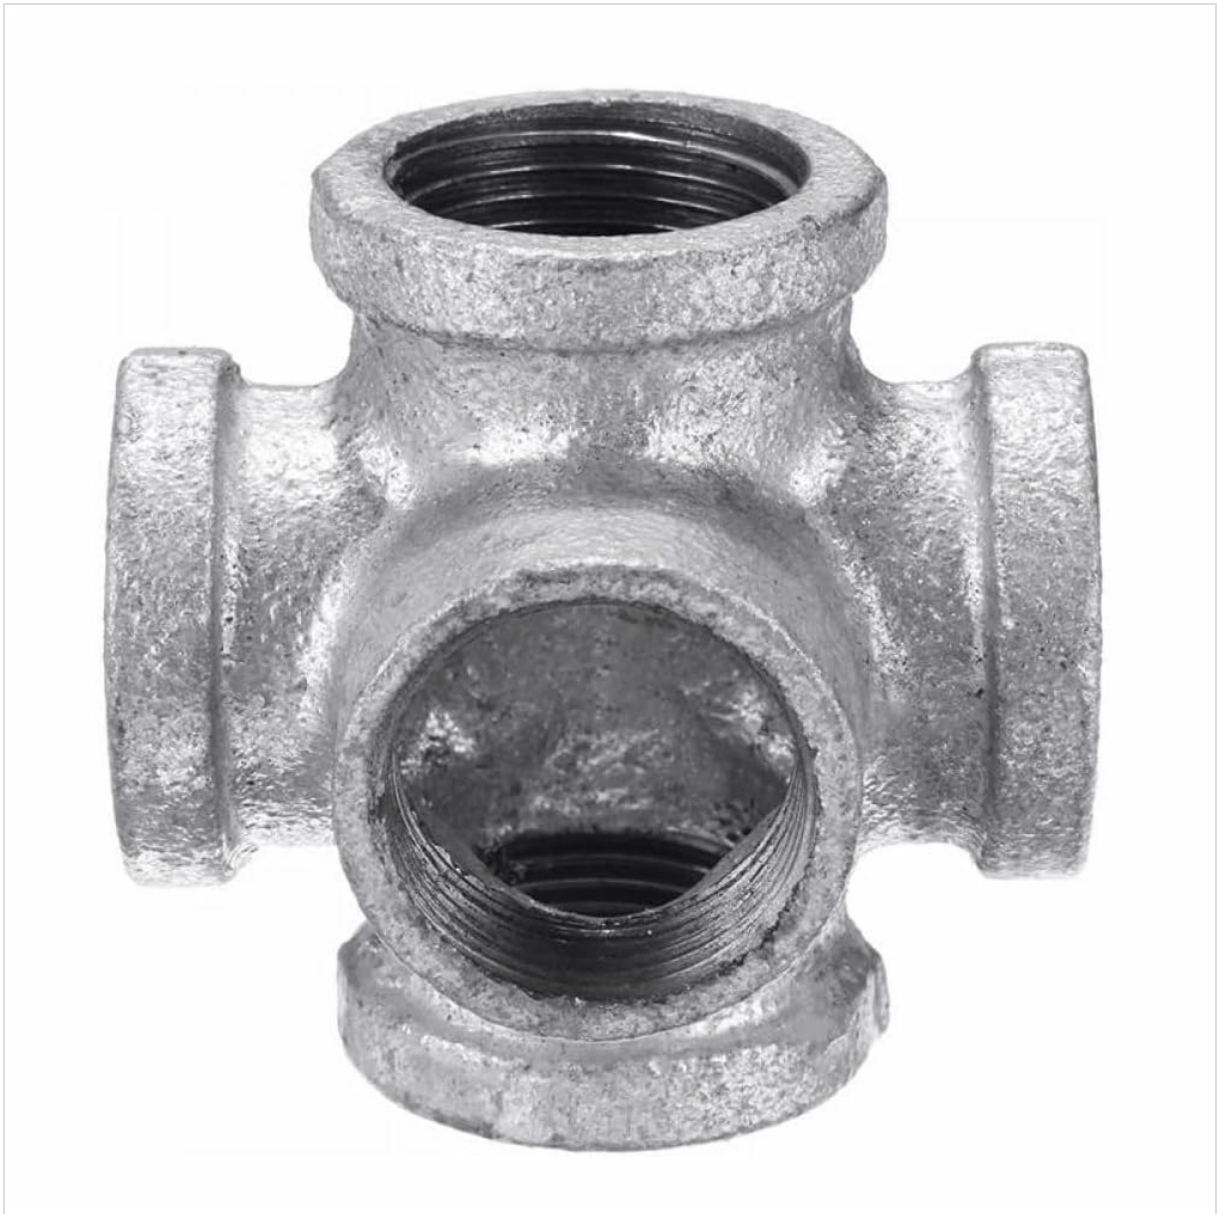
Figure 1: Front view of the TopHomer 5-Way Outlet Cross Female Pipe Fitting, 1-inch. This image shows the five threaded outlets designed for connecting multiple pipes.

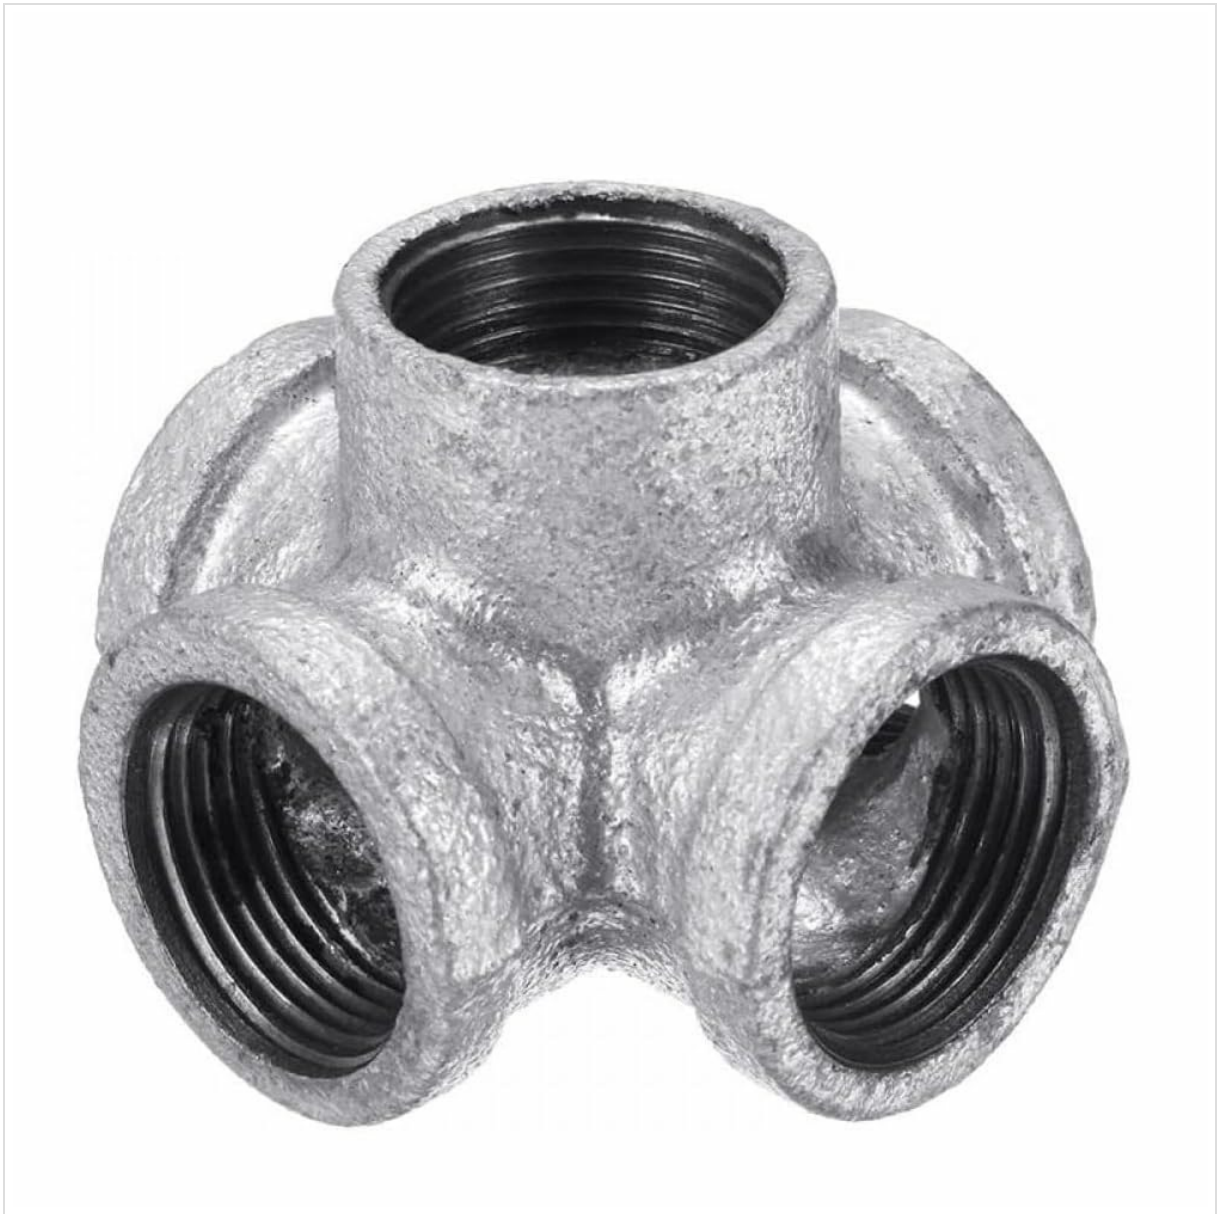
Figure 2: Angled view of the 5-way pipe fitting, illustrating the multiple connection points for complex piping configurations.

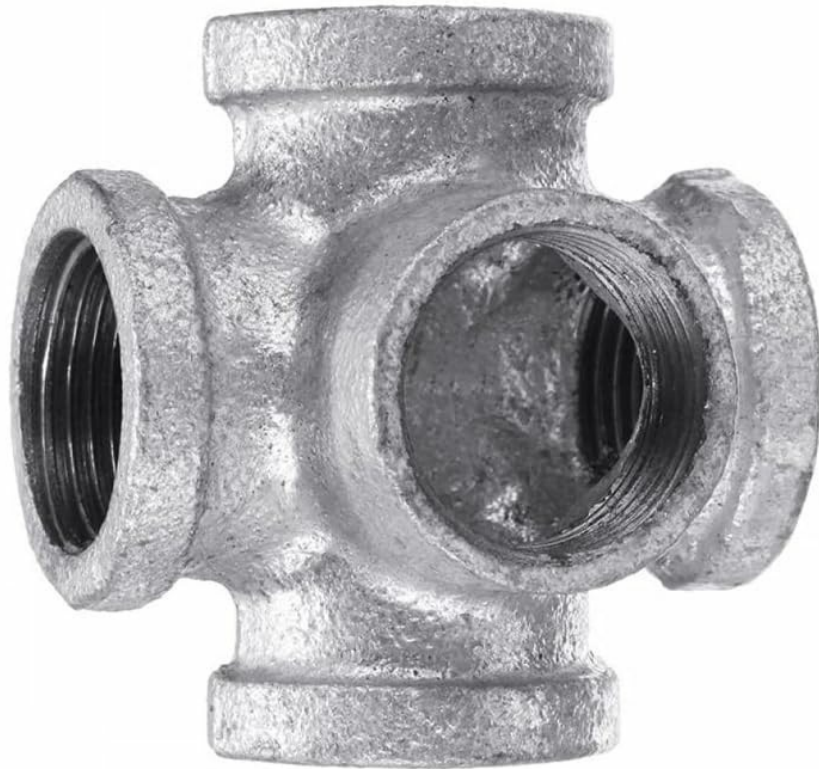
Cast Steel, Hard and Wear-Resistant

Figure 3: The 5-way pipe fitting, emphasizing its cast iron construction for durability and wear resistance.
