# Instruction Manual: Replacement Main Drive Belt for Crosley VAW3584GW1 HD Washer

Model: FRIC-PL-APP-TP-22052025-019039

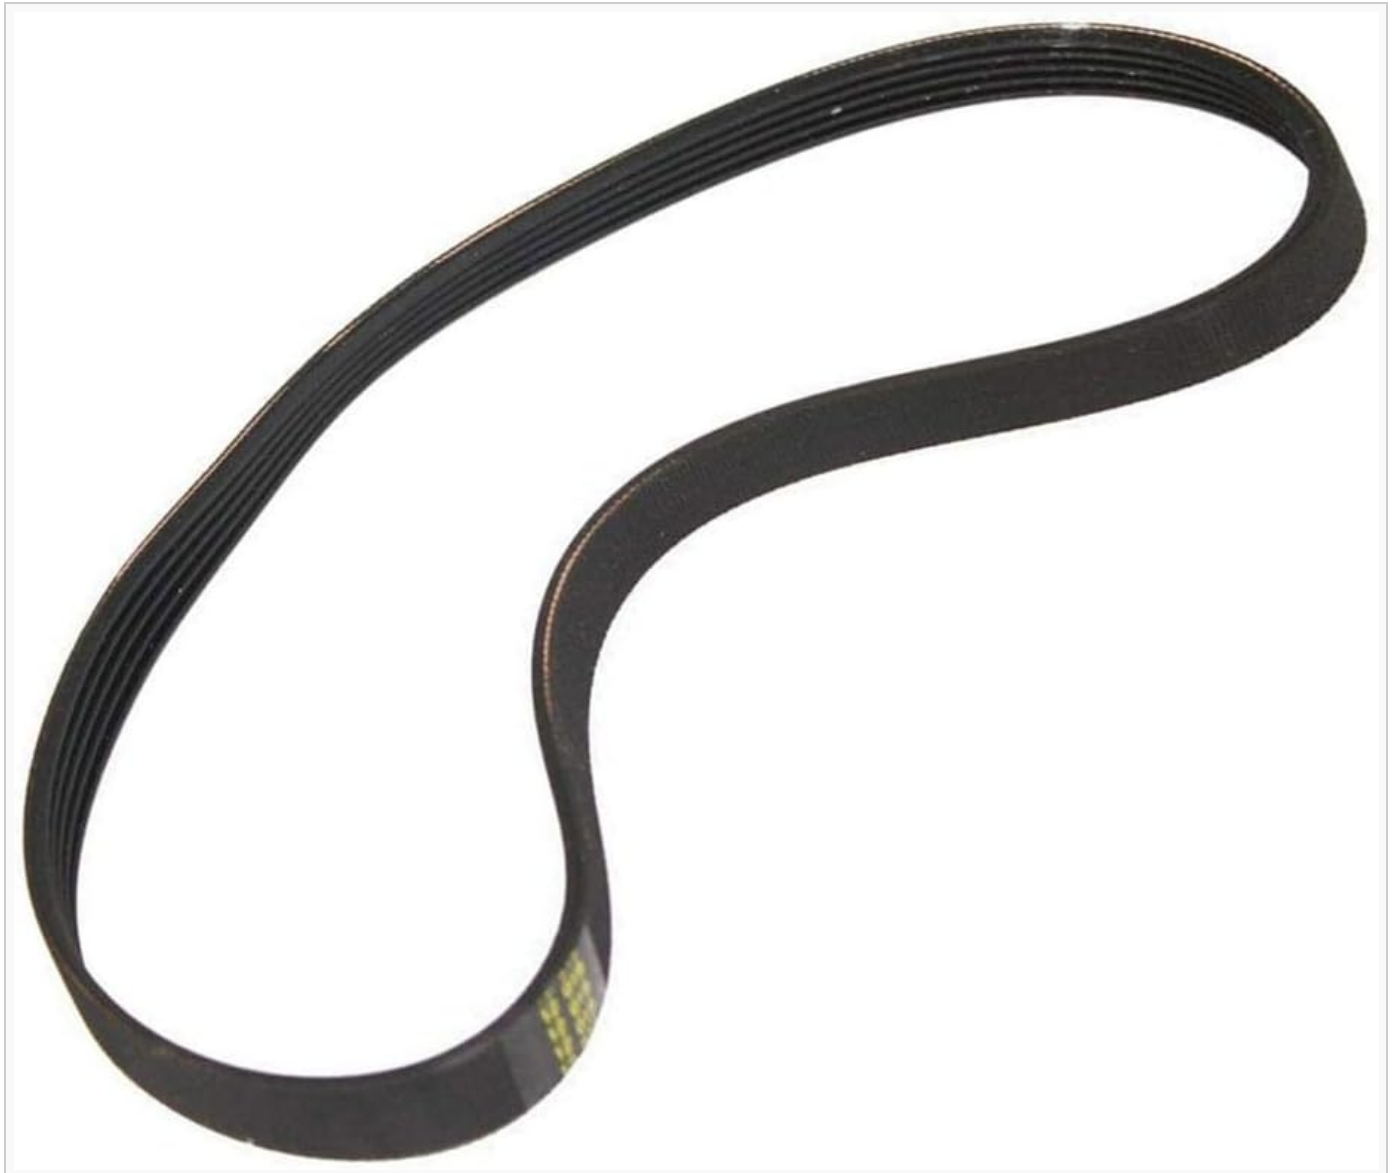
**Figure 3.1:** The replacement main drive belt. This image shows the black, multi-ribbed belt designed to transmit power from the motor to the washer drum. Proper orientation with the ribbed side facing the pulleys is essential for effective operation.

pulley. This often requires significant force and careful manipulation to ensure the belt seats correctly in the grooves of both pulleys. Ensure the ribbed side of the belt faces the pulleys.
