Fricparts 11028082700

Fricparts Replacement Tub Bearings and Seal Kit

Model: 11028082700 for Kenmore Washers

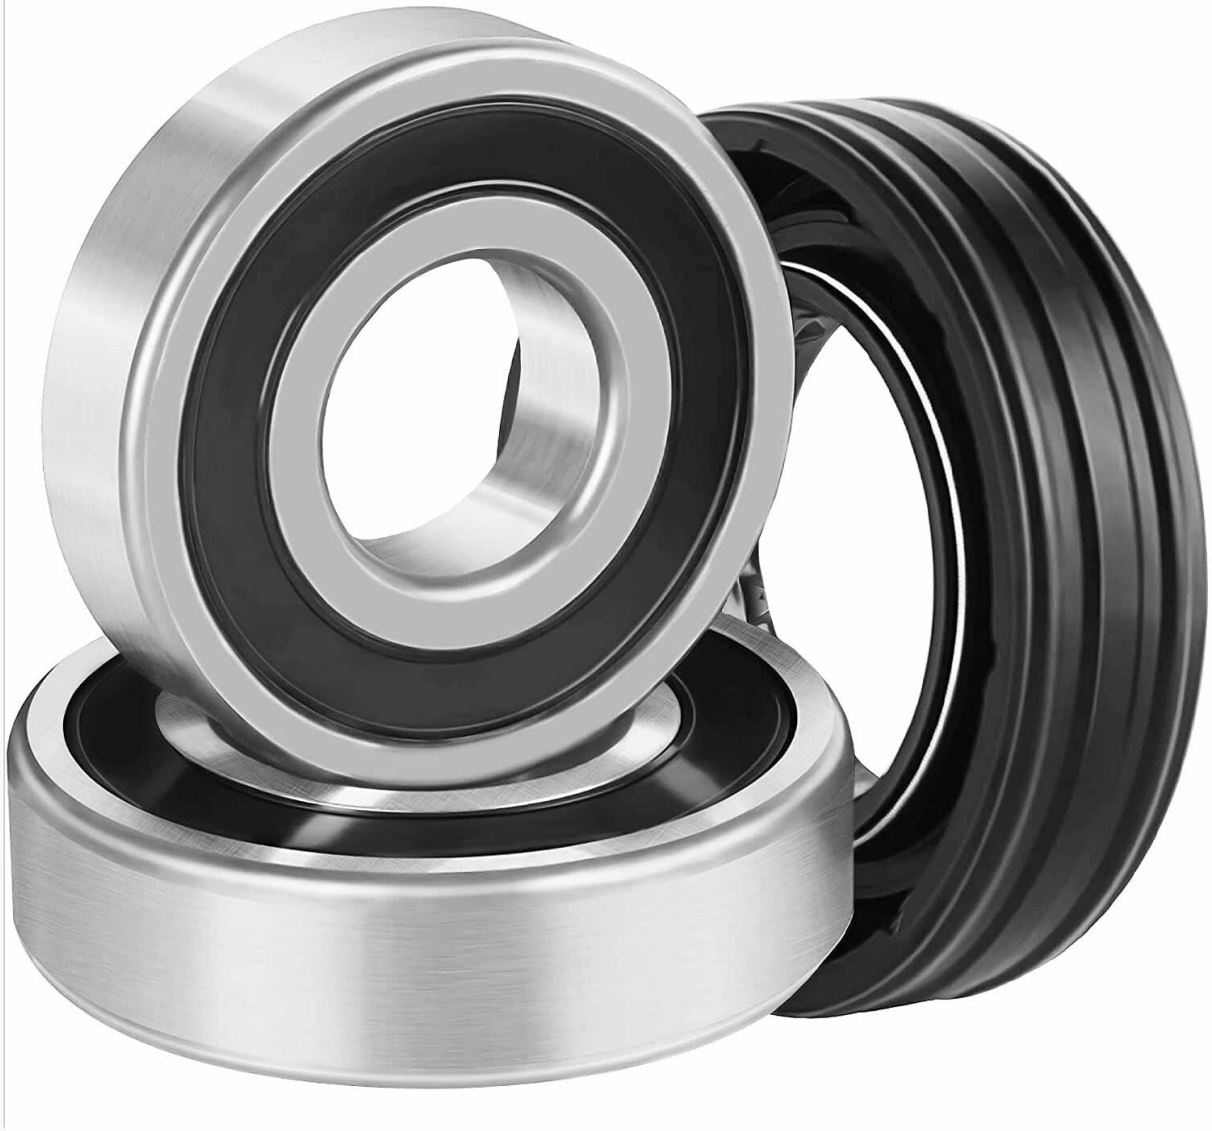
Image 1: The Fricparts 11028082700 replacement kit, including two tub bearings and one tub seal. The bearings are metallic with a black inner ring, and the seal is black and ribbed.

- **Part Number:** 11028082700
- **Model Compatibility:** Designed for specific Kenmore washer models (verify compatibility with your appliance's service manual).
- **Kit Contents:** Typically includes two tub bearings and one tub seal.
- **Manufacturer:** Fricparts
- **ASIN:** B0F9PCTXWX
- **First Available:** May 23, 2025
