Carrier ML5 Asset Tracker Telematics Module Instruction Manual

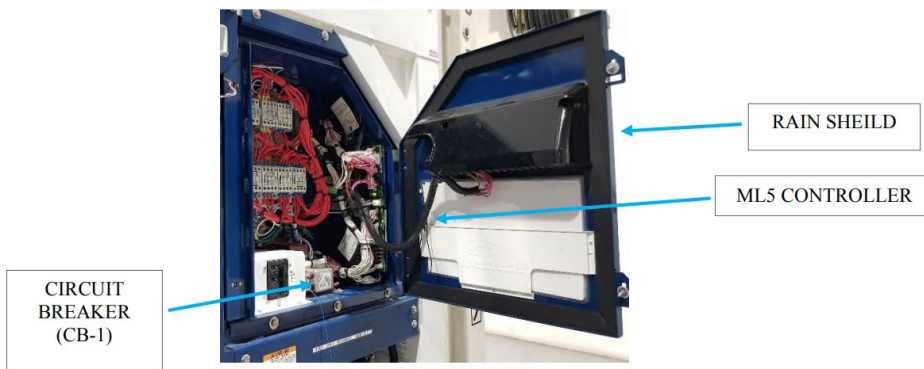
Figure 1: Control Box with Door Open

3. Open the control box door. See Figure 1.

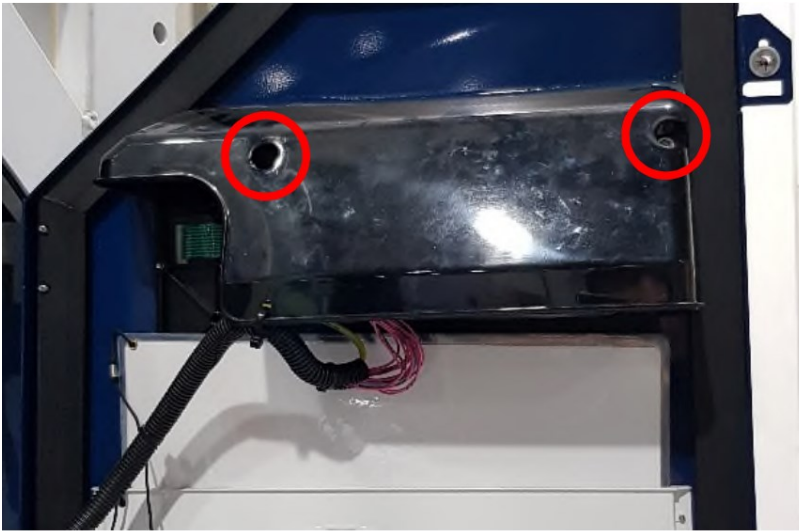
Figure 2a: Removal of Rain Shield

4. Remove the rain shield by removing the screws using a flat head screwdriver. Temporarily reinstall the two screws to hold display in place for the next step. See Figure 2a and 2b.
5. Clean area of any residue caulk on either the rain shield or the control box door.

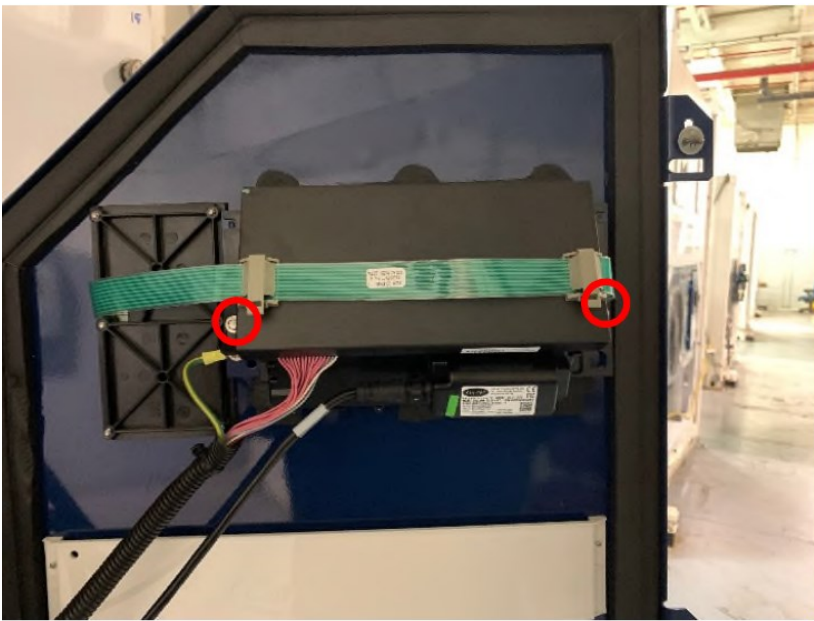
**Figure 3: Module
Installation**

6. Remove the two lower screws on the display.
7. Position the Telematics module with the flat side of the module facing towards the door and reinstall the two screws on the display to secure / mount the module in place. See Figure 3.

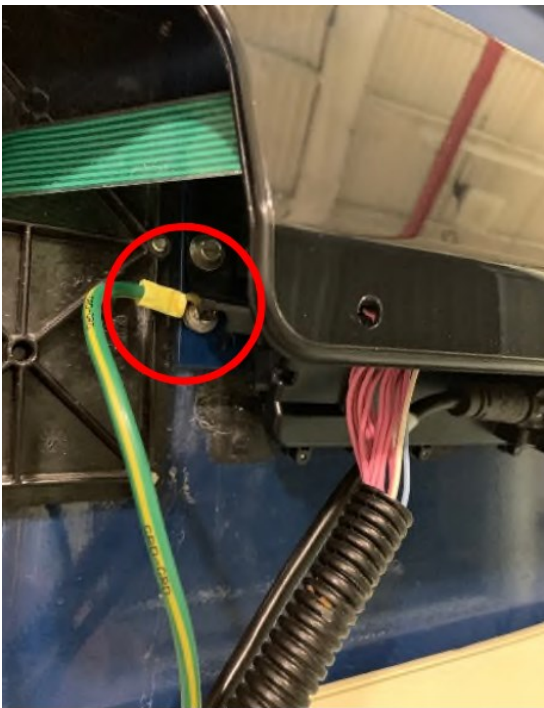
**Figure 4a: Module
Installation**

8. Note the ground screw location and wire orientation. See Figure 4a. The module may need to be pushed up when tightening it down to clear the ground screw.

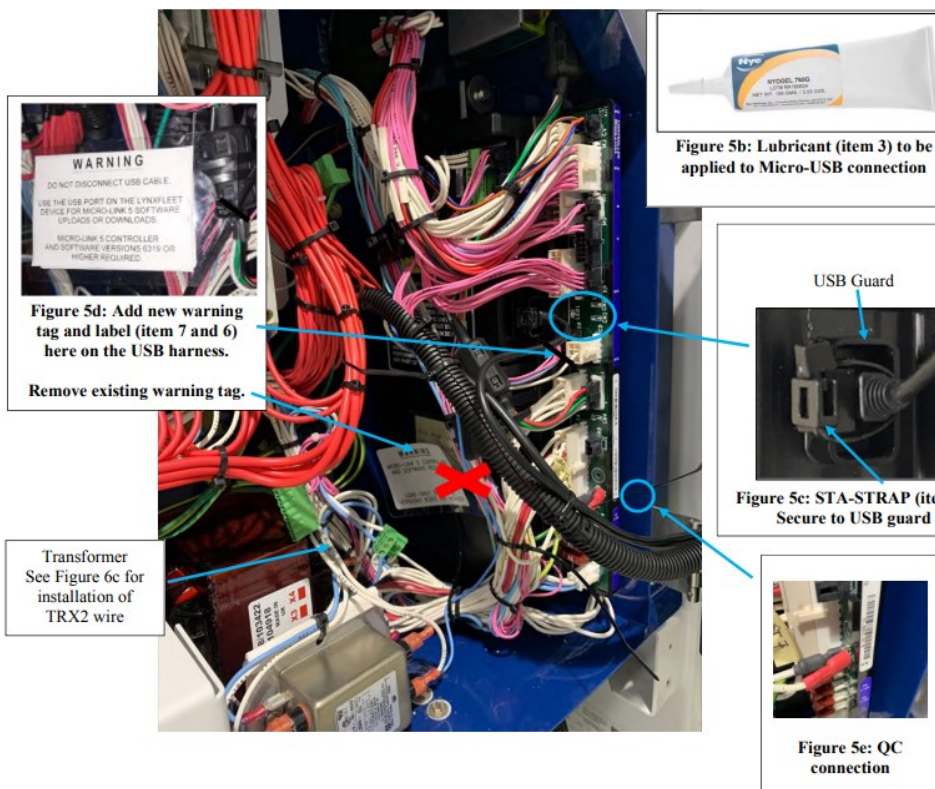
9. Apply electrical contact dielectric grease to the micro-USB connector on the ML5 and the micro-USB plug. See figure 5b.
10. Plug the micro-USB (item 1) to the ML5 controller connector and secure with the STAStrap (item 3) to the USB guard and pull tie wrap to secure USB cable. See Figure 5c and 5d.
11. Locate the existing software tag and remove it from the unit. See figure 5d.
12. Take the clear plastic tag (item 7) and apply new label (item 6). See figure 5d.
13. Secure tag to the USB cable near the controller using wire tie. See figure 5d.
14. The power cable splits into QC and TRX2. Connect the wire marked QC to the QC connector on ML5 controller. See Figure 5e.

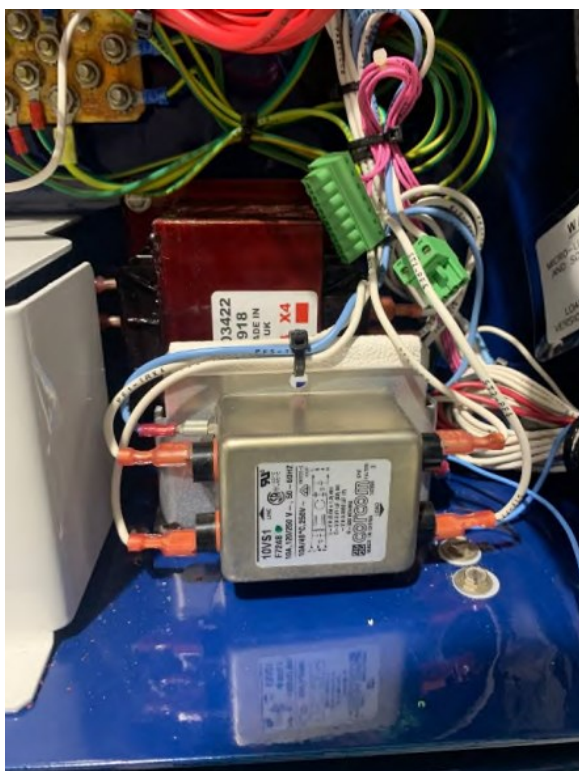
Figure 6a: Filter location

15. Loosen the mounting screws of the filter in front of the transformer using a flathead screwdriver so it can be rotated out of the way. See fig. 6a and 6b.

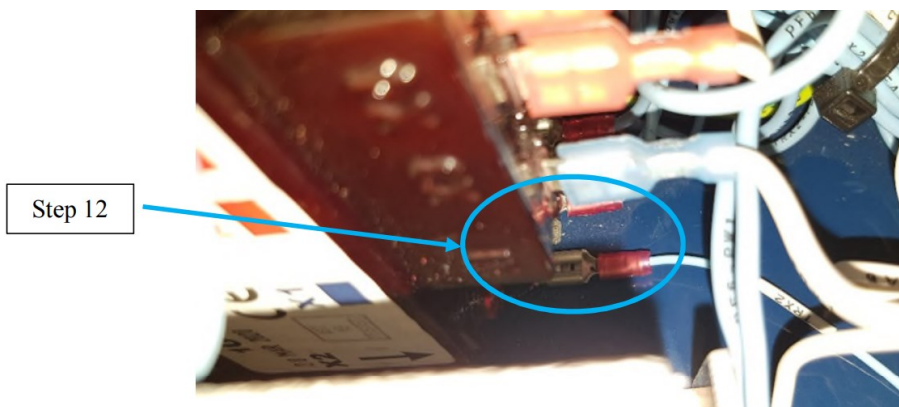
Figure 6c: TRX2 connection to Transformer

16. Connect the wire marked TRX2 to the low voltage side of transformer at an open X2 connector. See Figure 6c.

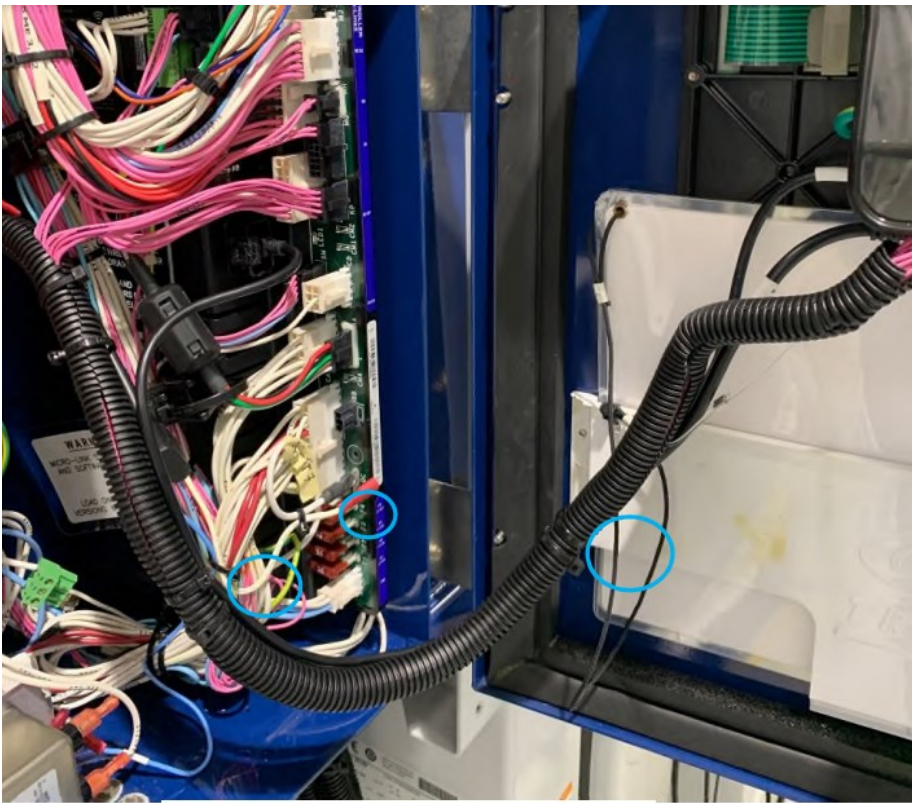
Figure 7a: Securing wire harness

17. Move the filter back to its original place and secure it with the mounting screw.
18. With the door fully open, neatly secure the wire harness using the wire ties and securing to existing display cable conduit. See Figure 7a.

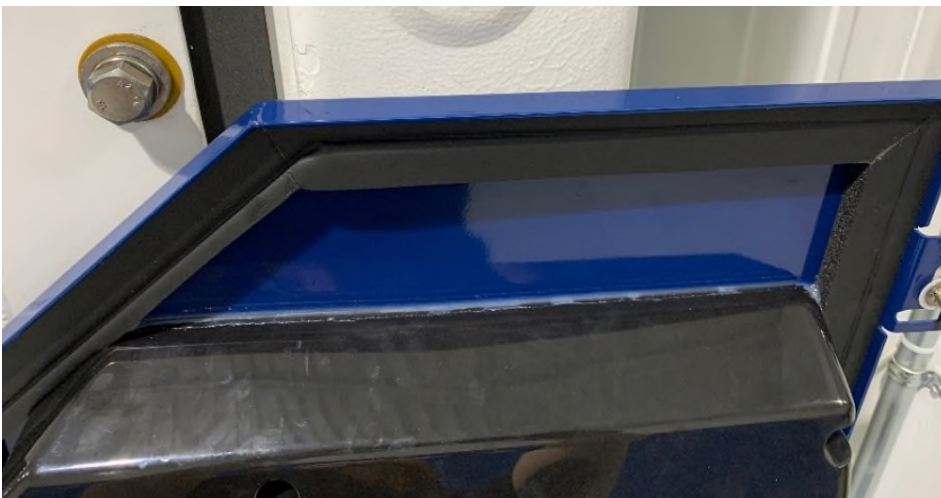
19. Remove the top screws on the display. Reinstall rain shield using these screws.
20. Caulk along the top of the rain shield to prevent water ingress. See figure 7b.

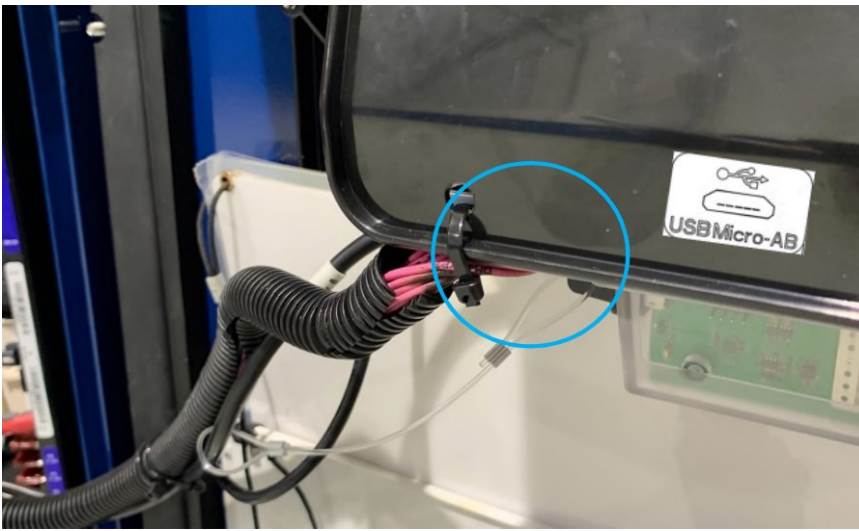
Figure 7c: Routing wire harness and label location

21. Secure the wire harnesses to the rain shield via the hole as shown below in figure 7c. If there is no hole, drill a hole with a 1/4" or 6mm drill bit.
22. Clean the rain shield with an appropriate cleaner and add the USB label (item 5) to the rain shield to the right of the harness mounting hole. Location shown in figure 7c.
