Engineering Data

Mini Series VRF

MDV-V230WN1(AU)

MIH200T1HN18(S)

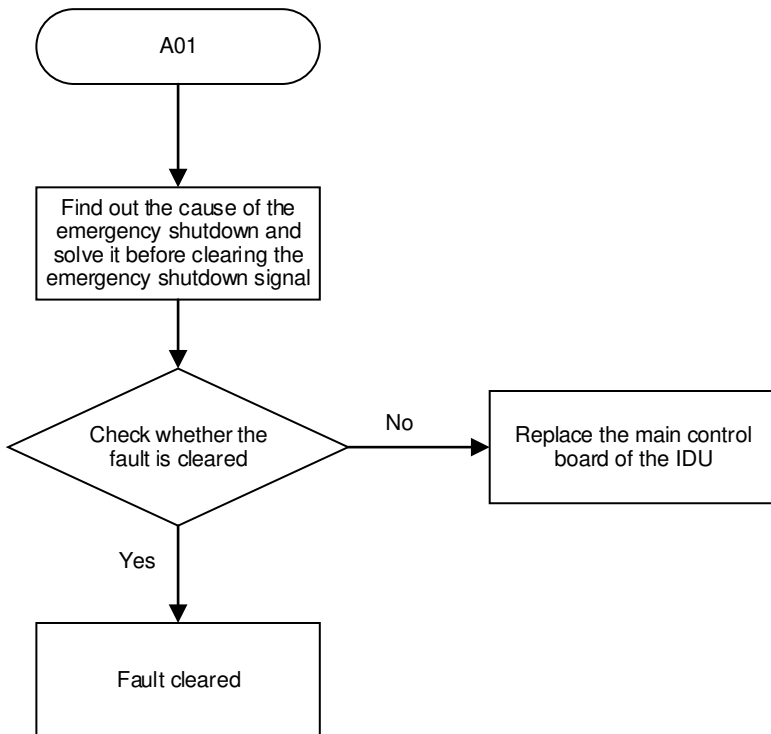
Panel, display box, and wired controller
Error impact	The faulty IDU and other IDUs of the same system: stop running, displaying code "A01" (V6 platform indoor unit displays "A0" code)	
	ODU of the same system: stop running, displaying code "A01" (V6 platform outdoor unit displays "A0" code)	
Error trigger	When the IDU receives an emergency shutdown signal from the ODU	
Error recovery	After troubleshooting, power on again	
Possible cause	<ul style="list-style-type: none"> ■ An emergency shutdown signal is received. ■ The IDU main control board is damaged. 	
Troubleshooting	<div data-bbox="517 651 1291 1382">

<pre> graph TD A01([A01]) --> B[Find out the cause of the emergency shutdown and solve it before clearing the emergency shutdown signal] B --> C{Check whether the fault is cleared} C -- No --> D[Replace the main control board of the IDU] C -- Yes --> E[Fault cleared] </pre> </div> <p>Note:</p> <p>1. Emergency shutdown is usually caused by the outdoor unit receiving an emergency shutdown command sent by the central controller or external reasons. For detailed handling instructions, please refer to the corresponding outdoor unit troubleshooting manual.</p>

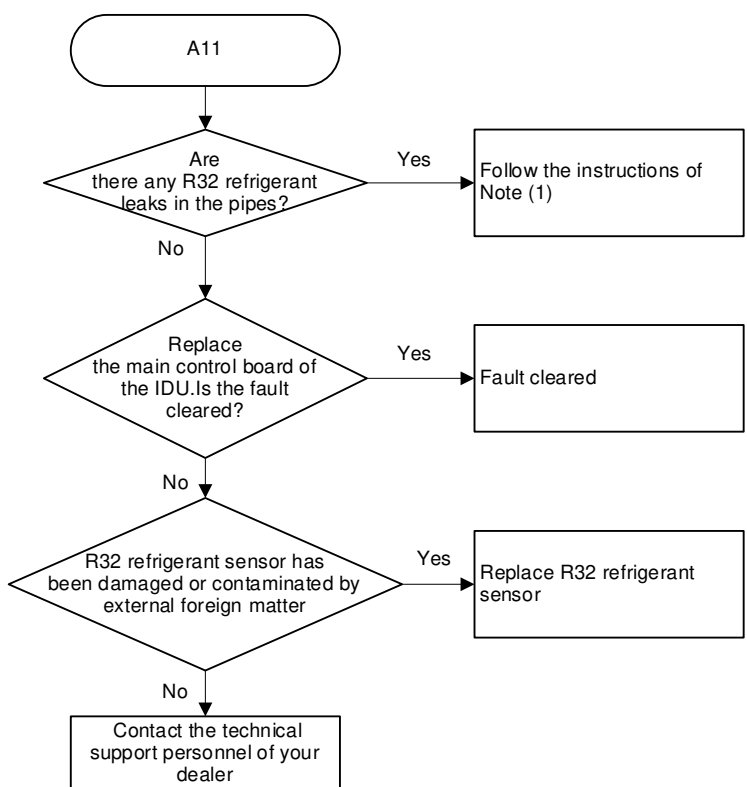
Error recovery	Has not detected the refrigerant leak signal and has received the signal of refrigerant fault rectification	
Possible cause	<ul style="list-style-type: none"> R32 refrigerant of IDUs leaks. R32 refrigerant sensor is damaged or contaminated with external foreign matter (e.g. steam, oil) Abnormal communication among IDU main control board, adapter board and R32 refrigerant detection device control board IDU main control board or adapter board or R32 refrigerant detection device control board damaged 	
Troubleshooting

<pre> graph TD Start([A11]) --> D1{Are there any R32 refrigerant leaks in the pipes?} D1 -- Yes --> N1[Follow the instructions of Note (1)] D1 -- No --> D2{Replace the main control board of the IDU. Is the fault cleared?} D2 -- Yes --> E1[Fault cleared] D2 -- No --> D3{R32 refrigerant sensor has been damaged or contaminated by external foreign matter?} D3 -- Yes --> E2[Replace R32 refrigerant sensor] D3 -- No --> E3[Contact the technical support personnel of your dealer] </pre> <p>Note 1: Adapter board ENC1 dip switch setting When the function of determining refrigerant</p>

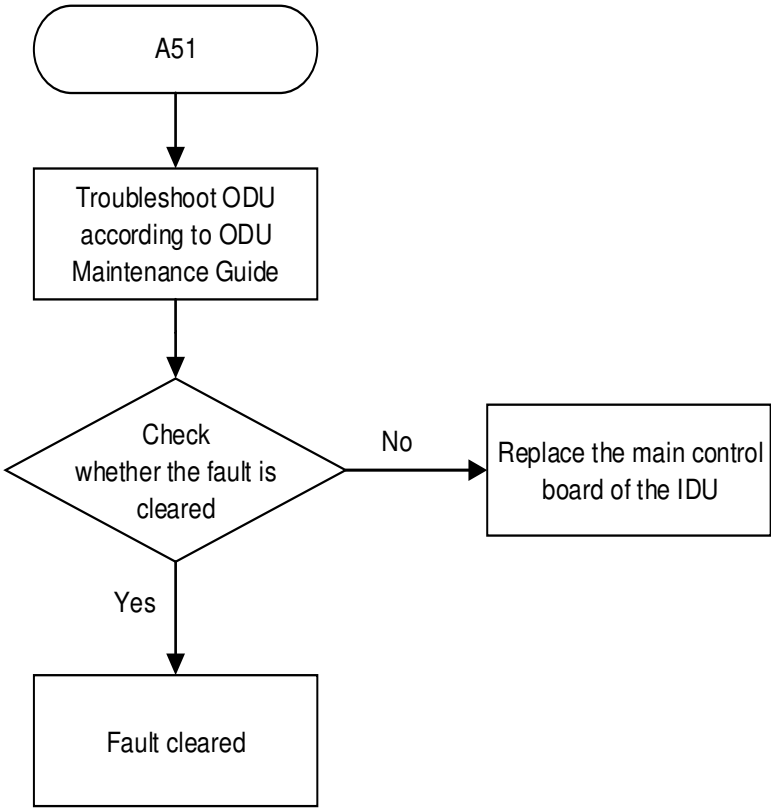
<pre> graph TD A51([A51]) --> B[Troubleshoot ODU according to ODU Maintenance Guide] B --> C{Check whether the fault is cleared} C -- No --> D[Replace the main control board of the IDU] C -- Yes --> E[Fault cleared] </pre>

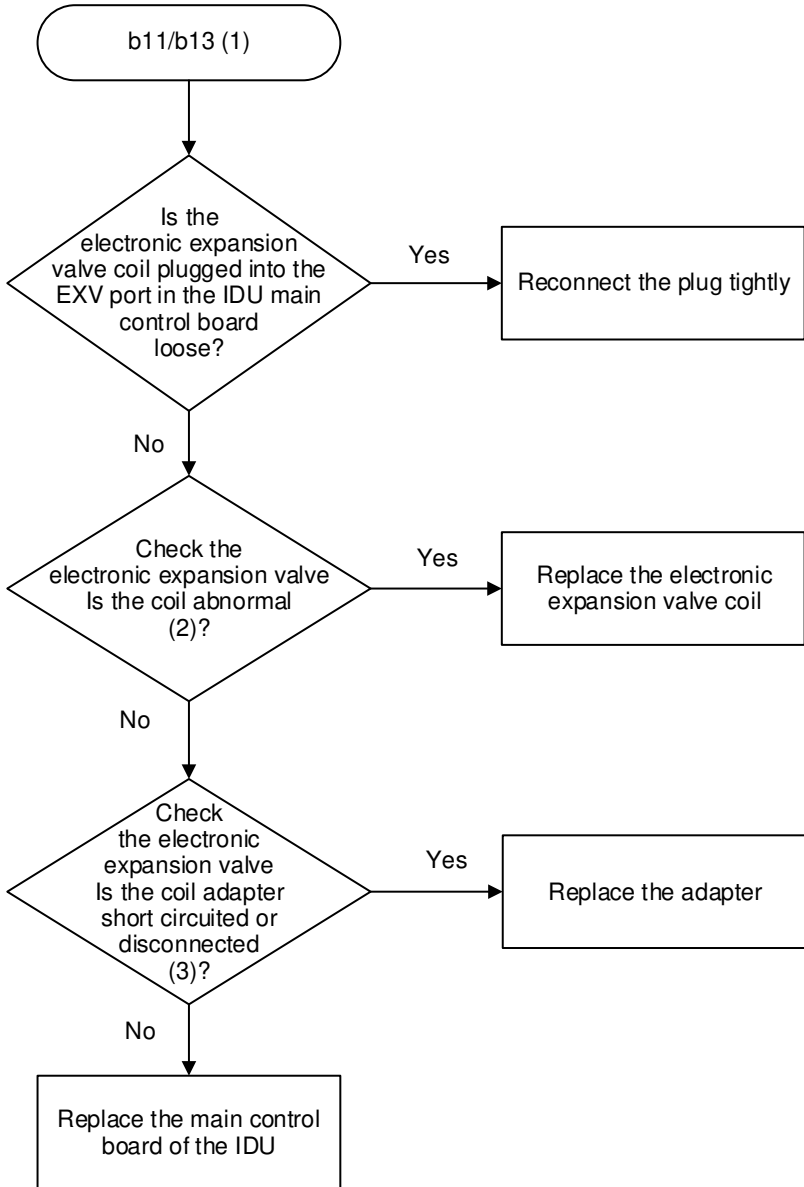
<pre> graph TD Start([b11/b13 (1)]) --> D1{Is the electronic expansion valve coil plugged into the EXV port in the IDU main control board loose?} D1 -- Yes --> A1[Reconnect the plug tightly] D1 -- No --> D2{Check the electronic expansion valve Is the coil abnormal (2)?} D2 -- Yes --> A2[Replace the electronic expansion valve coil] D2 -- No --> D3{Check the electronic expansion valve Is the coil adapter short circuited or disconnected (3)?} D3 -- Yes --> A3[Replace the adapter] D3 -- No --> A4[Replace the main control board of the IDU] </pre> <p>Note:</p>

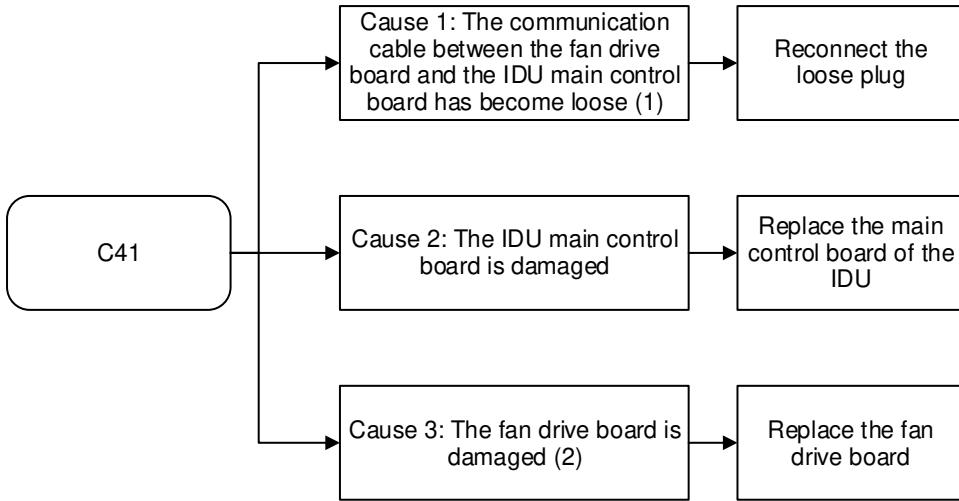
<pre> graph LR C41([C41]) --> C1[Cause 1: The communication cable between the fan drive board and the IDU main control board has become loose (1)] C41 --> C2[Cause 2: The IDU main control board is damaged] C41 --> C3[Cause 3: The fan drive board is damaged (2)] C1 --> R1[Reconnect the loose plug] C2 --> R2[Replace the main control board of the IDU] C3 --> R3[Replace the fan drive board] </pre> </div> <p>Note:</p> <ol style="list-style-type: none"> Communication cables are only provided for units whose fan drive board is independent of the IDU main control board. For units whose fan drive board is welded onto the main control board, if either the fan drive board or main control board becomes faulty, the whole control board has to be replaced.

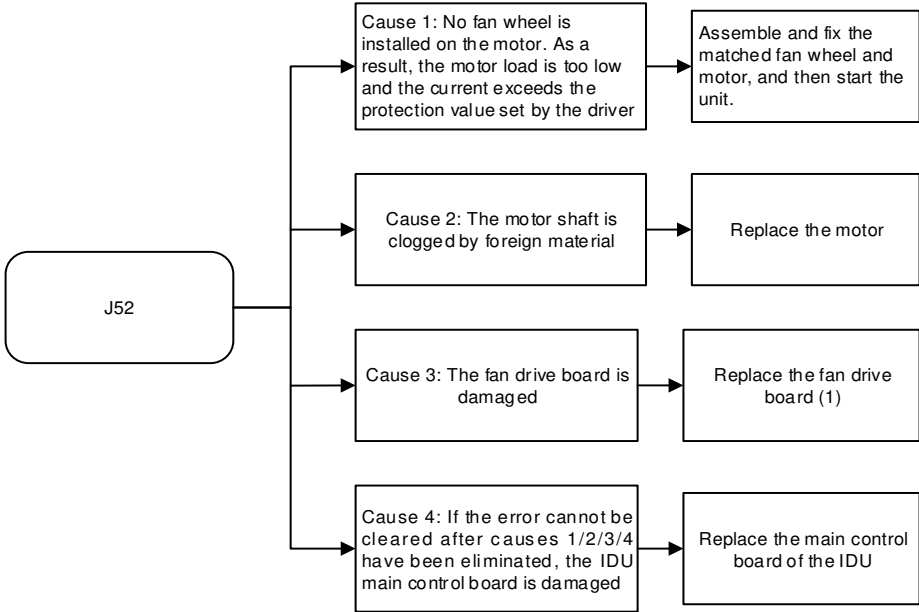
<pre> graph LR J52(J52) --> C1[Cause 1: No fan wheel is installed on the motor. As a result, the motor load is too low and the current exceeds the protection value set by the driver] J52 --> C2[Cause 2: The motor shaft is clogged by foreign material] J52 --> C3[Cause 3: The fan drive board is damaged] J52 --> C4[Cause 4: If the error cannot be cleared after causes 1/2/3/4 have been eliminated, the IDU main control board is damaged] C1 --> A1[Assemble and fix the matched fan wheel and motor, and then start the unit.] C2 --> A2[Replace the motor] C3 --> A3[Replace the fan drive board (1)] C4 --> A4[Replace the main control board of the IDU] </pre> </div> </div> <p>Note 1: Please observe the following rule when replacing the fan drive board: For units whose fan drive board is welded onto the main control board, if either the fan drive board or main control board becomes faulty, the whole control board has to be replaced.</p>

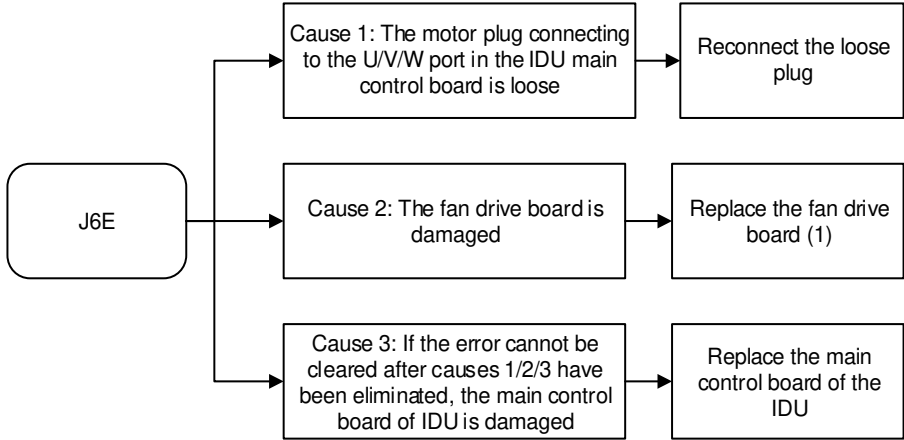
<pre> graph LR J6E([J6E]) --> C1[Cause 1: The motor plug connecting to the U/V/W port in the IDU main control board is loose] J6E --> C2[Cause 2: The fan drive board is damaged] J6E --> C3[Cause 3: If the error cannot be cleared after causes 1/2/3 have been eliminated, the main control board of IDU is damaged] C1 --> R1[Reconnect the loose plug] C2 --> R2[Replace the fan drive board (1)] C3 --> R3[Replace the main control board of the IDU] </pre> <p>Note 1: Please observe the following rule when replacing the fan drive board: For units whose fan drive board is welded onto the main control board, if either the fan drive board or main control board becomes faulty, the whole control board has to be replaced.</p>
