**Subject:** E448 Error Code

**Models:** DVM, CHILLER

**Title:** Fan Motor 1 Locked in Outdoor Unit

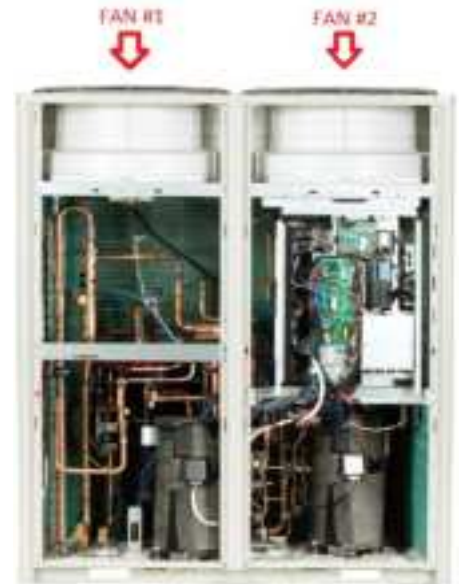
*Fan 1 is on the left-hand side of the unit*

Fan #1 is on the left-hand side of unit

4. There are two plug connections for each fan motor. Power (red, white, and black) and hall effect sensor. (See Fan Motor Connector Image)
  5. Follow and inspect wiring. Make sure there is no damage to wires or plugs.

6. Make sure all plugs and spade connectors are secure and connected properly.
  7. Disconnect power plug (Fan motor 1 is white plug, Fan motor 2 is blue plug) Check resistance at plug going to Fan motor. Red-White, Red- Black and White to Black. The resistance value between each winding should be equal, under  $10\Omega$  and open to ground.

8. Reverse connector plugs for Fan motor 1 and Fan motor 2. (Fan Motor and Hall Effect plug)
  9. Restore power to the unit. If the E448 error returns, replace fan PCB. If the error changes to E348, replace the fan motor.

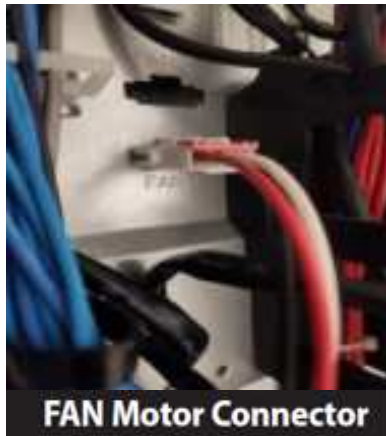
1. Turn the power to the system off and wait 15 minutes.
2. Inspect the fan blade and make sure there are no obstructions.
3. Verify blade spins freely.
4. There are two plug connections for fan motor. Power (red, white, and black) and hall effect sensor.
5. Follow and inspect wiring. Make sure there is no damage to wires/plugs.
6. Make sure all plugs and spade connectors are secure and connected correctly.
7. Unplug power plug (Fan motor1 is white plug) Ohm out connections. U-V, U-W, V-W. The resistance value between each winding should be equal, under 10Ω and open to ground.
8. If all values are within range, remove fan connections from board and connect inverter checker to Fan PCB.
9. Press K2 button 11 times to initiate the inverter test for fan motor 1. Inverter test video
10. If the inverter test fails, replace Fan PCB. If it passes, replace fan motor.

**\*\* Before reconnecting any wire harnesses, leave the unit powered OFF for 15 – 20 min\*\***
