# iRobot Roomba 560 Fan Replacement

Replace the fan inside of the Roomba 560's vacuum bin.

Scritto Da: TJ Tamura

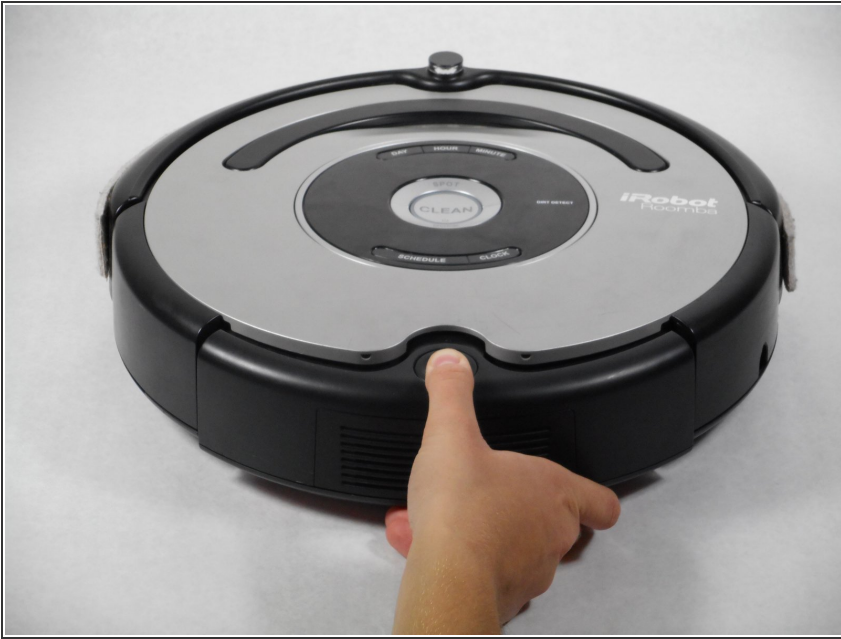
## Passo 1 — Fan

- Press the black circular button on the back end of the Roomba and pull the bin out towards you to remove the vacuum bin.

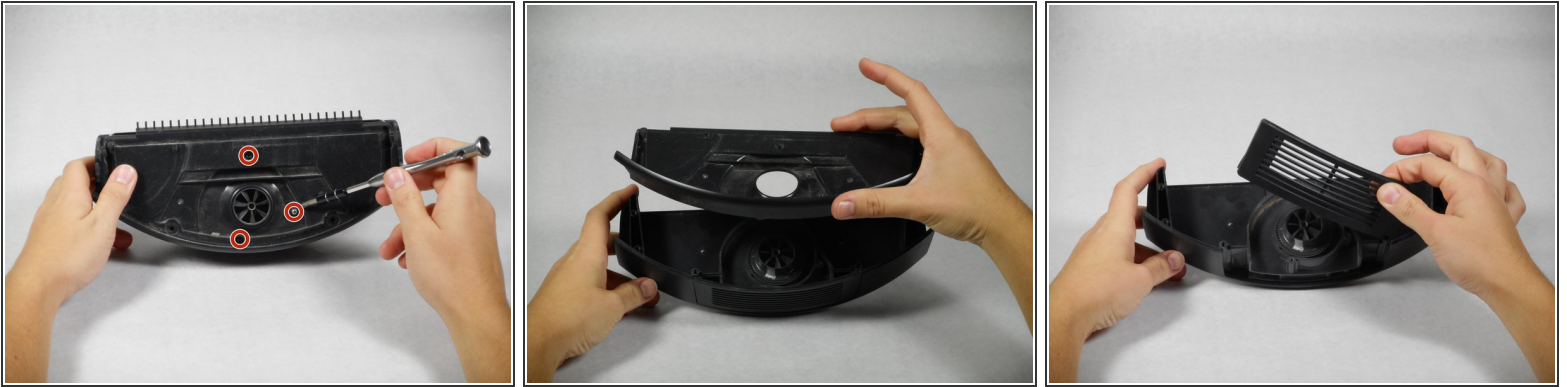
### Passo 3

- Remove the three 10 mm screws that surround the fan using the Phillips JIS #1 driver.
- Remove the casing that surrounds the fan by pulling it straight up.
- ⓘ The casing is composed of 2 parts (the large top casing, and a small air filter). If these parts detach, they are very easy to put back together. Do not lose the air filter.

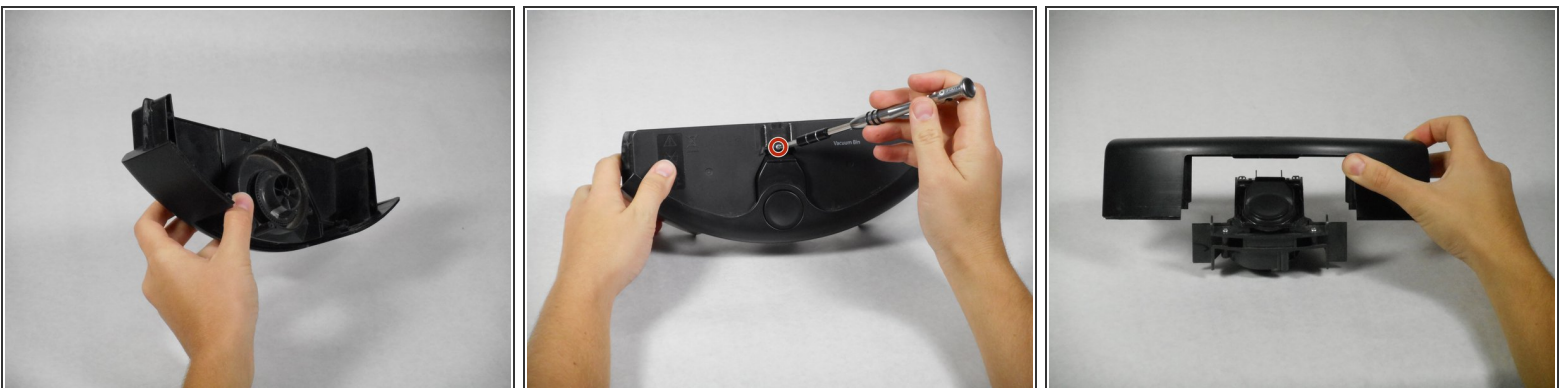
### Passo 4

- Turn over the remainder of the fan casing and remove the single 15mm screw, using the Phillips JIS #1 screwdriver.
- Remove the casing from the fan and battery component by pulling it straight up.
