SIB 65 09 20

## RECALL CAMPAIGN 20V-243: HEAD AIR BAG (LEFT-SIDE)

This Service Information Bulletin (Revision 2) replaces SI B65 09 20 **dated May 2020**.

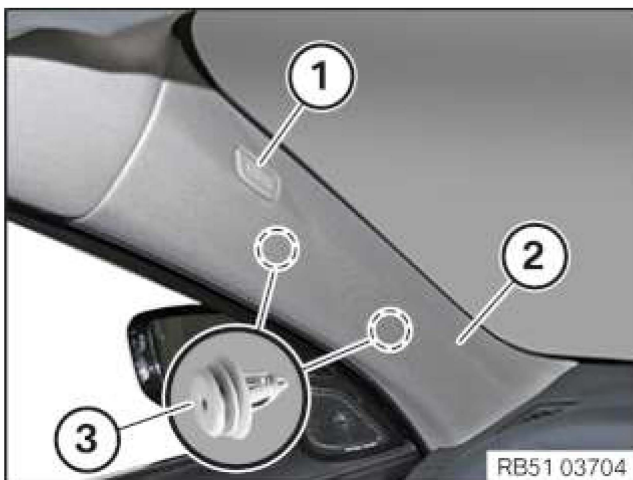
- Unclip cover panel (1) and unscrew the bolt below it.
- Detach A-pillar trim panel (2) from the clips (3) and remove upward.
