Subject: E210 Error Code

Models: DVM Heat Recovery, ECO Heat Recovery

Title: MCU Communication Error. There is no communication for 2 minutes between Outdoor Unit and MCU(s).

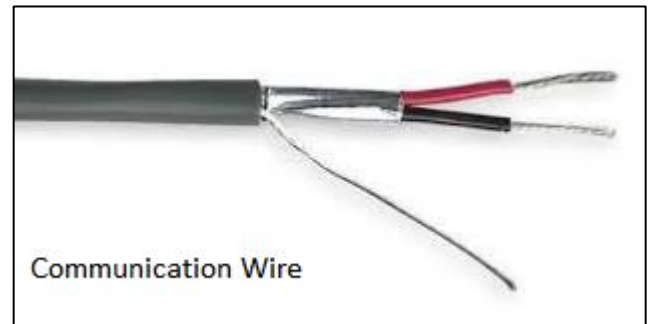
1. Verify all MCU and HR changers have 208/230Volts
2. Make sure communication wire is 16/2 stranded shielded wire
3. Verify communication wiring is a true daisy chain from condenser and land on MCU or HR changer 1st as shown in the image below. Verify there are no breaks, junction boxes or splices in comm wire.
