# Evaluation Report

## Case IH 8380 Mower Conditioner

## CASE IH 8380 MOWER CONDITIONER

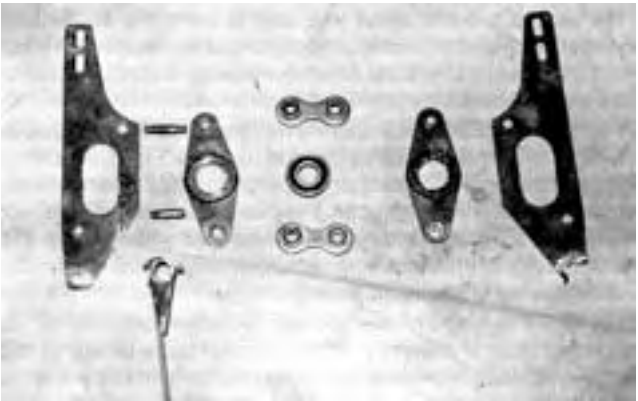
**Sway Bar:** At 106 hours the lower link pin in the right sway bar failed (FIGURE 4). Damage was confined to the sway bar assembly and the sickle head on the right knife bar. The sway bar was replaced as a unit. The sickle head was also replaced.

FIGURE 4. Failed Knife Drive Mechanism.

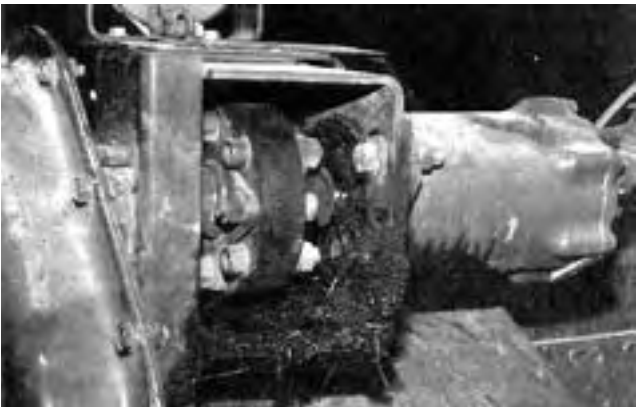
**Hydraulic Motor:** The oil seal on the output shaft leaked a small quantity of oil throughout the duration of the test. No attempt to repair was made (FIGURE 5).

FIGURE 5. Leaking Oil Seal on Hydraulic Motor.
